RE: Permit to Mine No. 603
In Situ Uranium Wellfield Release Report

Power Resources, Inc Smith Ranch-Highland Uranium Project URANIUM IN SITU WELLFIELD FLUID RELEASE REPORT

FAILURE OF BRASS NIPPLE HOSE CONNECTIONS ON INJECTION WELL HI-35

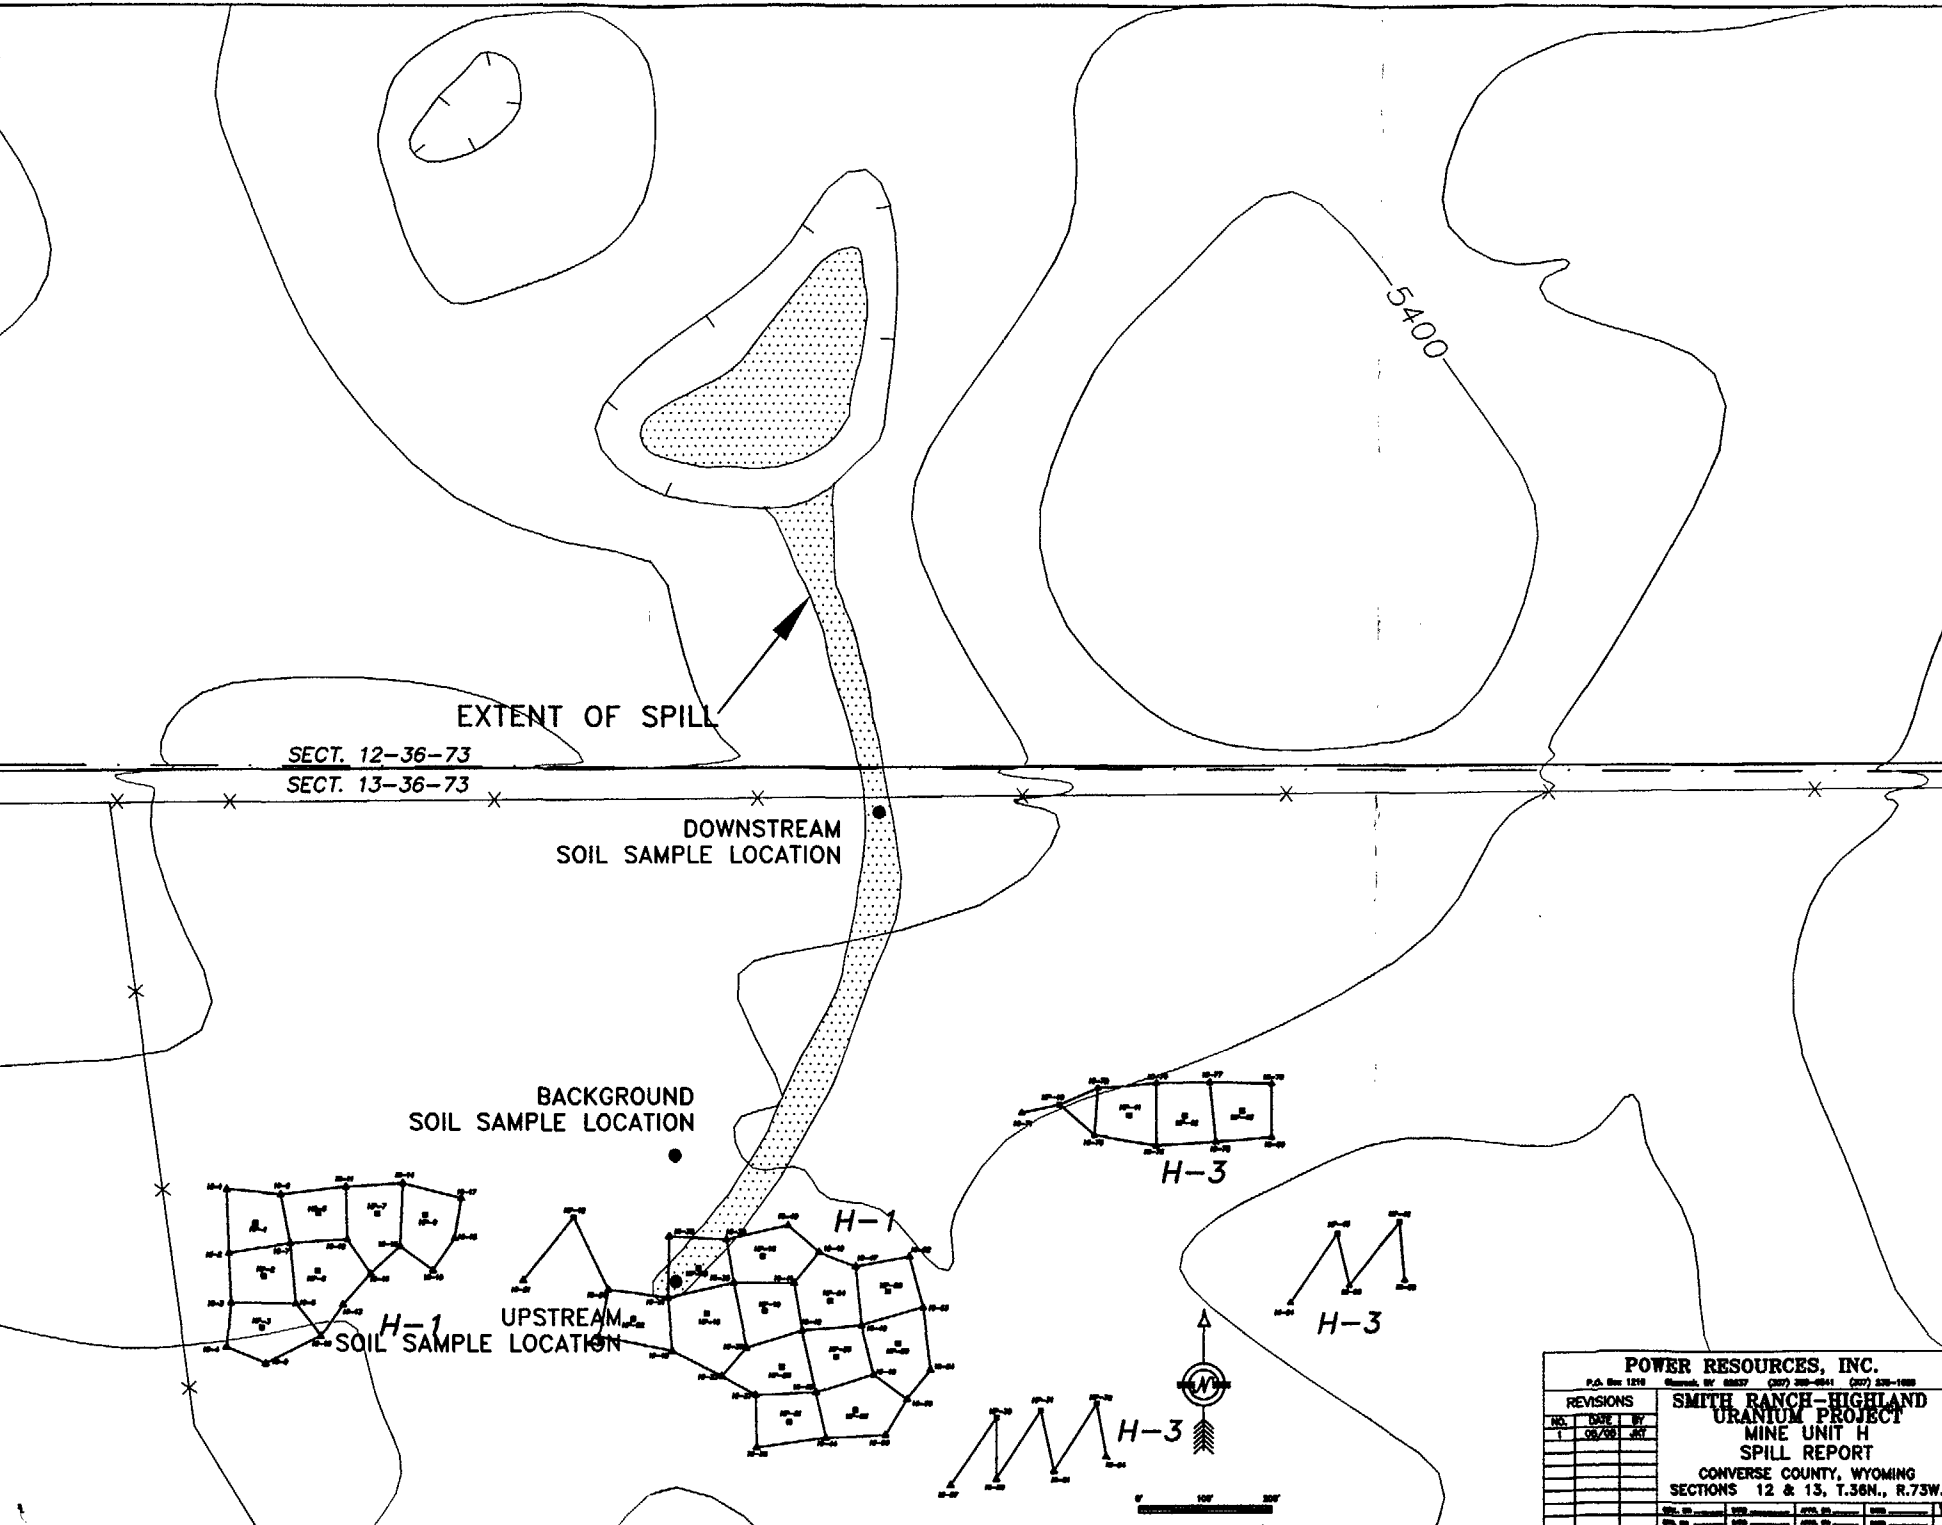
**SMITH RANCH-HIGHLAND
URANIUM PROJECT
MINE UNIT H
SPILL REPORT**
CONVERSE COUNTY, WYOMING
SECTIONS 12 & 13, T.36N., R.73W.

An estimated 20,700 gallons of Injection Fluid flowed from the hose onto the ground. The released fluid flowed approximately 1400 feet down an ephemeral draw where it then entered a small playa. A portion of the playa was ponded with runoff water from recent rain and snow events and a portion of the spilled Injection Fluid mixed with this runoff water. A retaining trench was dug upstream of the playa to catch any remaining fluid draining from the draw. Samples of the pond were taken and sent to an external lab for analysis and additional soil samples will be taken to determine potential effects in the playa area.

The release occurred in the SW ¼, SE ¼, Section 12, T36N, R72W and affected approximately 1.5 acres. The exact location and extent of the spill is shown on the attached map.
