Byron Station, Unit 1
Facility Operating License No. NPF-37
NRC Docket No. STN 50-454

Subject: Response to Request for Additional Information Regarding the Byron Station, Unit 1, Loop Stop Isolation Valve

Attachment 2: Plant Issue Resolution Documentation #2005-02, Revision 1

Response to NRC Request for Additional Information (RAI)
Regarding the Byron Station, Unit 1
Loop Stop Isolation Valve, 1C
(Equipment Tag 1RC8002C)

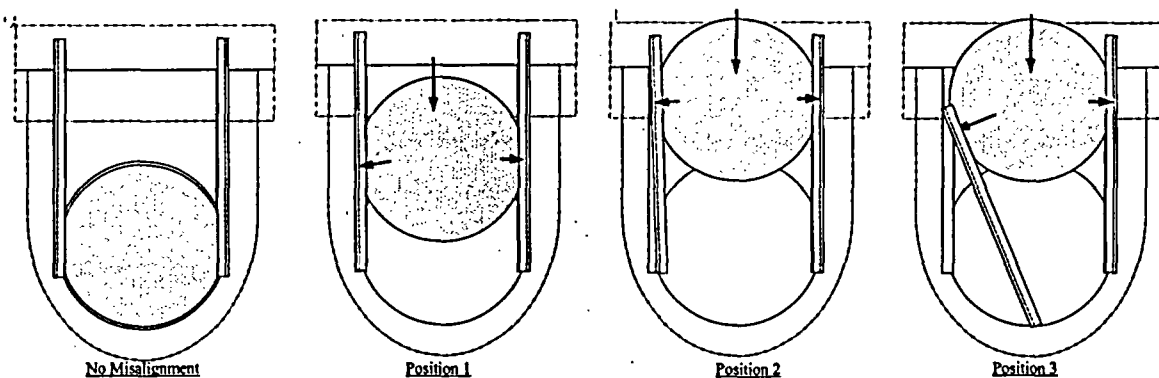
No formal calculations have been performed in evaluating the guide integrity; however, using a very simplified approach, three misalignment positions (as illustrated below) were considered for the guide to evaluate the potential for significant damage up to and including fracture. The results of these three cases are based on standard equations used in determining moments of inertia, bending moments and total stresses in the mispositioned guide.

Position 1

The valve guide on the shelf of its retaining groove with a misalignment of approximately one degree. For this location, the valve disk is assumed to contact the guide at its mid-height.

Position 2

The valve guide on the edge of the shelf with a misalignment of approximately four degrees. Based on valve geometry, the disk would contact the guide at approximately 1/4th its length.

Position 3

The valve guide end resting at the bottom of the valve. This would result in an angle of approximately 20 degrees. At this position, the valve disk would be bound up against the guide at approximately 1/10th its length. In addition, a 10-degree misalignment is also considered in the direction along the flow.

For position 1, the guide is postulated to be slightly out of alignment. The thrust force required to yield the guide was calculated assuming this guide takes 100% of the thrust force generated by the valve operator. Considering the guide as a simple beam supported at its ends, the normal force (i.e., perpendicular to the guide) required to yield the guide is 11,700 lbs. At one degree, this corresponds to a vertical thrust force greater than 600,000 lbs. The deflection of the guide was also calculated at the mid-height based on the load required to yield the guide. The calculated deflection at the mid-height is approximately 1/2-inch, which is greater than the offset of the guide; thus, the guide would deflect into the retaining groove in the valve body resulting in additional support of the guide before it could reach the yield limit of the guide material.

Position 3 considered the valve guide at the bottom of the valve body with 20 degree misalignment plus 10 degree misalignment in the direction of the flow. This configuration will result in biaxial bending of the guide. At this location the disk makes contact with the guide at approximately 1/10 its length. The thrust force acting on the guide required to cause yielding of the guide under these conditions is approximately 85,000 lbs. Considering the thrust is also resisted by the other guide from friction caused by the lateral shifting of the disk due to misalignment of the opposite guide, the total thrust required to cause deformation will be much greater, i.e., in the 100,000 to 150,000 lb range.
