Final Report – Scenario Disposition

**SPENT FUEL POOL
PHYSICAL INSPECTION**

**Search for Unaccounted For A-49 Fuel Rod Segments and
Other Special Nuclear Material**

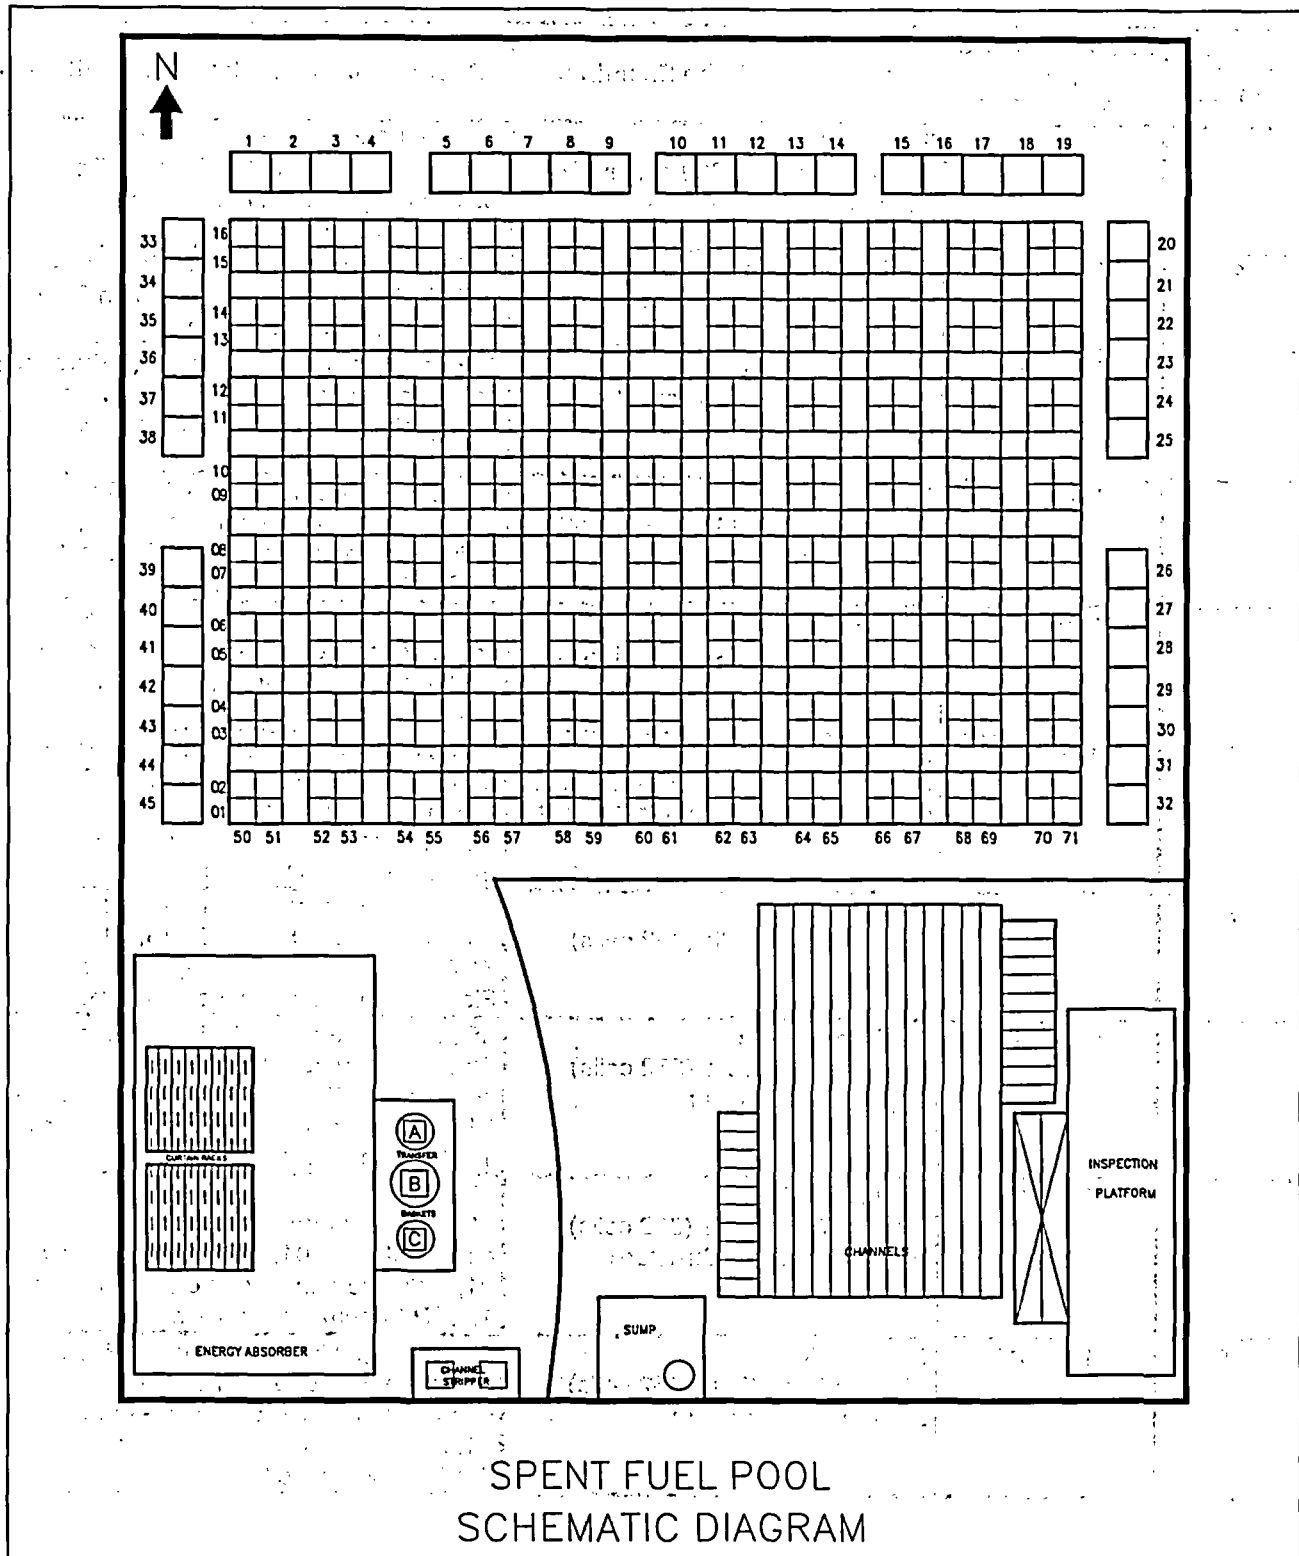
Figure 1

Area/ Item No.	SNMP Scenario No. SAP8065936	Area or Item to be Examined	Description & Location of Area/Item
1	1-04-01a	Fuel Rack Area Fuel Assemblies (389 assemblies, does <u>not</u> include UD6N)	389 Fuel Assemblies located in the Peripheral Cells and the Storage Rack Cells as depicted on Figure 1, SFP Schematic Diagram.
2	1-04-01b	Fuel Rack Area Peripheral Cells (45 cells)	45 Peripheral Cells noted as locations 1 – 45, inclusive and as depicted on Figure 1, SFP Schematic Diagram.
3	1-04-01c	Fuel Rack Area Peripheral Cells (45 cells) Upper Rack Structure	45 Peripheral Cells Upper Rack Structure noted as locations 1 – 45, inclusive and as depicted on Figure 1, SFP Schematic Diagram.
4	1-04-01d	Fuel Rack Area Peripheral Cells (45 cells) Middle- Tier Rack Structure	45 Peripheral Cells Middle-Tier Rack Structure noted as locations 1 – 45, inclusive and as depicted on Figure 1, SFP Schematic Diagram.

5	1-04-01e	Fuel Rack Area Peripheral Cells (45 cells) Lower Rack Structure	45 Peripheral Cells Lower Rack Structure noted as locations 1 – 45, inclusive and as depicted on Figure 1, SFP Schematic Diagram.
6	1-04-01f	Fuel Rack Area Peripheral Cells (45 cells) Between Cells and SFP Walls (North, East & West)	Areas of the Peripheral Cells Between Cells and SFP Walls (North, East & West) noted as locations 1 – 45, inclusive and as depicted on Figure 1, SFP Schematic Diagram.
7	1-04-01g	Fuel Rack Area Storage Rack Cells (352 cells)	352 Storage Rack Cells bounded by the grid coordinates 50-01, 50-16, 71-16 and 71-01, inclusive and as depicted on Figure 1, SFP Schematic Diagram.
8	1-04-01h	Fuel Rack Area Storage Rack Cells (352 cells) Upper Rack Structure	352 Storage Rack Cells Upper Rack Structure bounded by the grid coordinates 50-01, 50-16, 71-16 and 71- 01, inclusive and as depicted on Figure 1, SFP Schematic Diagram.
