RE: Permit to Mine No. 603
In Situ Uranium Wellfield Release Report

Power Resources, Inc Smith Ranch-Highland Uranium Project URANIUM IN SITU WELLFIELD FLUID RELEASE REPORT

FAILURE OF FUSED JOINT ON 6-INCH POLY FEEDER LINE AT THE VALVE STATION MANHOLE

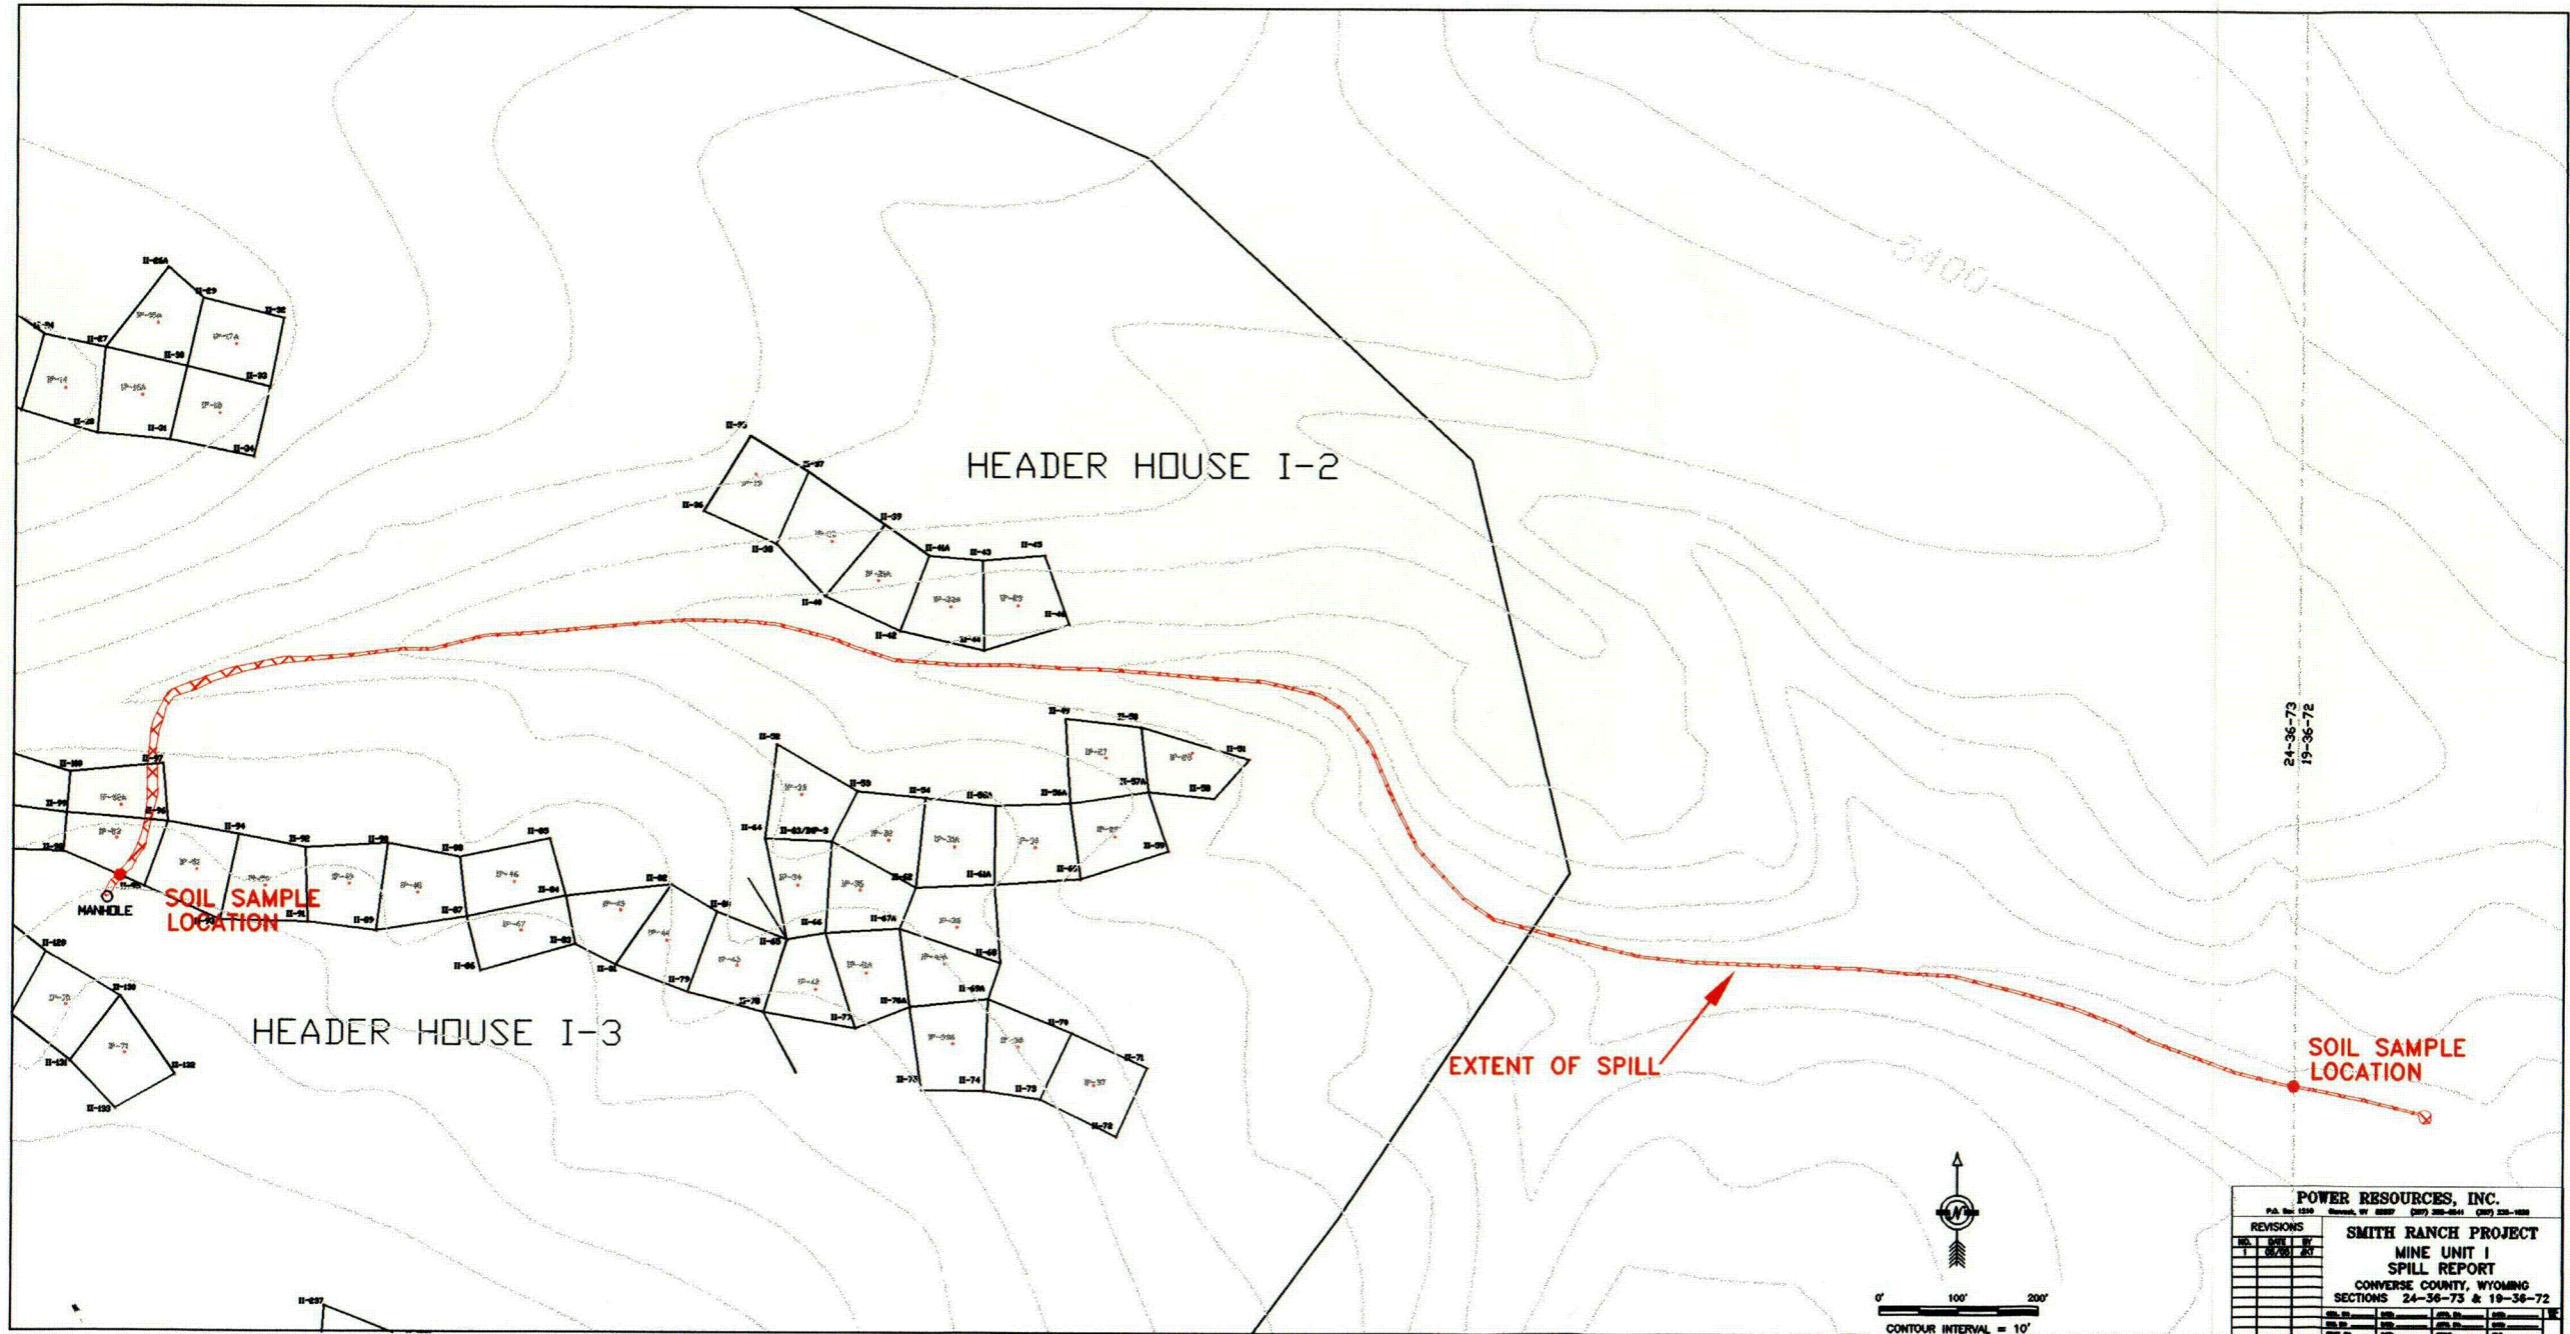
SMITH RANCH PROJECT
MINE UNIT I
SPILL REPORT
 CONVERSE COUNTY, WYOMING
 SECTIONS 24-36-73 & 19-36-72

The release occurred in the SE ¼, SW ¼, Section 24, T35N, R73W and affected approximately 0.22 acres. The exact location and extent of the spill is shown on the attached map.
