July 10, 2005
JAFP-05-0106

**SUBJECT: James A. FitzPatrick Nuclear Power Plant
Docket No. 50-333
Request for Additional Information on Relief Request No. RR-38,
Proposed Alternative to Perform a Temporary Non-Code Repair in
accordance with 10 CFR 50.55a(a)(3)(ii)**

**Additional Information on Relief Request No. RR-38
Non-Code and Code Repair Discussion**

**Additional Information on Relief Request No. RR-38
Temporary Support for RHR SDC Line**

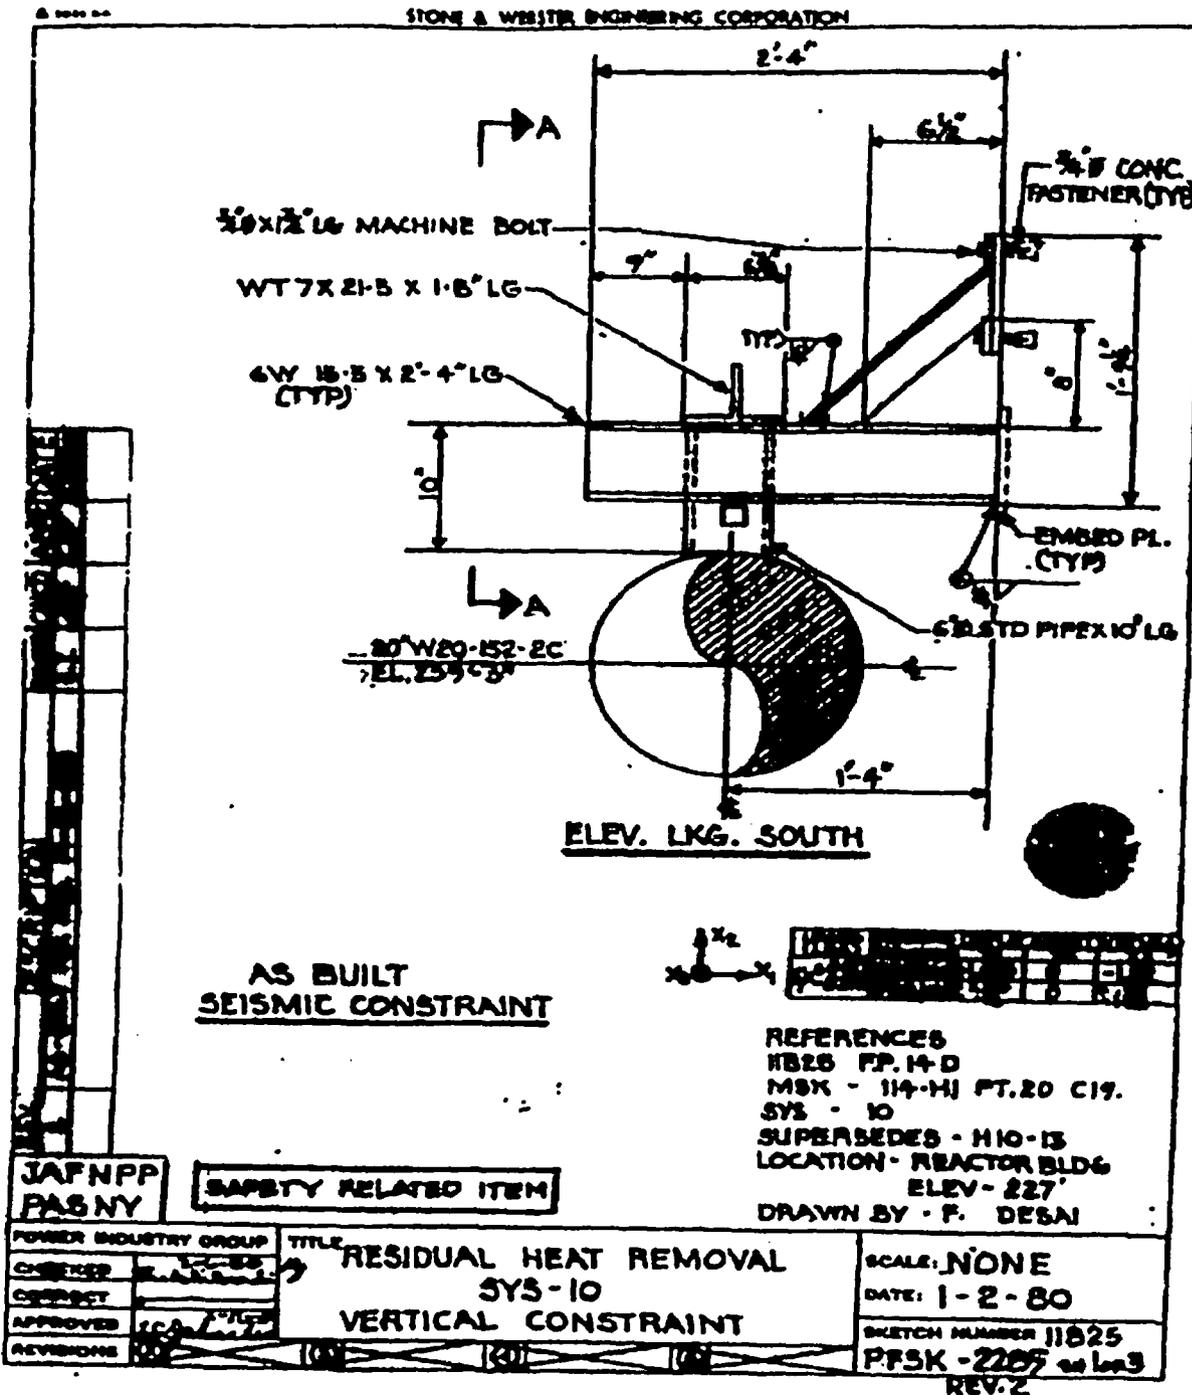
Additional Information on Relief Request No. RR-38
 Temporary Support for RHR SDC 1 line

The subject piping through-wall crack is a 6.5" linear crack in the 20" RHR SDC pipe, which follows the toe of the pipe support trunnion-to-pipe fillet weld. This integral attachment weld is a 3/8" fillet weld, continuous around the 6" (6.625" OD) pipe trunnion for a total length of 21" with the crack comprising about 31% of the total length. The crack extent was determined based on a VT-1 ISI Visual exam (100% of the weld), and confirmed by a "Fluorescent Wet-Mag" Surface exam for about 60% of the weld based on accessibility. The remaining third of the weld (back side of the trunnion) opposite of the crack was verified to have no indications based on a PT Surface exam.

The subject degraded pipe support (PFSK-2285) is designed as a two-way vertical support, primarily for a downward dead load, but also for plus and minus vertical dynamic loads (seismic and torus-attached piping loads) as well as a small downward thermal load. The support configuration is designed as a lateral sliding support such that the pipe is not restrained in any of the lateral directions (except for minor lateral loading on the support due to friction). Less than two feet away is another permanent rigid support (PFSK-2084), which assists primarily in carrying downward loads, but no dynamic upwards load. The piping displacements are negligible due to the line being supported and restrained in all directions for dynamic load conditions (seismic and torus loads). The only operating conditions that are not specifically analyzed for is fluid transients and normal piping vibration, which are outside the design requirements. Fluid transients (such as water hammer) would not be expected to cause a significant challenge to this degraded pipe and support due to the lateral and axial dynamic restraints on the piping (anchor, snubbers, and struts). The normal piping vibration was attributed as the primary factor in the apparent high cycle fatigue failure at the trunnion-to pipe attachment (Ref. Root Cause Analysis Report for CR-JAF-2005-02749). This piping vibration has been significantly dampened out at the subject PFSK-2285 trunnion location by the addition of a shim plate under the bearing plate at support PFSK-2084 immediately after the pipe leak was discovered.

- The primary cause of the failure was high cycle fatigue due to vibration. The condition developed during shutdown cooling mode of operation cumulative over the 30 year life of the plant. The localized vibration at this failed trunnion support has been significantly reduced by restoring the adjacent support (PFSK-2084) by installing a shim plate where the support was not load-bearing as intended. The reduced vibration at the failed trunnion support during shutdown cooling mode is no longer a significant concern for the relatively short term that this degraded condition will remain in effect.

- The pipe crack will be stressed-relieved locally by applicable technique recognized within fracture mechanics (commonly referred to as “crack arrest”), which involves drilling approximately 1/8” diameter hole through the pipe at each end of the crack. This effectively prevents the crack propagation mechanism by eliminating the stress riser at the tips of the crack.

- The primary design load at the degraded PFSK-2284 support is dead load (4525# compared to either dynamic load case (+/-1097# seismic, or +/-2610# Torus loading). The bearing shim plate installed at existing adjacent support PFSK-2084 (only 2 feet away) will enable the that support to assist in carrying the dead load. As an extra measure, a suitable temporary deadweight support is positioned under the pipe only a few feet down the pipe on the opposite side of the failed trunnion from PFSK-2084. Thereby two rigid dead load supports, straddling the degraded pipe support PFSK-2285 in close proximity provides a significant level of redundancy for the primary loading, and significantly reduces the downward load on the PFSK-2285 trunnion (for the DL+THER+SEIS+Torus loads all acting downward).

- A conservative evaluation has been performed to demonstrate that the fillet weld attachment between the trunnion and pipe for PFSK-2285 could be reduced 50% in length, and still provide adequate load capacity for the design conditions.
