VIRGINIA ELECTRIC AND POWER COMPANY
RICHMOND, VIRGINIA 23261

VIRGINIA ELECTRIC AND POWER COMPANY
SURRY POWER STATION UNIT 1
ASME SECTION XI INSERVICE INSPECTION PROGRAM
PARTIAL EXAMINATION RELIEF REQUESTS
RESPONSE TO REQUEST FOR ADDITIONAL INFORMATION

Virginia Electric & Power Company
Surry Power Station Unit 1
Third Ten Year Interval

Relief Request No. PRT-05 Revision 1

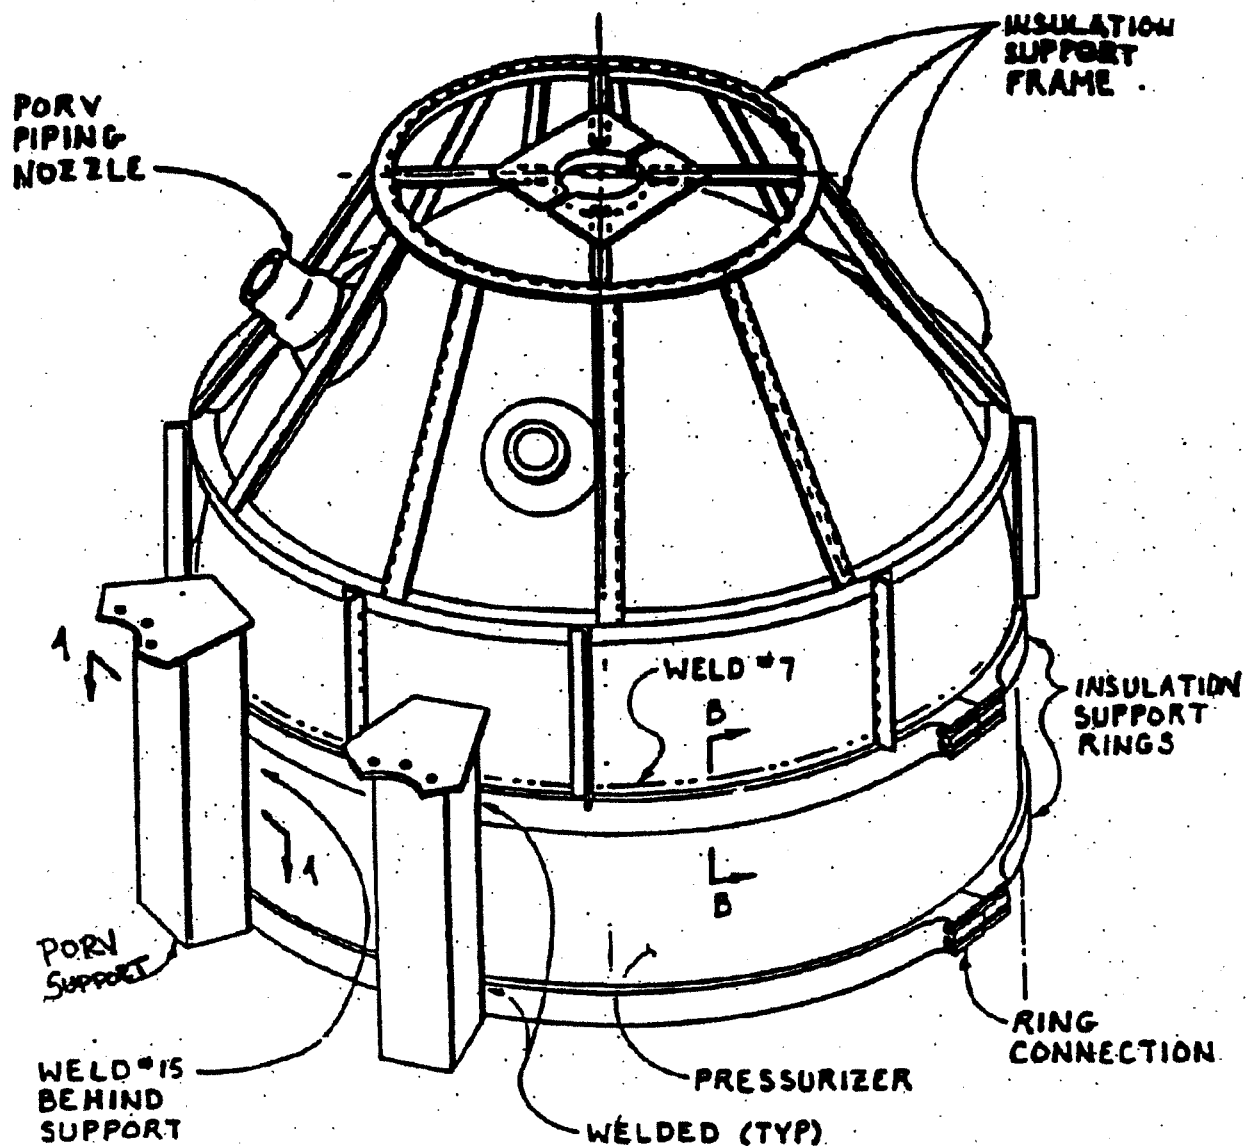
Figure 1

- a. The licensee provided, as Figure 1, a sketch showing how the pressurizer insulation support ring and the power-operated relief valve (PORV) welded support restrict access to make scans on Welds 1-07 and 1-15. This sketch adequately explains the limited access to examine the shell-to-head and intersecting longitudinal weld from the shell side. Also, the licensee provided the tables to indicate completed volumetric percentages for each of the scans on each weld. For example:

The pressurizer is covered with an insulation support ring (Figure 1). The insulation support ring is 6 inches wide at the location where examination interference is encountered for weld 1-07. As seen in Figure 1, this insulation support ring and a power operated relief valve support prevent the required volumetric coverage of both the upper circumferential head weld 1-07 and the intersecting longitudinal weld 1-15. Total removal of the insulation support ring at the mechanical connection is considered impractical due to high anticipated exposure levels, estimated at 18 man-rem. Partial removal of the support ring could allow some increased

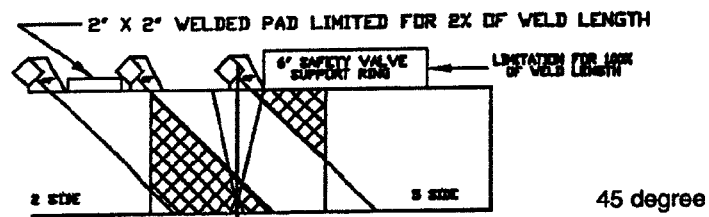
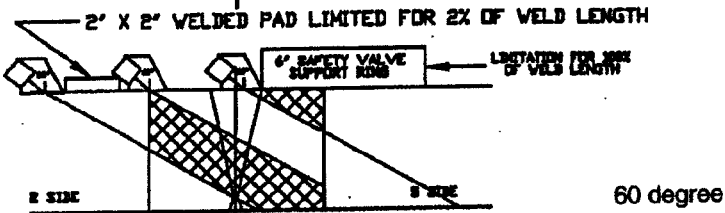
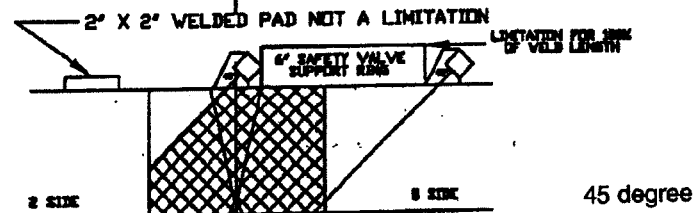
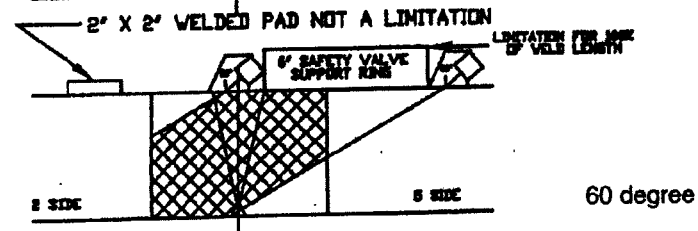
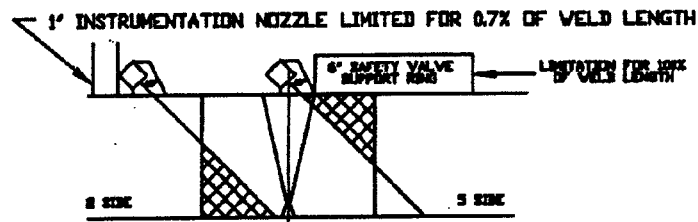
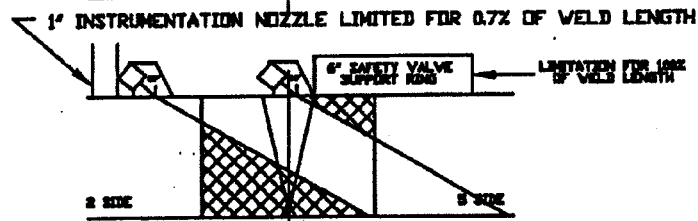
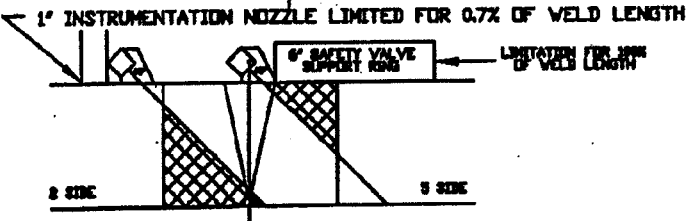
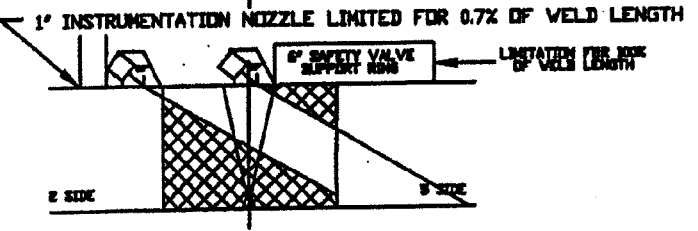
Weld 1-07, the circumferential head weld, was examined for 100% of the weld length. Examination coverage of the required volume was limited due to the position of hardware that supports the safety valves. Table 1 shows the percent volume that was examined by each scan direction. All areas were examined to the maximum extent practical for flaws oriented in the circumferential as well as the axial directions. The average total examination of all scan directions is 46%. These percentages are based on total volume of the weld per scan.

Figure 2 shows obstructions for weld 1-07 in the 2 and 5 directions using both 45 and 60 degree angle beams. The 2 direction was limited as shown by the safety valve support ring for the entire length of the weld. The 2" X 2" welded pad (typical of three) reduced the weld inspection as shown for 2% of the total weld length in the 2 direction. Also the instrument nozzles (typical of four) limited the 2 direction for 0.7% of the total weld length as shown for 45 and 60 degree angle beams. The 5 direction scan was limited by the safety valve support ring for the entire length of the weld. Total percentage covered is determined by calculating the cross sectional area not examined, multiplying by the percent limitation for the entire weld length attributed to that obstruction and subtracting from 100% coverage.

11448-WMKS-RC-E-2 1-07
 (Hatched areas represent no examination coverage)

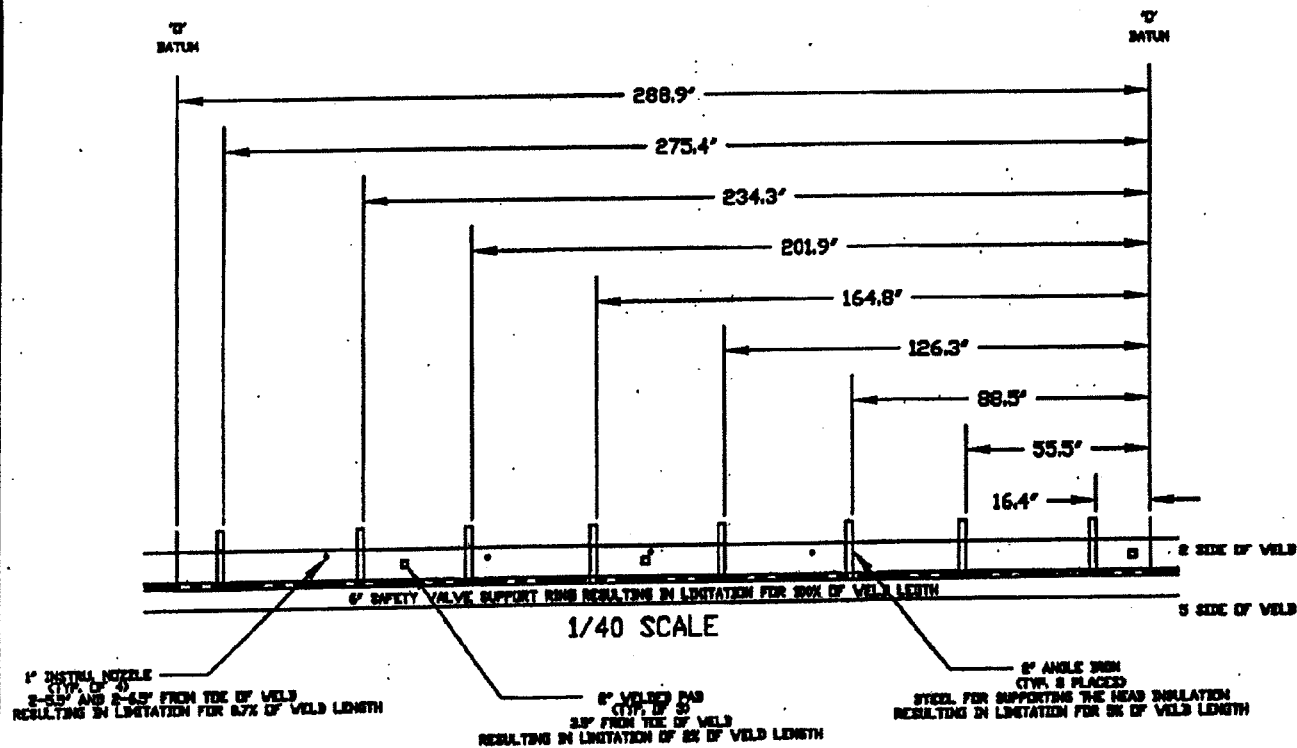
Figure 3 shows all obstructions laid out for the entire length of the weld with designated reference points. Reference for the 2 and 5 side orientation is shown.

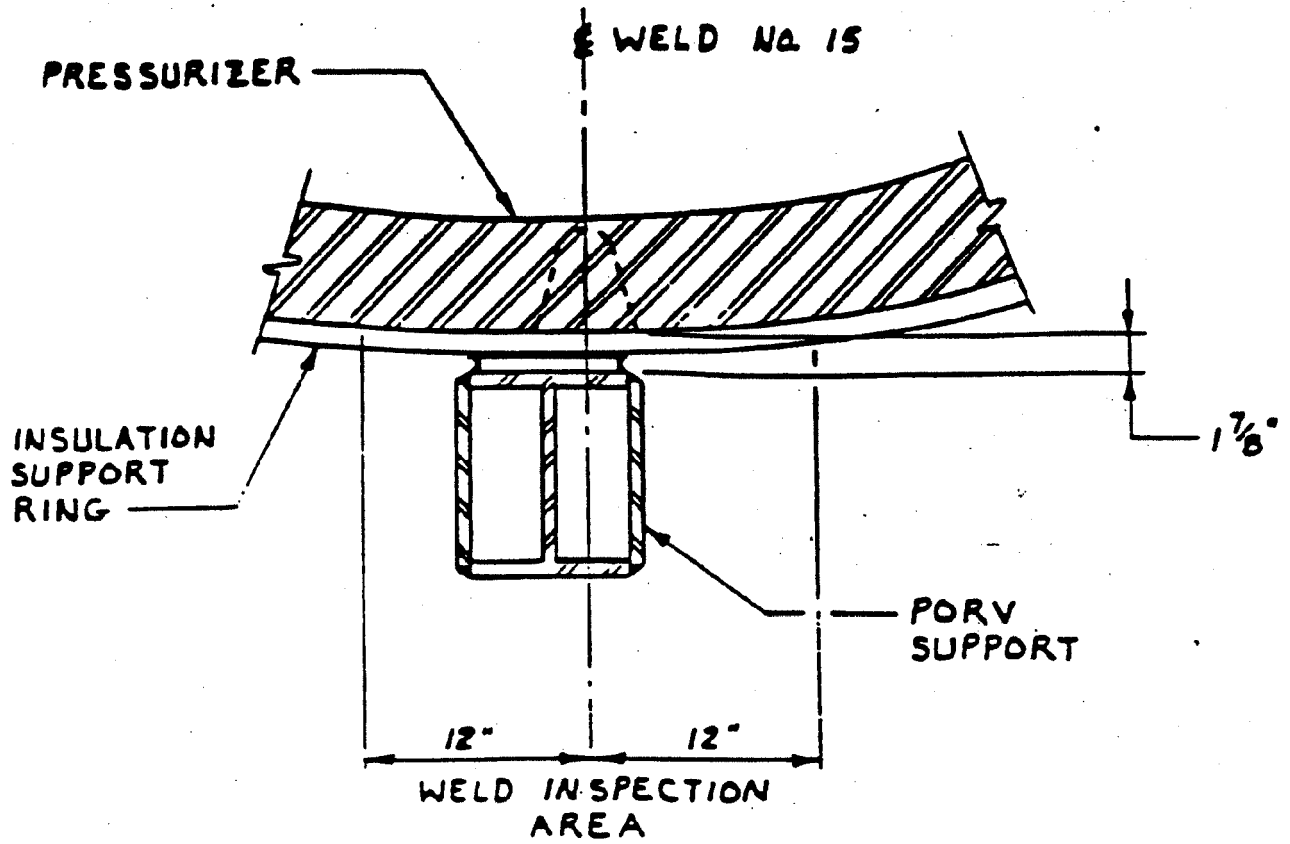
Weld 1-15 was examined to the maximum extent possible but was limited by the power operated valve support. Table 2 shows the percent volume achieved for each scan direction. All areas were examined to the maximum extent practical for flaws oriented in the circumferential and axial directions. The average total coverage of all scan directions is 30.5%, based on total volume of weld per scan.

Figure 4 shows the general configuration of obstruction for weld 1-15. Figure 5 gives greater detail for the particular scans for the 2 and 5 directions using 45 and 60 degree angle beams. The hatched areas indicate zero coverage due to the safety valve support. The percentage covered for the entire weld length is given for each scan direction on Figure 5 and was calculated by determining the cross sectional area not examined, multiplying by the percent limitation for the required weld length and subtracting from 100% coverage.

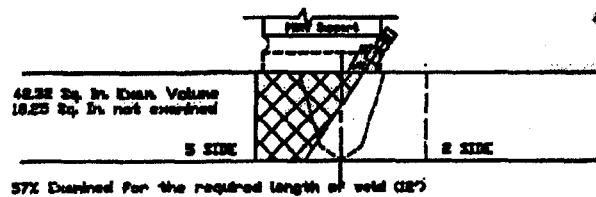
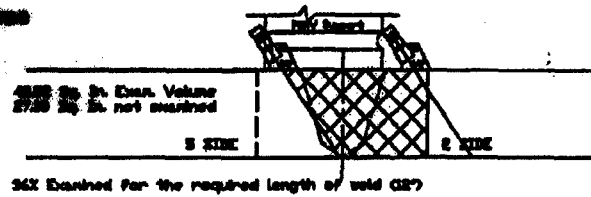
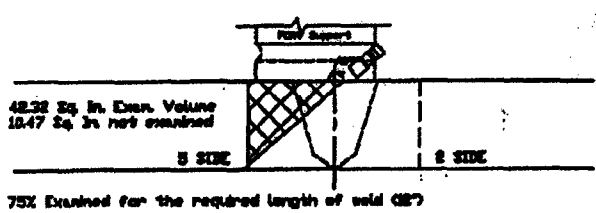
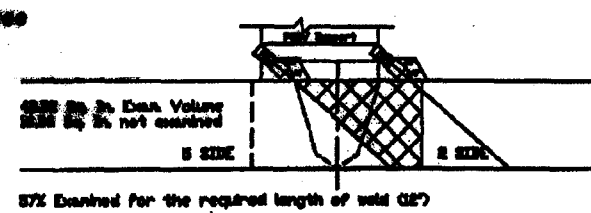
Figure 5

11448-WMKS-RC-E-2 1-15
 Pressurizer, Long Seam Weld
 (Hatched areas represent no examination coverage)
