Oconee Nuclear Station
Unit #1 Steam Generator
Discussion with NRC
Washington, DC
June 22, 2005

Introduction

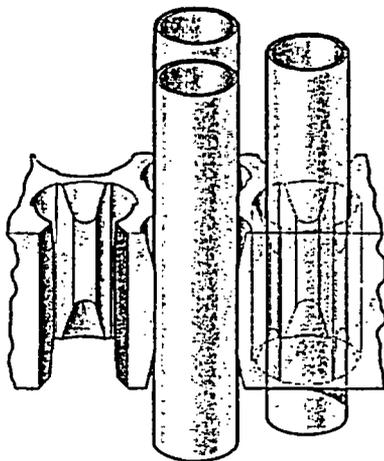
Hourglass Broached Hole

- Divergent nozzles have inherent flow instabilities due to jet switch from an imperfect configuration - tube is elastic
- Factors to consider:
 - Flow through a divergent cone can cause tube instability – prior worldwide experiences
- Actions:
 - BWC (M. Pettigrew) construct mock-up and perform tests
 - CFD model of tube to TSP interface

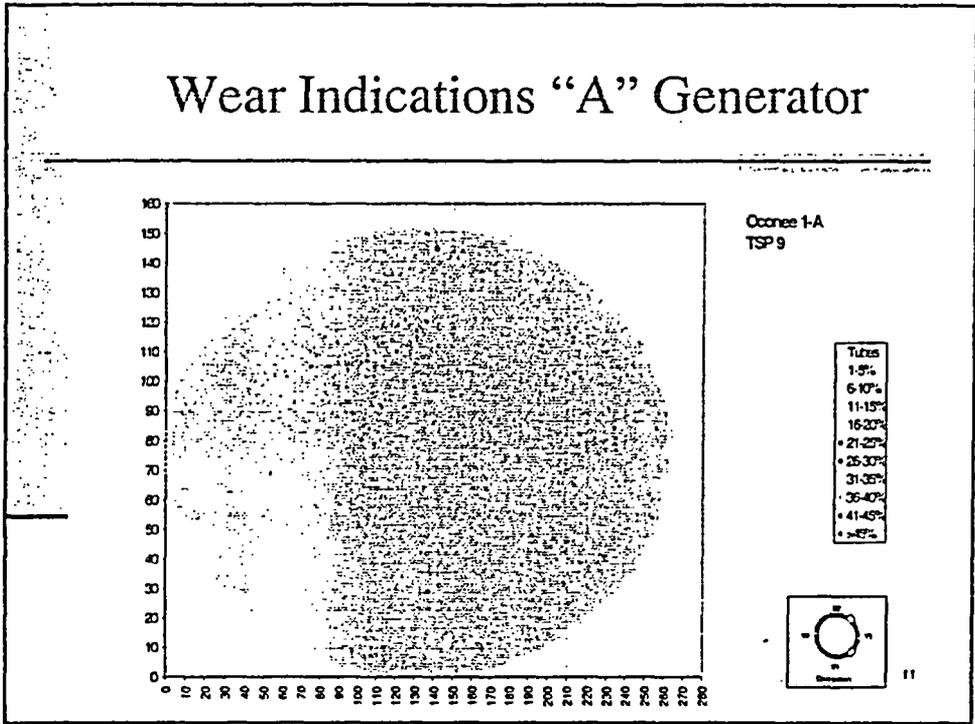
Wear Indications "A" Generator

- Most indications (~95%) appear in the superheated steam region in the periphery of the bundle
- Highest population of indications is at the 10th TSP followed by the 11th and the 9th

- Population of indications in the 12th TSP in the "B" SG is low but in the "A" SG 12th TSP the population is 4th highest
- The 15th TSP shows only a few indications (single side chamfer broached hole on the outer tubes ~10 inches)

- The outermost 4 tubes at the 14th TSP in both SGs has only 2 indications (1st four outer tubes are drilled not broached)
- 11th, 12th and 13th TSP have same broached hourglass holes with ½ inch bypass between the plate and the shroud blocked. The pattern of indications are similar with two exceptions

- The lack of indications at the 12th TSP of the "B" SG
 - Higher number of large indications at the 11th TSP in the "B" SG
- The 9th TSP is located just below the bleed port has broached single sided chamfer for ~14 outer tube rows. In the "A" SG this TSP has the most significant non-peripheral population of wear indications

- The single sided chamfer pattern for the 15th, 10th, and 9th TSP covers ~10 inches of the periphery. Indications at the 9th, and 10th TSP occur in both the single sided and hourglass broached holes
