South Texas Project
Unit 1
Docket No. STN 50-498
Request for Relief from ASME Boiler and Pressure Vessel Code,
Section XI Requirements for the Essential Cooling Water System (ECW Train 1C)
(Relief Request RR-ENG-2-40) (TAC No. MC-5192)

**SOUTH TEXAS PROJECT
REQUEST FOR RELIEF FROM ASME BOILER AND PRESSURE VESSEL CODE,
SECTION XI REQUIREMENTS FOR THE ESSENTIAL COOLING WATER SYSTEM
(ECW TRAIN 1C) (RELIEF REQUEST RR-ENG-2-40)**

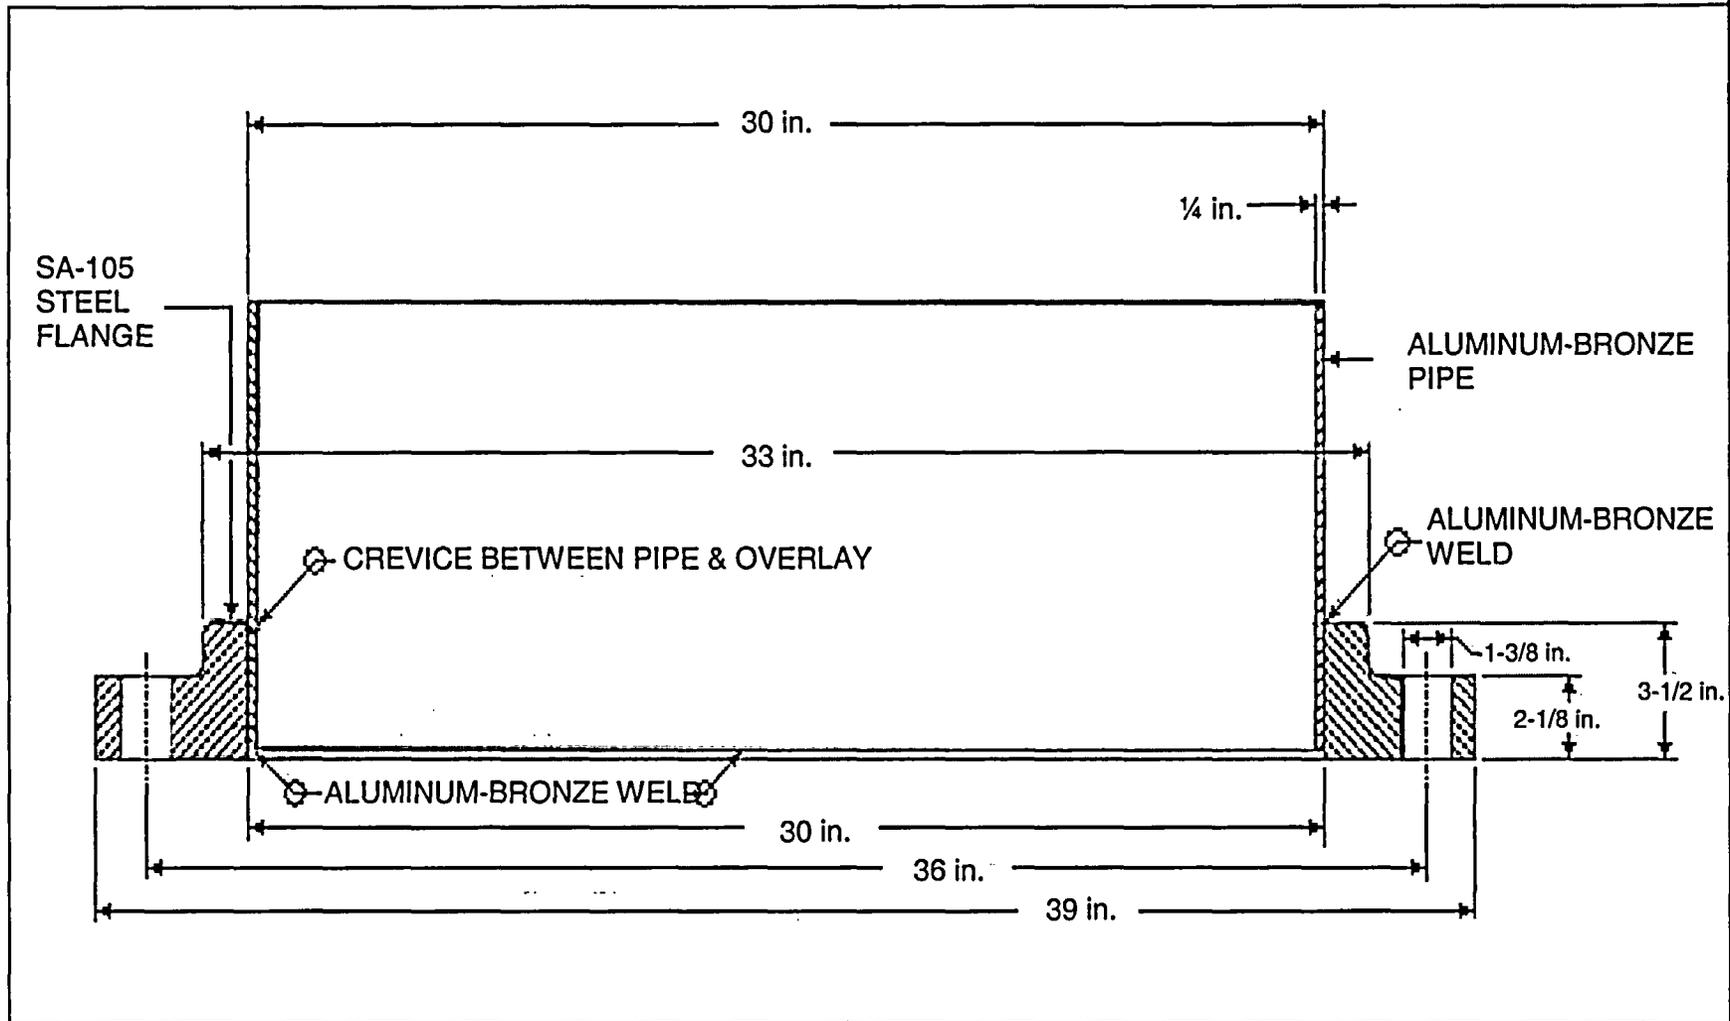
SLIP-ON FLANGE

Through-wall indications have been identified on the 30-inch pipe of the C train ECW system downstream of ECW valve EW-0101. Damage consists of pitting located immediately downstream of throttle valve EW-0101 on the inside wall of the pipe in an area covered outside the pipe by a slip-on flange. Some pitting has a maximum depth of 0.78 inch with corrosion extending into the flange. The root cause of the pitting was apparent cavitation resulting from required throttling of the upstream valve. While there is some damage to the slip-on flange, the slip-on flange and the attendant welds prevent leakage from the ECW system.

In addition, linear pipe indications were identified in the pipe underneath the flange in two areas.

- The ECW pipe separated from the connecting fillet weld resulting in a gap between the pipe and the flange. The separation extends approximately 20 inches along the pipe circumference.
- The second flaw is a through-wall circumferential crack 6.5" long located 3.5" from the flange face.

The apparent cause of these linear indications is high residual stresses initiated during assembly and exacerbated by high-cycle fatigue.

This relief request applies to damaged areas on the inside diameter of a 30-inch ECW pipe downstream of throttle valve EW-0101 for Component Cooling Water heat exchanger 1C. The damaged areas are covered external to the pipe by a slip-on flange where the pipe joins the throttle valve. The erosion has resulted in pitting of the aluminum-bronze pipe, to the point where the carbon steel material of the slip-on flange has experienced corrosion.

The pitting and linear pipe separations are through-wall, but underneath the pipe slip flange; consequently, there was no system leakage.

Contrary to ASME Section XI IWA-4310, defects were not removed prior to returning the affected train to service. The non-code repairs performed on the piping downstream of 1EW0101 consist of the following:

- Area 1 (Pitting/through-wall indications on the pipe near the flange face fillet weld):
 - Apply a seal weld to the pipe wall, or

- Remove the pipe wall where pitting is excessive. The remaining pipe shall be seal welded to the carbon steel slip-on flange, or
- Remove the pipe wall where pitting is excessive. The area from which the pipe is removed may have a replacement pipe segment installed that shall be seal welded on the perimeter to the existing pipe/flange.

- Area 2 (Separation between either side of the inside diameter fillet weld and the pipe wall/flange):

- Apply seal weld between the pipe wall and flange.

- Area 3 (Minor pitting of the pipe wall wetted surfaces near the flange):

- Apply a seal weld to the pipe wall, or
- Remove the pipe wall where pitting is excessive and seal-weld the remaining pipe to the carbon steel slip-on flange, or
- Remove the pipe wall where pitting is excessive. The area from which the pipe is removed may have a replacement pipe segment installed that shall be seal welded on the perimeter to the existing pipe/flange.

- Area 4 (Linear indication in the pipe wall 3.5 inches from the flange face):

- Apply seal weld to the length of the crack. Build up seal weld to approximately 1/4-inch thickness.

Voids and imperfections on wetted surfaces downstream of Valve 1-EW0101 were filled with Belzona 1111 to minimize further degradation. The Belzona application is not intended to repair the pressure boundary parts to satisfy the piping minimum wall thickness requirements. Belzona will serve solely as a barrier against erosion and corrosion until code repairs can be implemented.

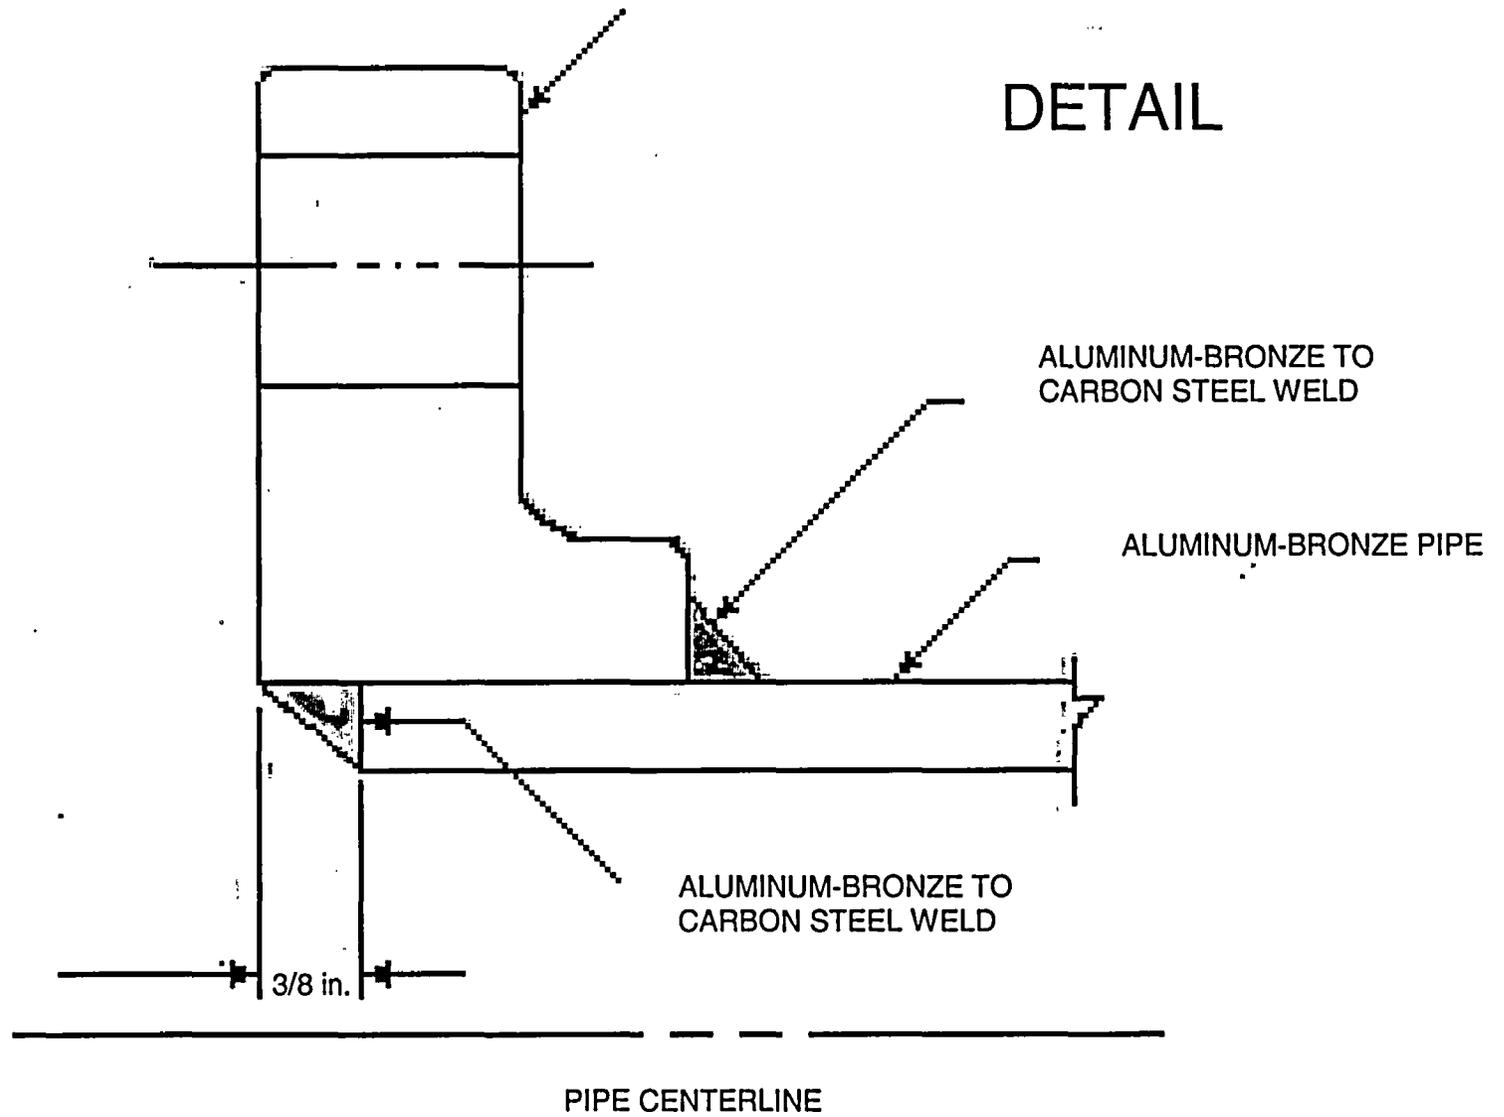
DETAIL

The aluminum-bronze pipe has a nominal diameter of 30 inches and a nominal thickness of 0.25 inch. The pipe material is SB 169 CA-614 rolled and welded plate (6-8 percent aluminum) fabricated to SA-155 tolerances. The slip-on flange material is SA-105 carbon steel. The slip-on flange is welded to the 30-inch aluminum bronze pipe with fillet welds at both ends. The configuration is depicted in the attached figures.
