102-05316-DMS/CKS/DJS
August 3, 2005

**Subject: Palo Verde Nuclear Generating Station (PVNGS)
Unit 2
Docket No. STN 50-529
License No. NPF-51
Licensee Event Report 2005-002-00**

4. TITLE
T/S 3.0.4 Violation; mode change made with one of two required LPSI pumps inoperable

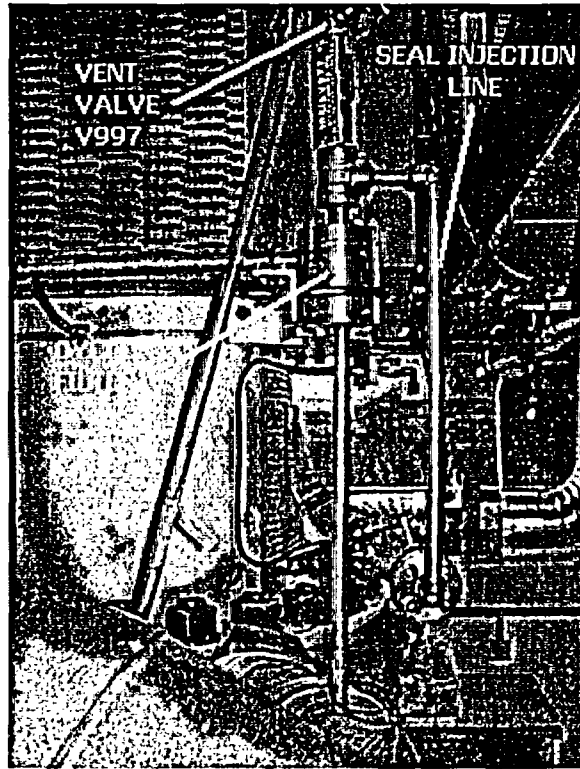
PHOTO : Cyclone Filter / High Point Vent

Apparent Cause: air accumulation in the seal flush water lines apparently interfered with the supply of water to the seal faces allowing the seal to overheat and degrade.

The seal assembly is supplied with high pressure, clean, cooling water through the 'flush port' in the gland plate (inboard of the seal faces). The flush port injection line is piped from the LPSI pump's cyclone filter which is external to the pump. The cyclone filter is a high point in the injection line and is vented by means of a valve (valve designator 2PSIAV997). This valve vents the cyclone filter, the injection line, and the seal assembly. The injection lines were not blocked or obstructed, as they were verified the clear during the seal replacement.

The LPSI A pump was started six times between April 18, 2005 when the seal was replaced and May 17, 2005 when the evidence of leakage was observed in the pump room. Prior to the first two starts, the pump was vented at valve 2PSIAV977, which is considered a vent point only addressed by procedure when bringing the pump out of a maintenance activity or at the discretion of the Control Room Supervisor. It was not procedurally required to vent at 2PSIA977 and therefore not vented at that location prior to the next four starts creating the possibility that air entrained in the system accumulated in the cyclone separator while the pump was shut down and caused seal degradation during one or more of the last four pump starts. There is no evidence to conclusively indicate the observed degradation occurred with any single pump start.

The photograph on the following page illustrates the equipment discussed in this report.

- A corrective maintenance work order (CM #2800334) was initiated for the leaking mechanical seal and the LPSI 'A' Pump was repaired on May 18, 2005. The mechanical seal was removed, disassembled, inspected, rebuilt, and reinstalled using in-house Mechanical Maintenance procedure 31MT-9SI01.
- CRAI #2819014 has been generated to require Operations to vent the cyclone filter prior to each manual LPSI or Containment Spray (CS) (EIS: BE) pump start.
