**DOMINION ENERGY KEWAUNEE, INC.**  
**KEWAUNEE POWER STATION**  
**LICENSEE EVENT REPORT LER 2005-010-00**

Report No. 50-305/LER 2005-010-00

**TITLE (4)**  
**Inadequate Engineering Analysis to Support Service Water Pump Operability**

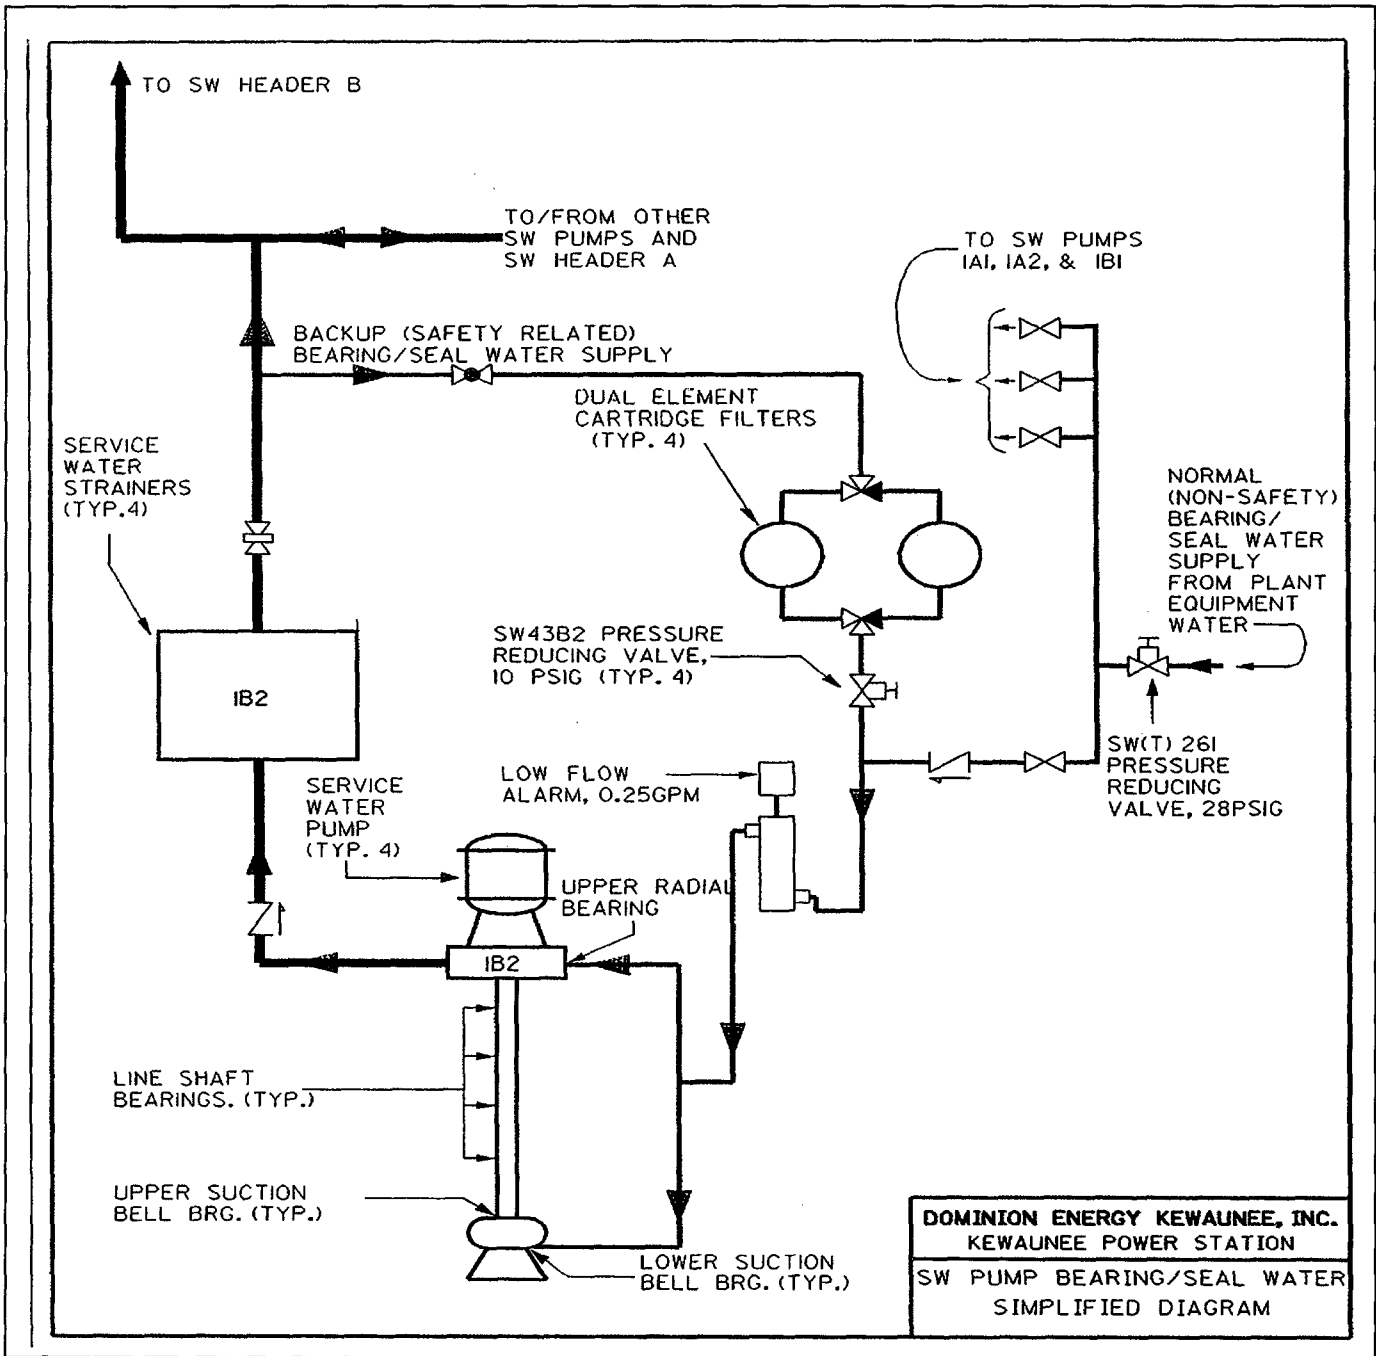
**FIGURE 1**

Safety related SW is supplied by four vertical centrifugal pumps (refer to Figure 1 on Page 5 of this LER). Cooling and lubrication for the bearings is provided by an external source of clean bearing/seal water. This external bearing/seal water flow is provided to keep the bearings free of dirt, prolonging bearing life. Bearing/seal water, injected near the packing gland, flows through the upper stuffing box bearing and down through all the line shaft bearings and the upper suction bell bearing. A second bearing/seal water line runs down the outside of the pump to the lower suction bell bearing.

The upper stuffing box bearing is located above the level of the pumped fluid. Therefore, if bearing/seal water to the stuffing box bearing is lost the bearing may operate dry. This would be expected to lead to the overheating of the bearing and possible seizure.

If a plant event causes a loss of the non-safety related plant equipment water system, the safety related SW supply would automatically begin supplying bearing/seal water to the SW pumps through the cartridge filters. If lake conditions were turbulent with increased sand and sediment levels in the intake water, or if there was a severe lake weed intrusion in progress, the cartridge filters could begin clogging. As discussed above, the exact time it might take until clogging became severe is not known. If the cartridge filters became excessively clogged, a low flow alarm in the control room [CR] would have occurred. An operator would have been dispatched to shift to the standby cartridge filter and maintenance would have been called to replace the filter that was taken out of service. It is not known how long the operators would have had to respond before bearing/seal water injection flow was completely lost. It is also not known how long a service water pump would continue to operate if bearing/seal water injection were completely lost. It is possible that the stuffing box bearing would overheat, leading to seizure of the shaft.
