Section 2:
Session 2: Continued Plant Operation

**Background and Technical Basis for the ASME Section XI Process for
Evaluation of Upper Head Penetration Flaws**

MAINTENANCE STRATEGY OF INCONEL COMPONENTS IN PWR PRIMARY SYSTEM IN FRANCE

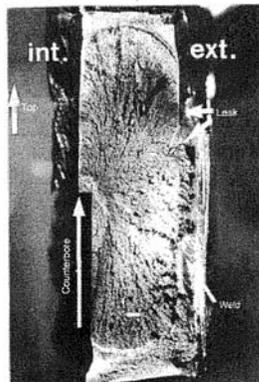
Secondly, after a destructive examination of the T54 VH penetration, the crack was initiated from inside and had a through wall extent that explained the leak.

Fig. 1: TWE crack in T54 VH penetration

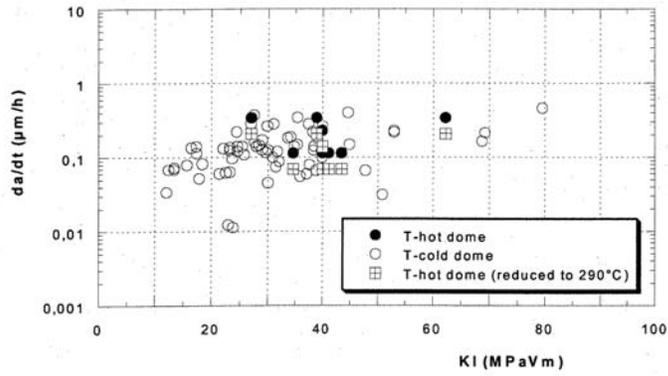
Figure 2 presents the variation of the crack growth rate da/dt as a function of the stress intensity factor K for the T-hot and T-cold domes. In this representation, the points corresponding to the T-hot dome do not differ from those corresponding to the T-cold dome.

Fig 2 : Field data - T-hot dome data (300°C) reduced to 290°C with $Q = 130$ KJ/mol and T-cold dome data (290°C)

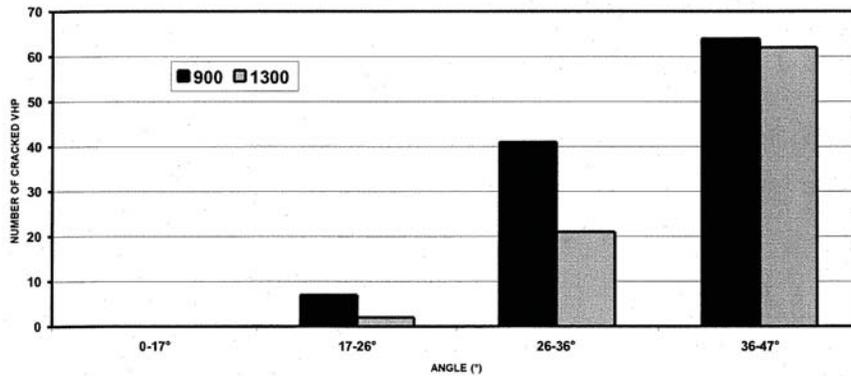
- Firstly, it is obvious that the level of stress has a major role for the initiation and propagation cracking. The main fact concerns the number of cracked VH penetrations and the circle where it belongs. Figure 5 shows that peripheral penetrations are mostly cracked compared with central ones.

Fig. 5 : Importance of the “angle effect” versus VH penetrations cracking

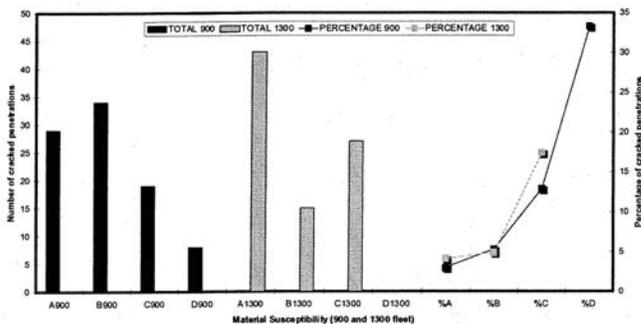
properties of each penetration. Figure 6 shows the effect of this susceptibility. Type B and C heat number are more often cracked than type A heat number but A type VH penetrations heat are more numerous. So in percentage, the value is undervalued. The effect also exists for type D but is less obvious due to the small amount of type D VH penetrations.

Fig 6 : Importance of the material susceptibility versus VH penetrations cracking (percentage values are given versus the total number of penetrations in standardized plant series 900 or 1300)

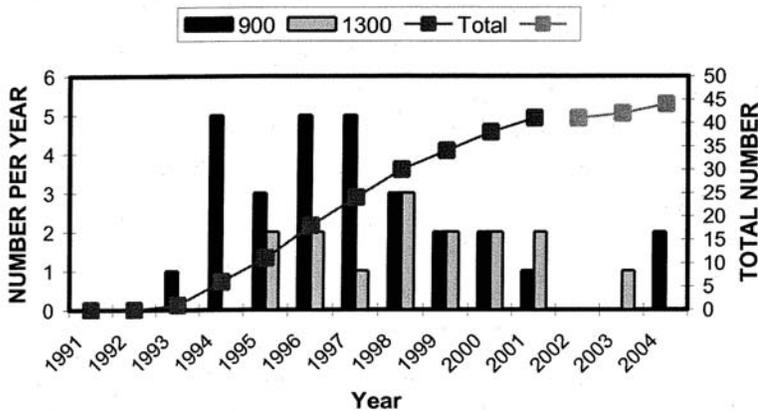
Replacement program started at the beginning of 1994. Up to now 41 VH have been replaced and 3 new ones will be installed in the next 2 years (see figure 7). As the CGR is low; it is expected to finish replacement around 2009-2010.

Fig. 7 : Vessel head replacement since 1993

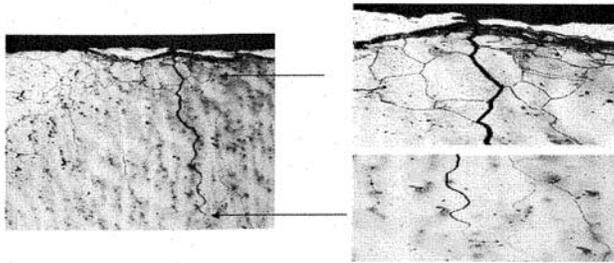
Forty-two stub welds in the hot branch and twenty ix in the cold branch have been inspected. No cracks were found except in the case of a SG water box hammered by a loose part. A small crack was discovered during the SG expertise after removal as shown on figure 8.

Fig. 8 : Expertise from a removed part of a hammered steam generator channel.

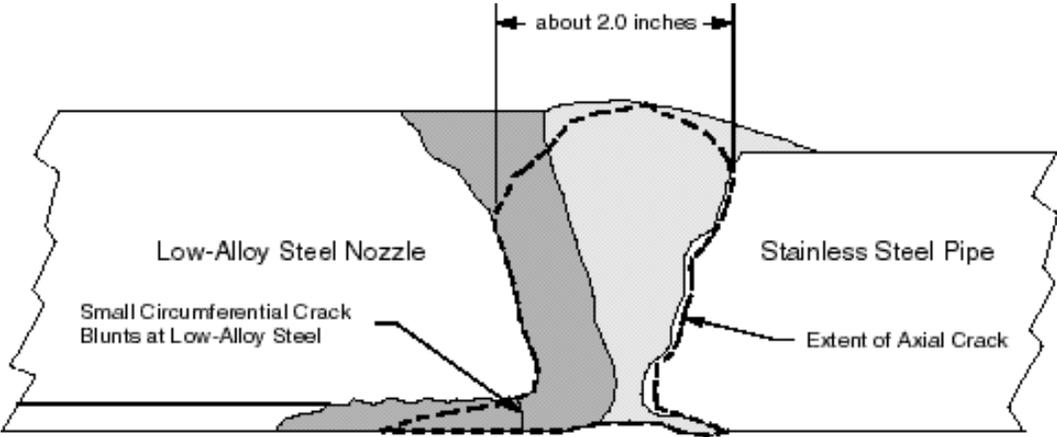
Figure 1
Locations of Cracks in VC Summer Hot Leg Outlet Nozzle Weld
