August 30, 2005

MEMORANDUM TO: Richard J. Laufer, Chief, Section 1
Project Directorate I
Division of Licensing Project Management

FROM: Patrick D. Milano, Sr. Project Manager, Section 1 /RA/
Project Directorate I
Division of Licensing Project Management

SUBJECT: SUMMARY OF TELEPHONE CONFERENCE ON MARCH 7, 2005,
REGARDING STEAM GENERATOR TUBE INSPECTIONS, CALVERT
CLIFFS NUCLEAR POWER PLANT, UNIT NO. 2

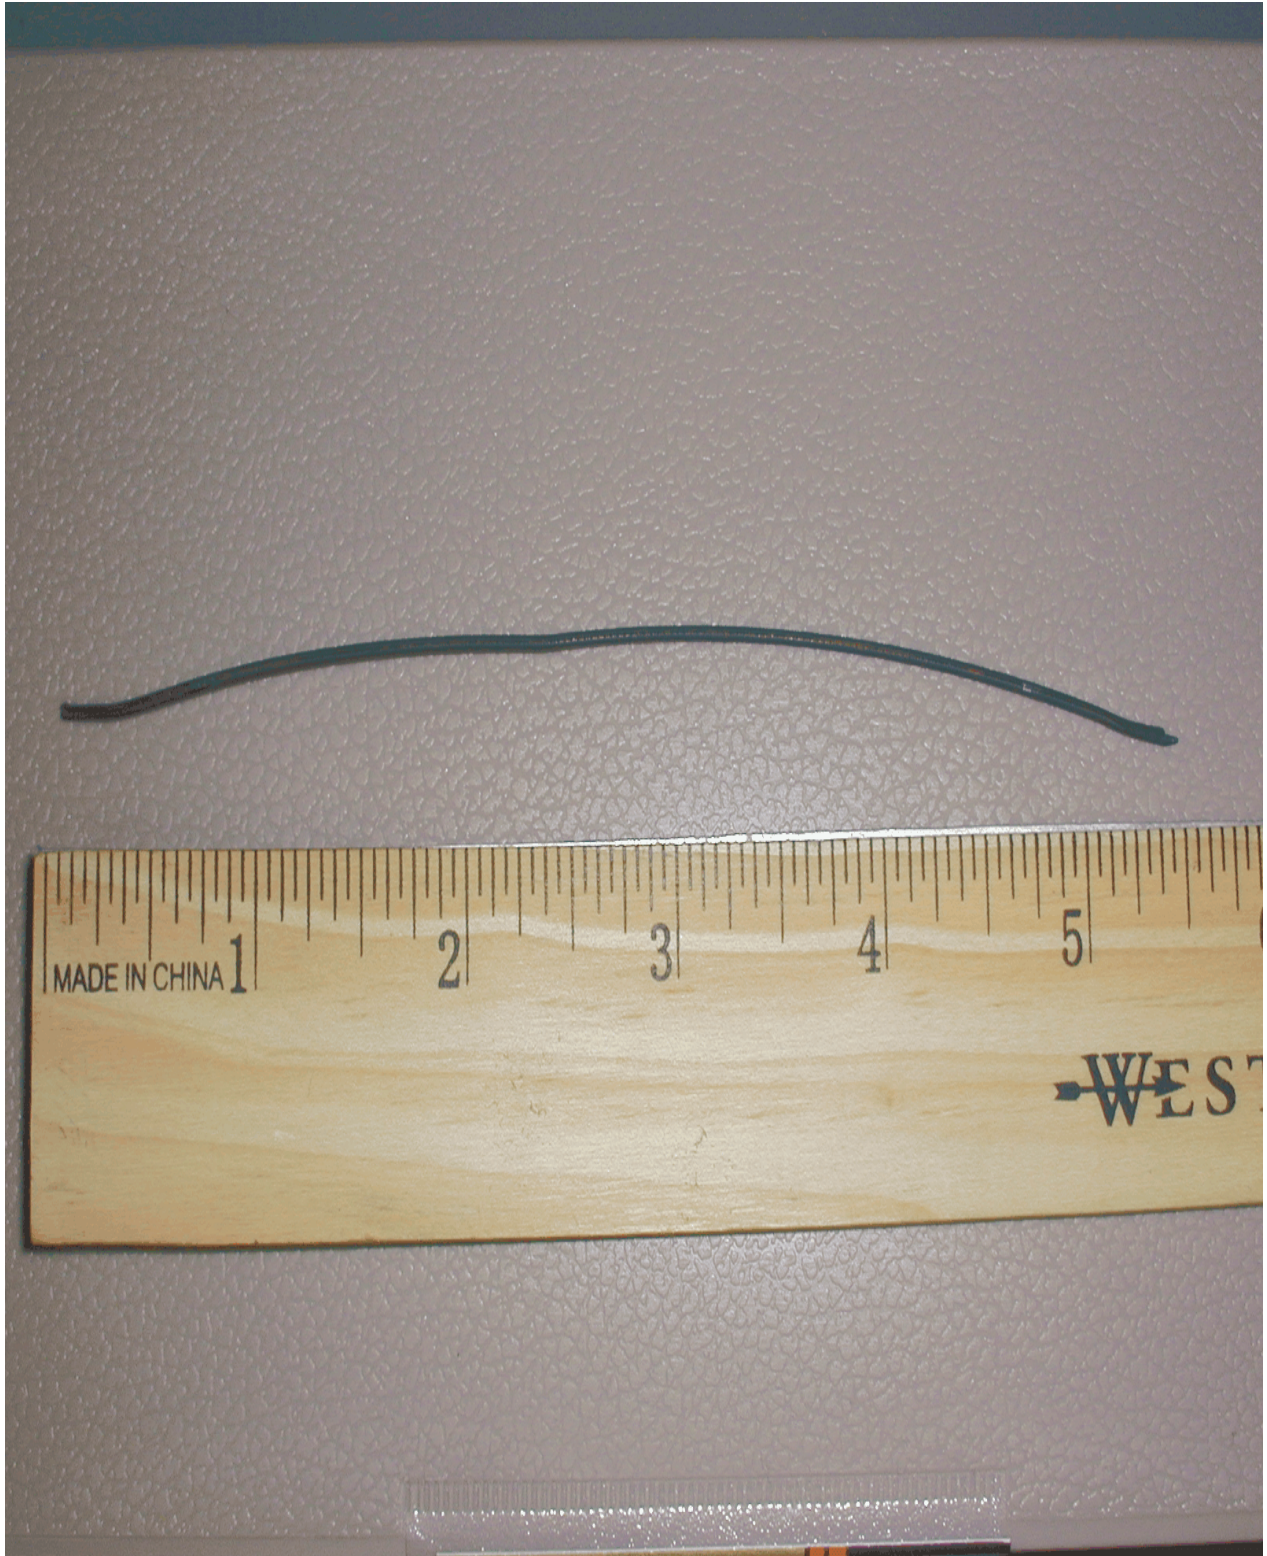
Attachment 1

In SG no. 22, a visual examination confirmed the presence of one possible loose part on the cold-leg side of the SG. The loose part was retrieved and identified as a 5.25-inch long, 0.045-inch diameter wire. The part is believed to have entered the SG through the secondary side of the plant. Further analysis of the part is planned. A visual inspection of neighboring tubes did not identify any additional loose parts. A rotating probe equipped with a +Point™ ECT coil was used to inspect 14 surrounding tubes from the top of the tubesheet to the first lattice grid tube support (approximately 35-inches in length). Three tubes were identified with wear. The wear on these tubes was estimated to be 5% through-wall (1 tube) and 6% through-wall (2 tubes). No other possible loose part indications were found in this region. Two pictures of the loose part (Attachment 1 with the part in the SG, and Attachment 2 after the part was removed from the SG) were provided in support of the phone call. The tubes will be left in service.

Cold Leg
Preiphery Annulus
