Augmented Inspection Team

Inspection of Uranium Hexafluoride  
(UF<sub>6</sub>) Release at Honeywell Site

December 22, 2003

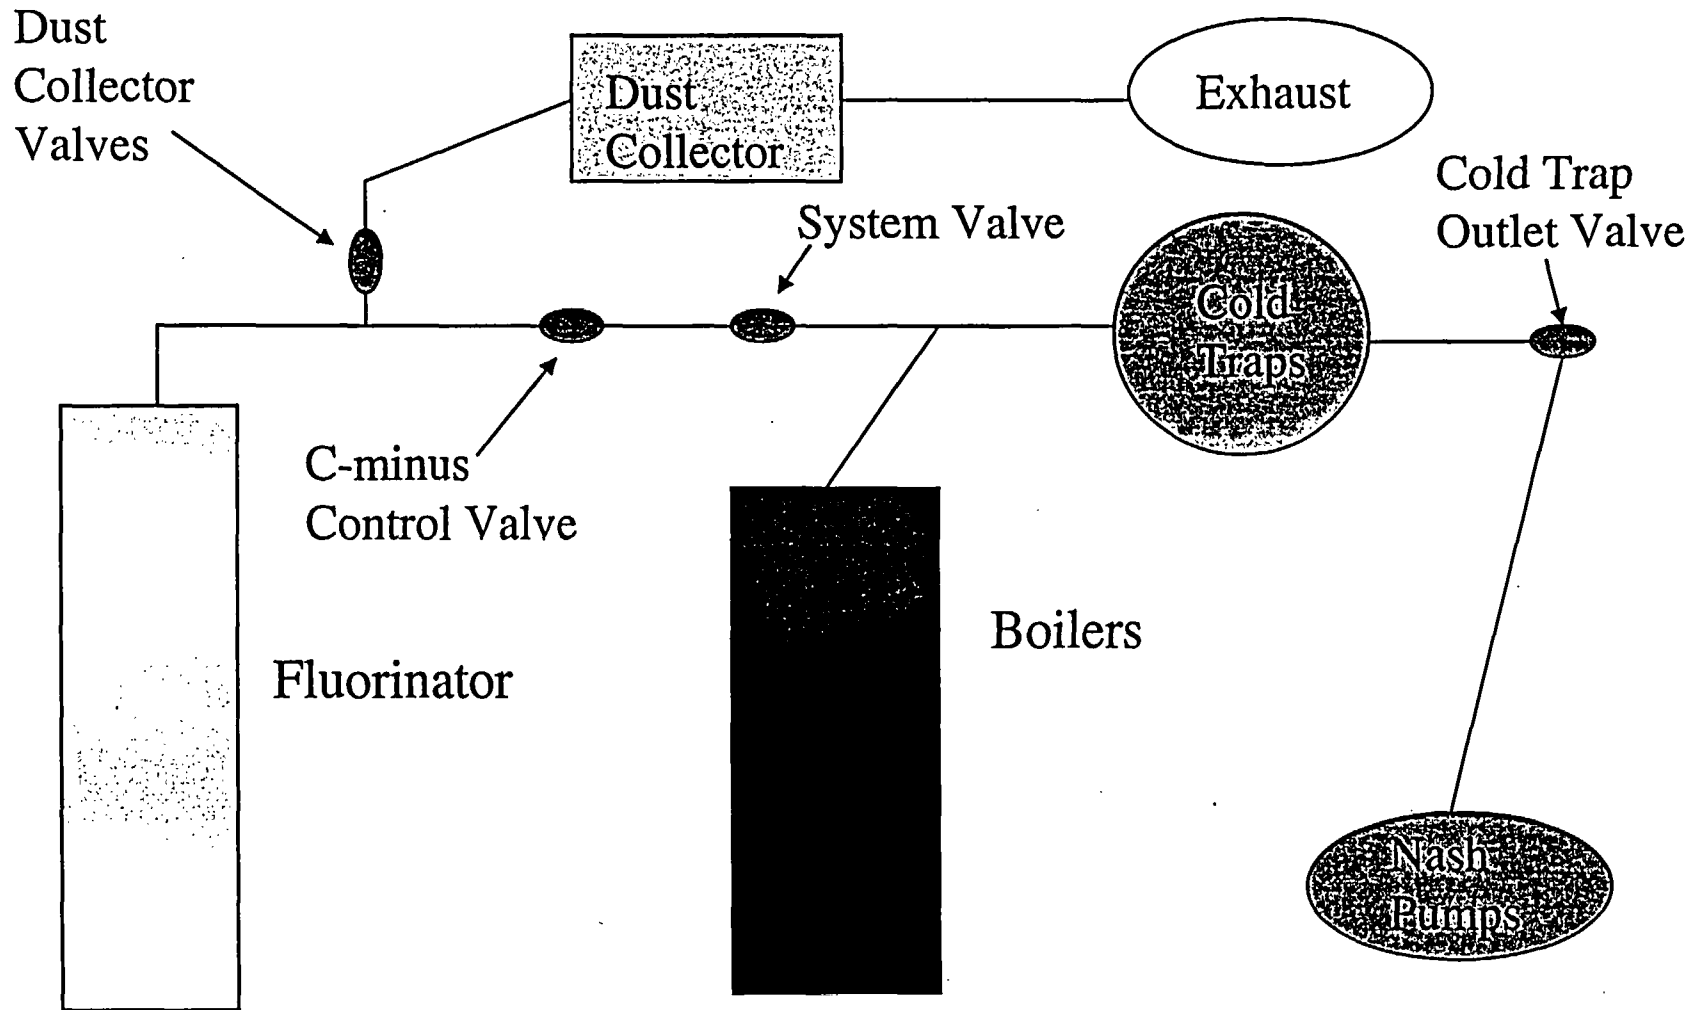
# Simplified Process Drawing

C-minus control valve that  
began to leak  $\text{UF}_6$

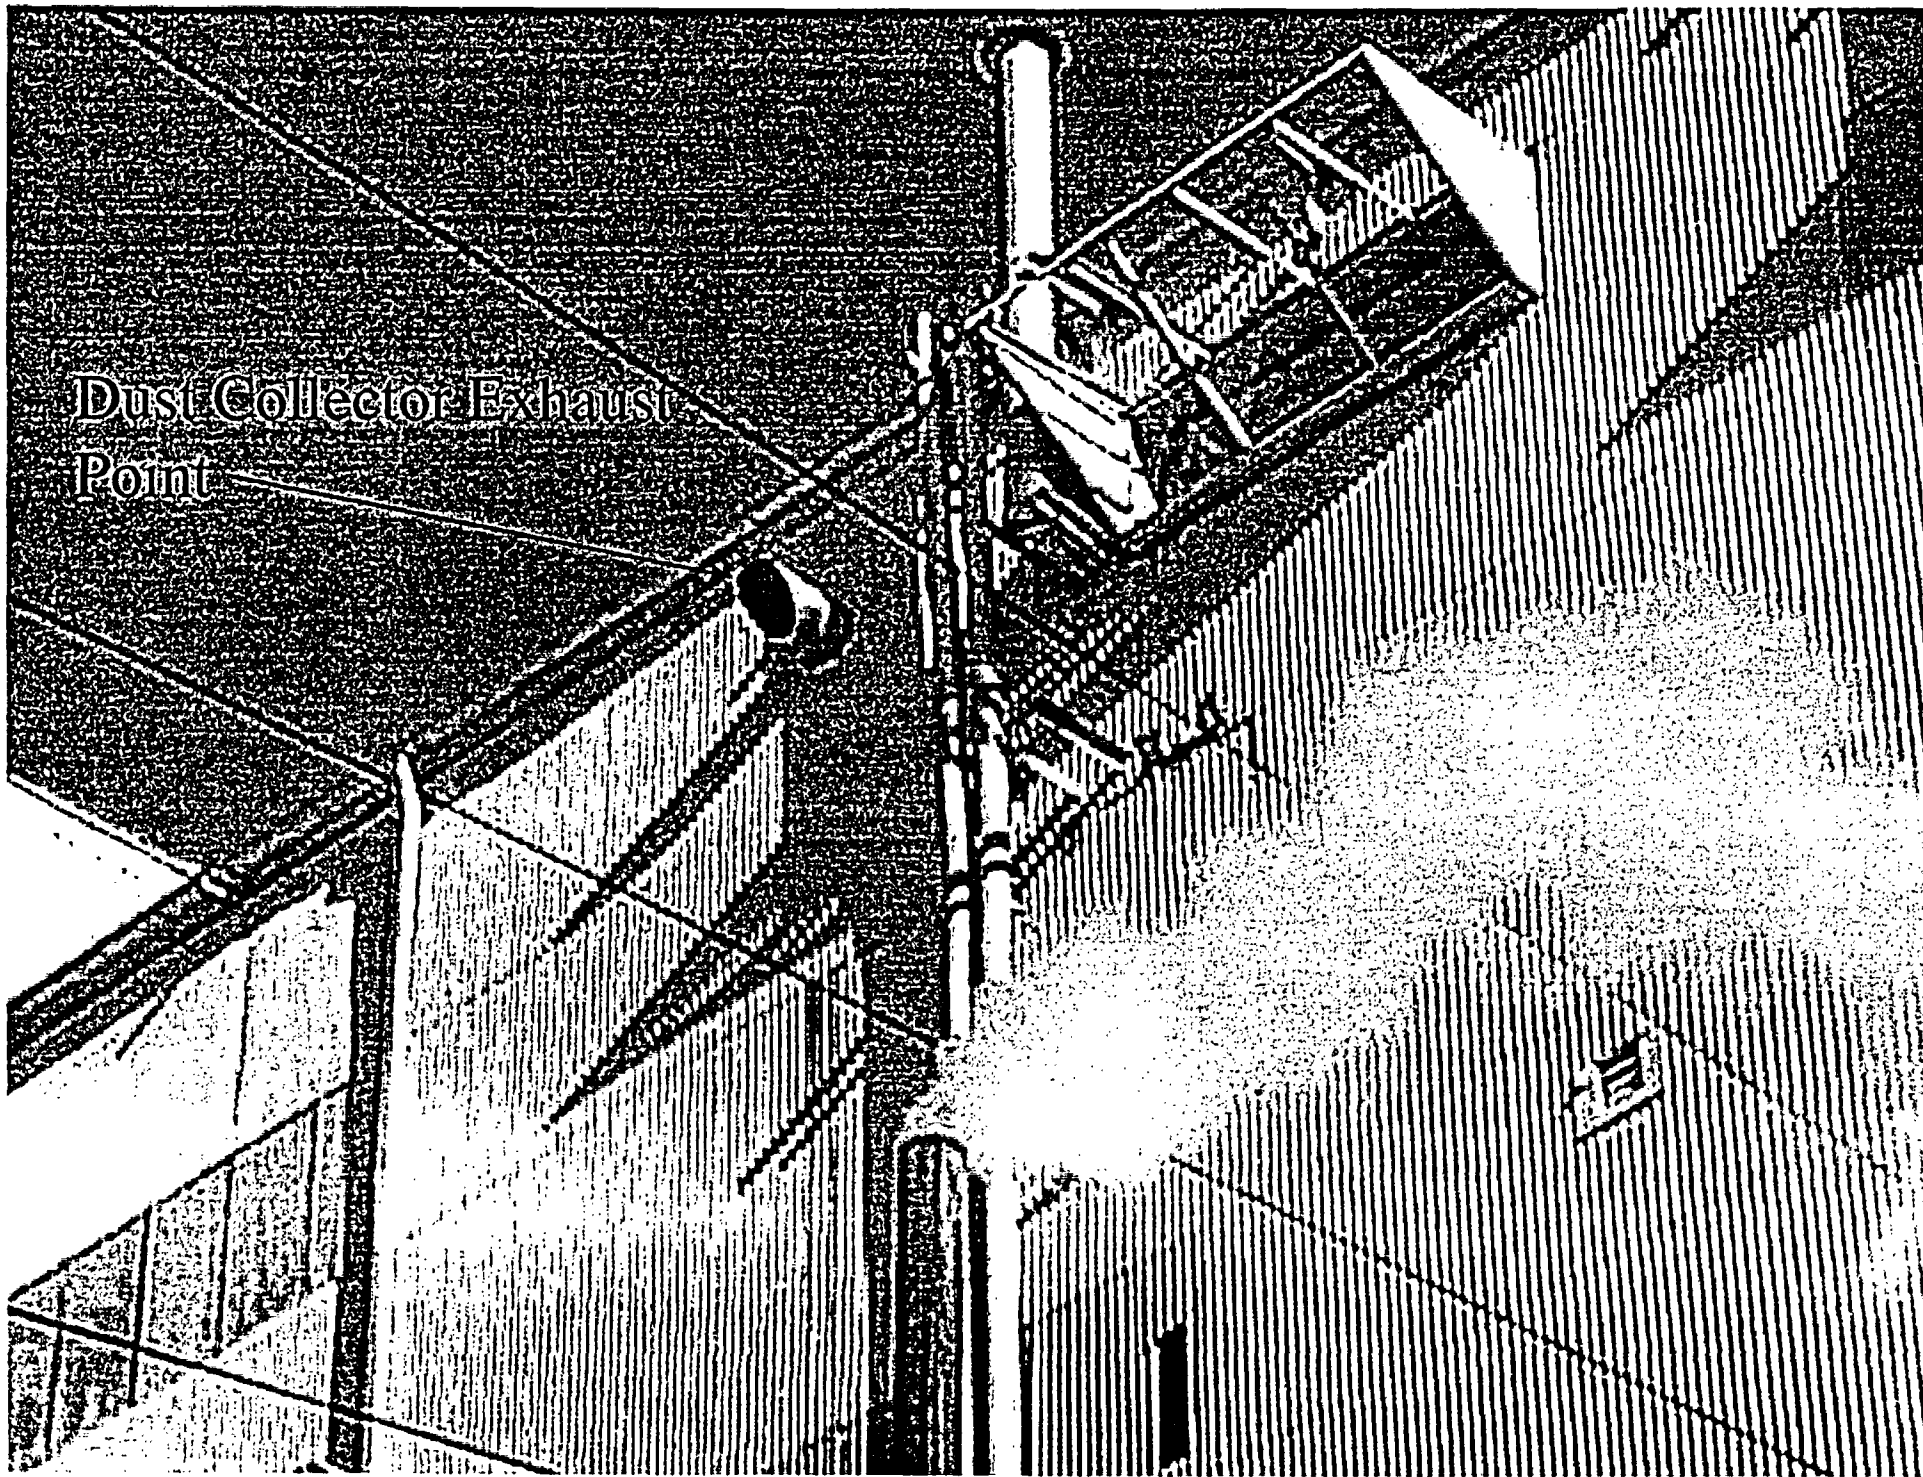
← Dust Collector Piping  
(Valve on other side)

← C-minus Valve  
Removed from here

← C-train System Valve

Dust Collector Exhaust  
Point
