U. S. Nuclear Regulatory Commission

Augmented Inspection Team

Inspection of Uranium Hexafluoride
(UF₆) Release at Honeywell Site

December 22, 2003

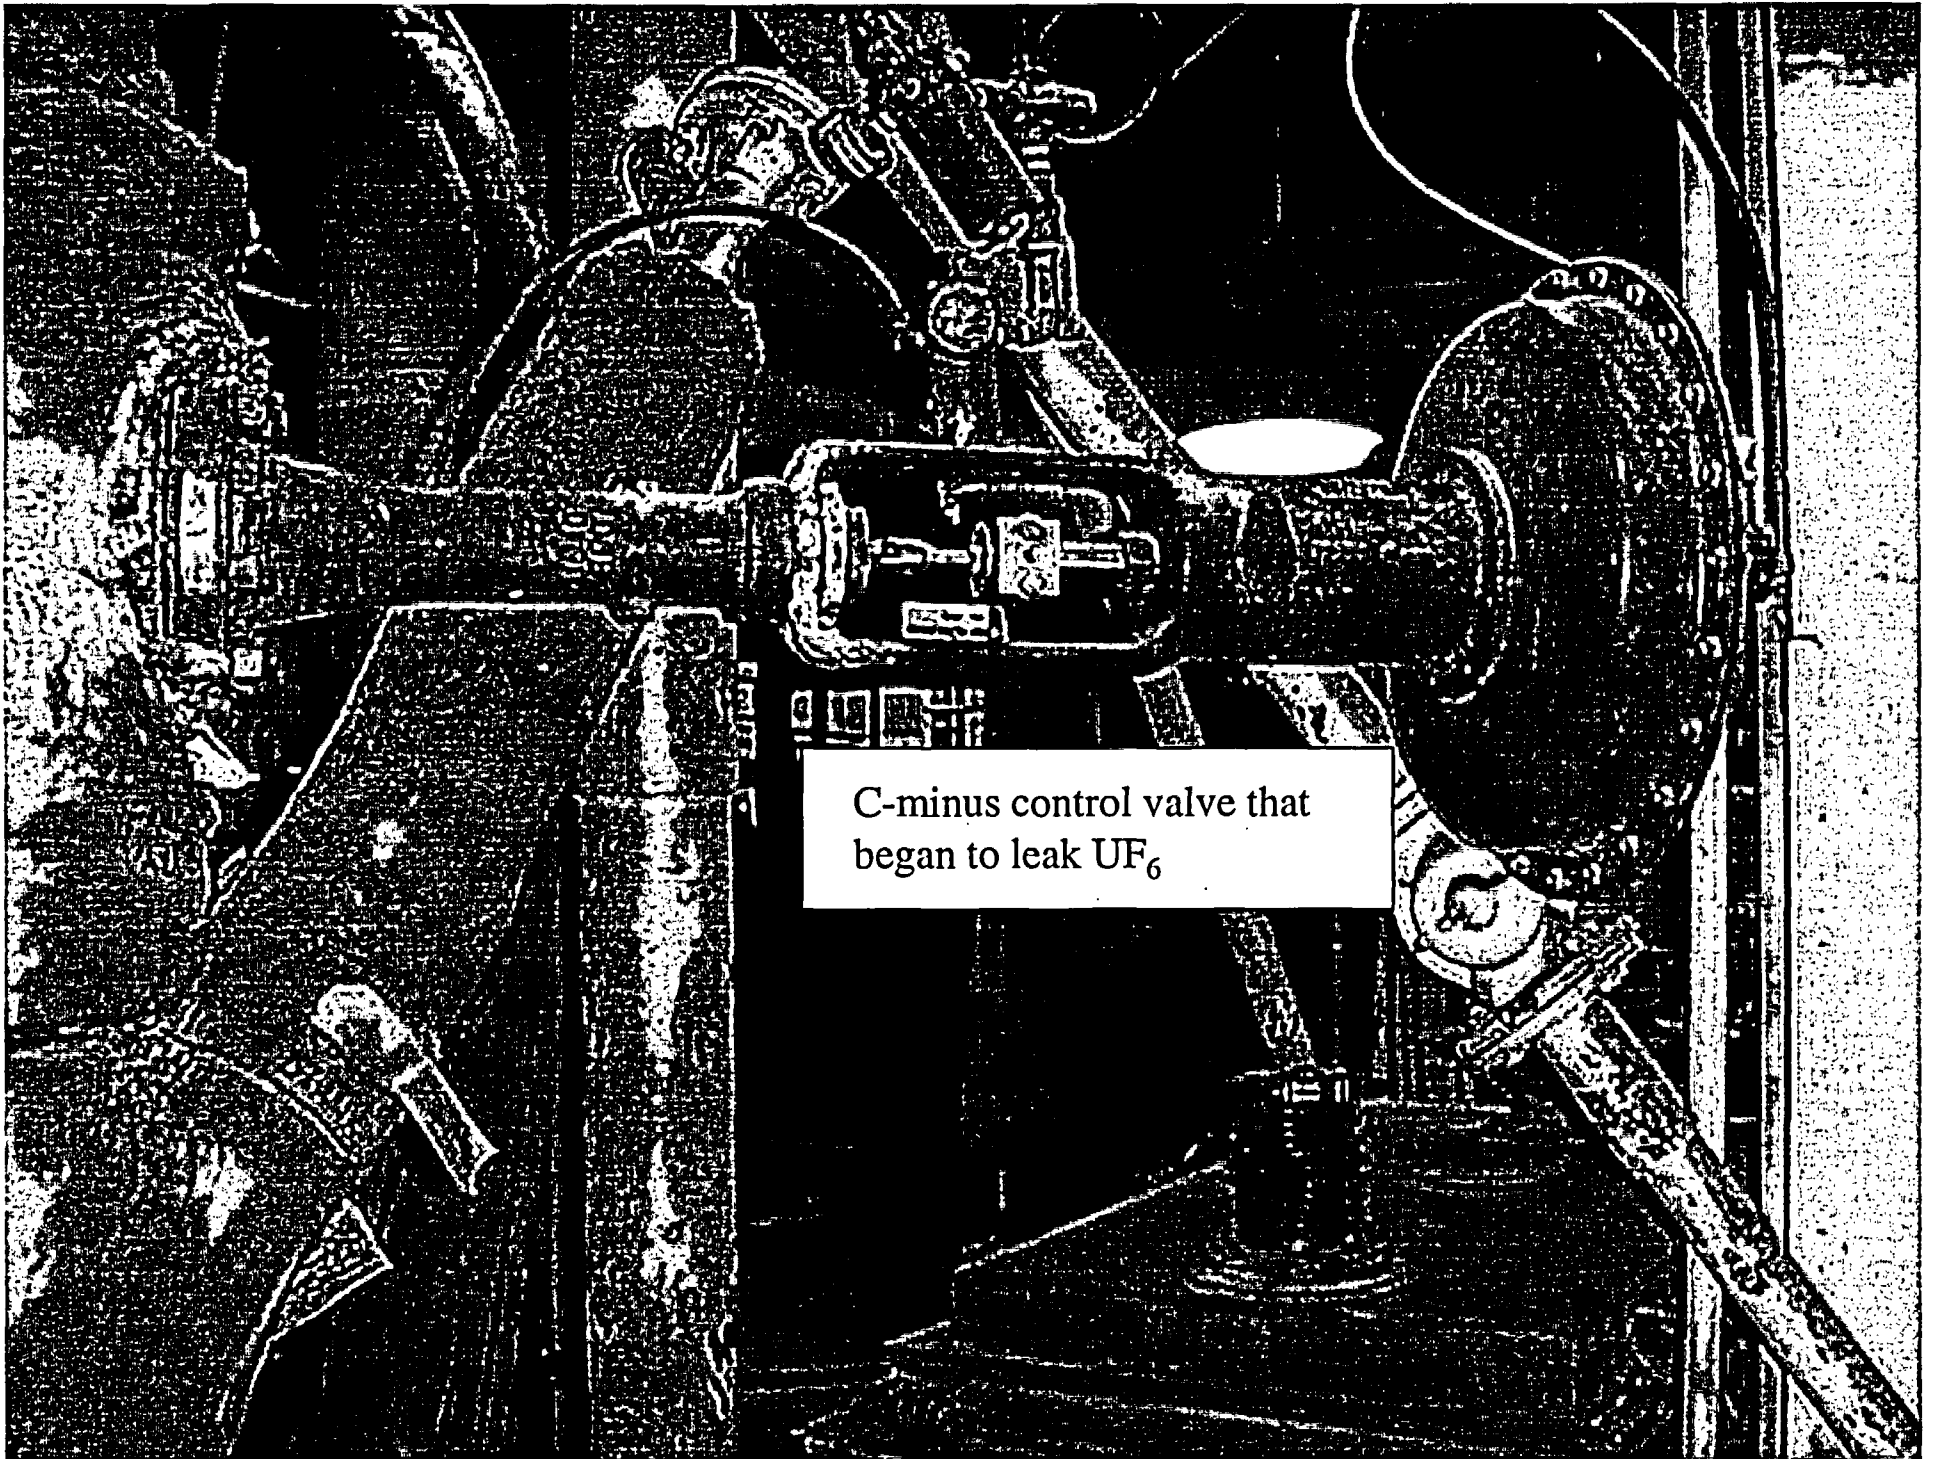
C-minus control valve that began to leak UF₆
