# U. S. Nuclear Regulatory Commission

Augmented Inspection Team

Inspection of Uranium Hexafluoride  
(UF<sub>6</sub>) Release at Honeywell Site

December 22, 2003

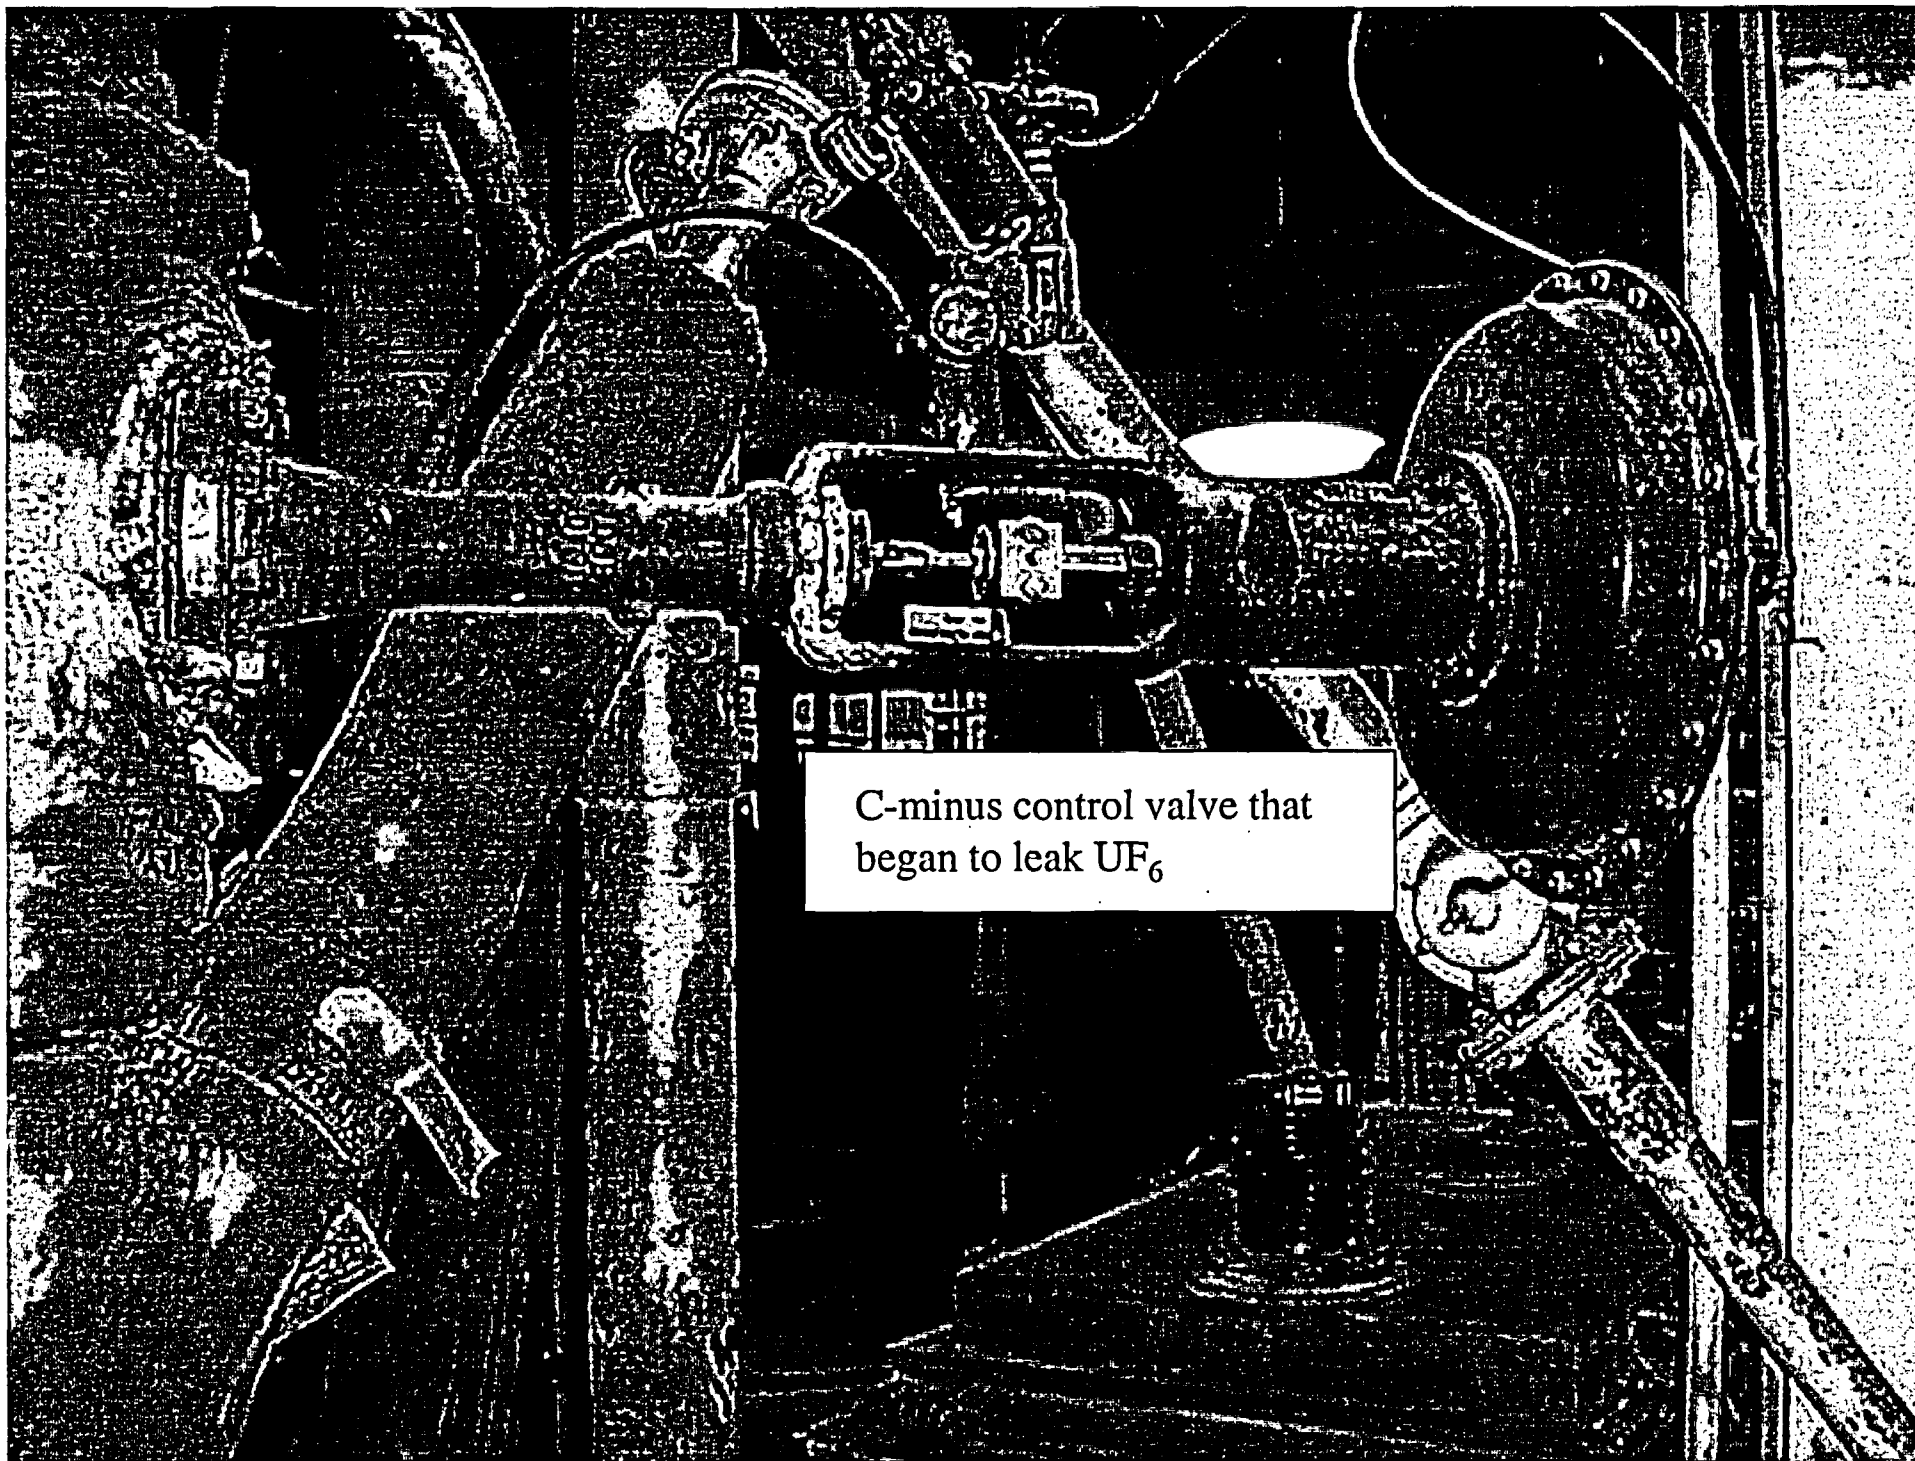
C-minus control valve that  
began to leak  $\text{UF}_6$

← Dust Collector Piping  
(Valve on other side)

← C-minus Valve  
Removed from here

← C-train System Valve

Dust Collector Exhaust  
Point
