U. S. Nuclear Regulatory Commission

Augmented Inspection Team

Inspection of Honeywell Uranium
Hexafluoride (UF₆) Release

December 22, 2003

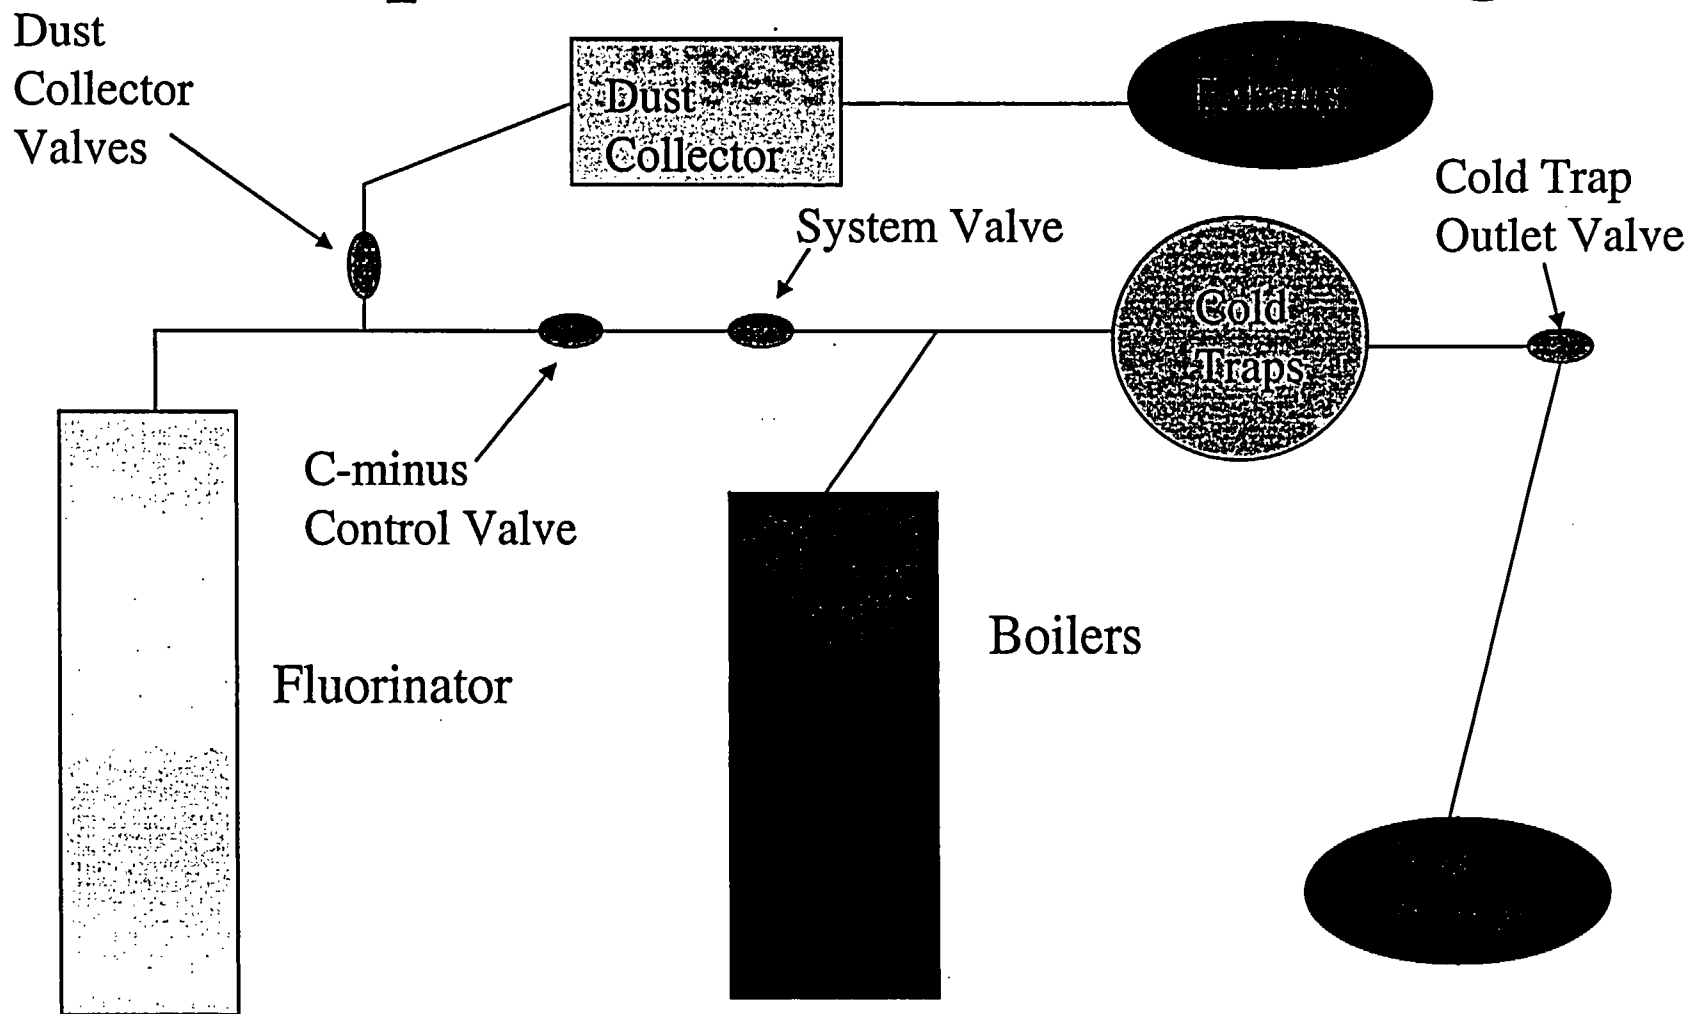
Simplified Process Drawing

- The AFO proceeded with the reconfiguration of the downstream pipes which isolated a section of process equipment and piping from the fluorinators to UF_6 storage tanks called cold traps
- This isolated section began to pressurize from the 90 psi nitrogen gas and from 70 psi of UF_6 entering from the recycling boilers

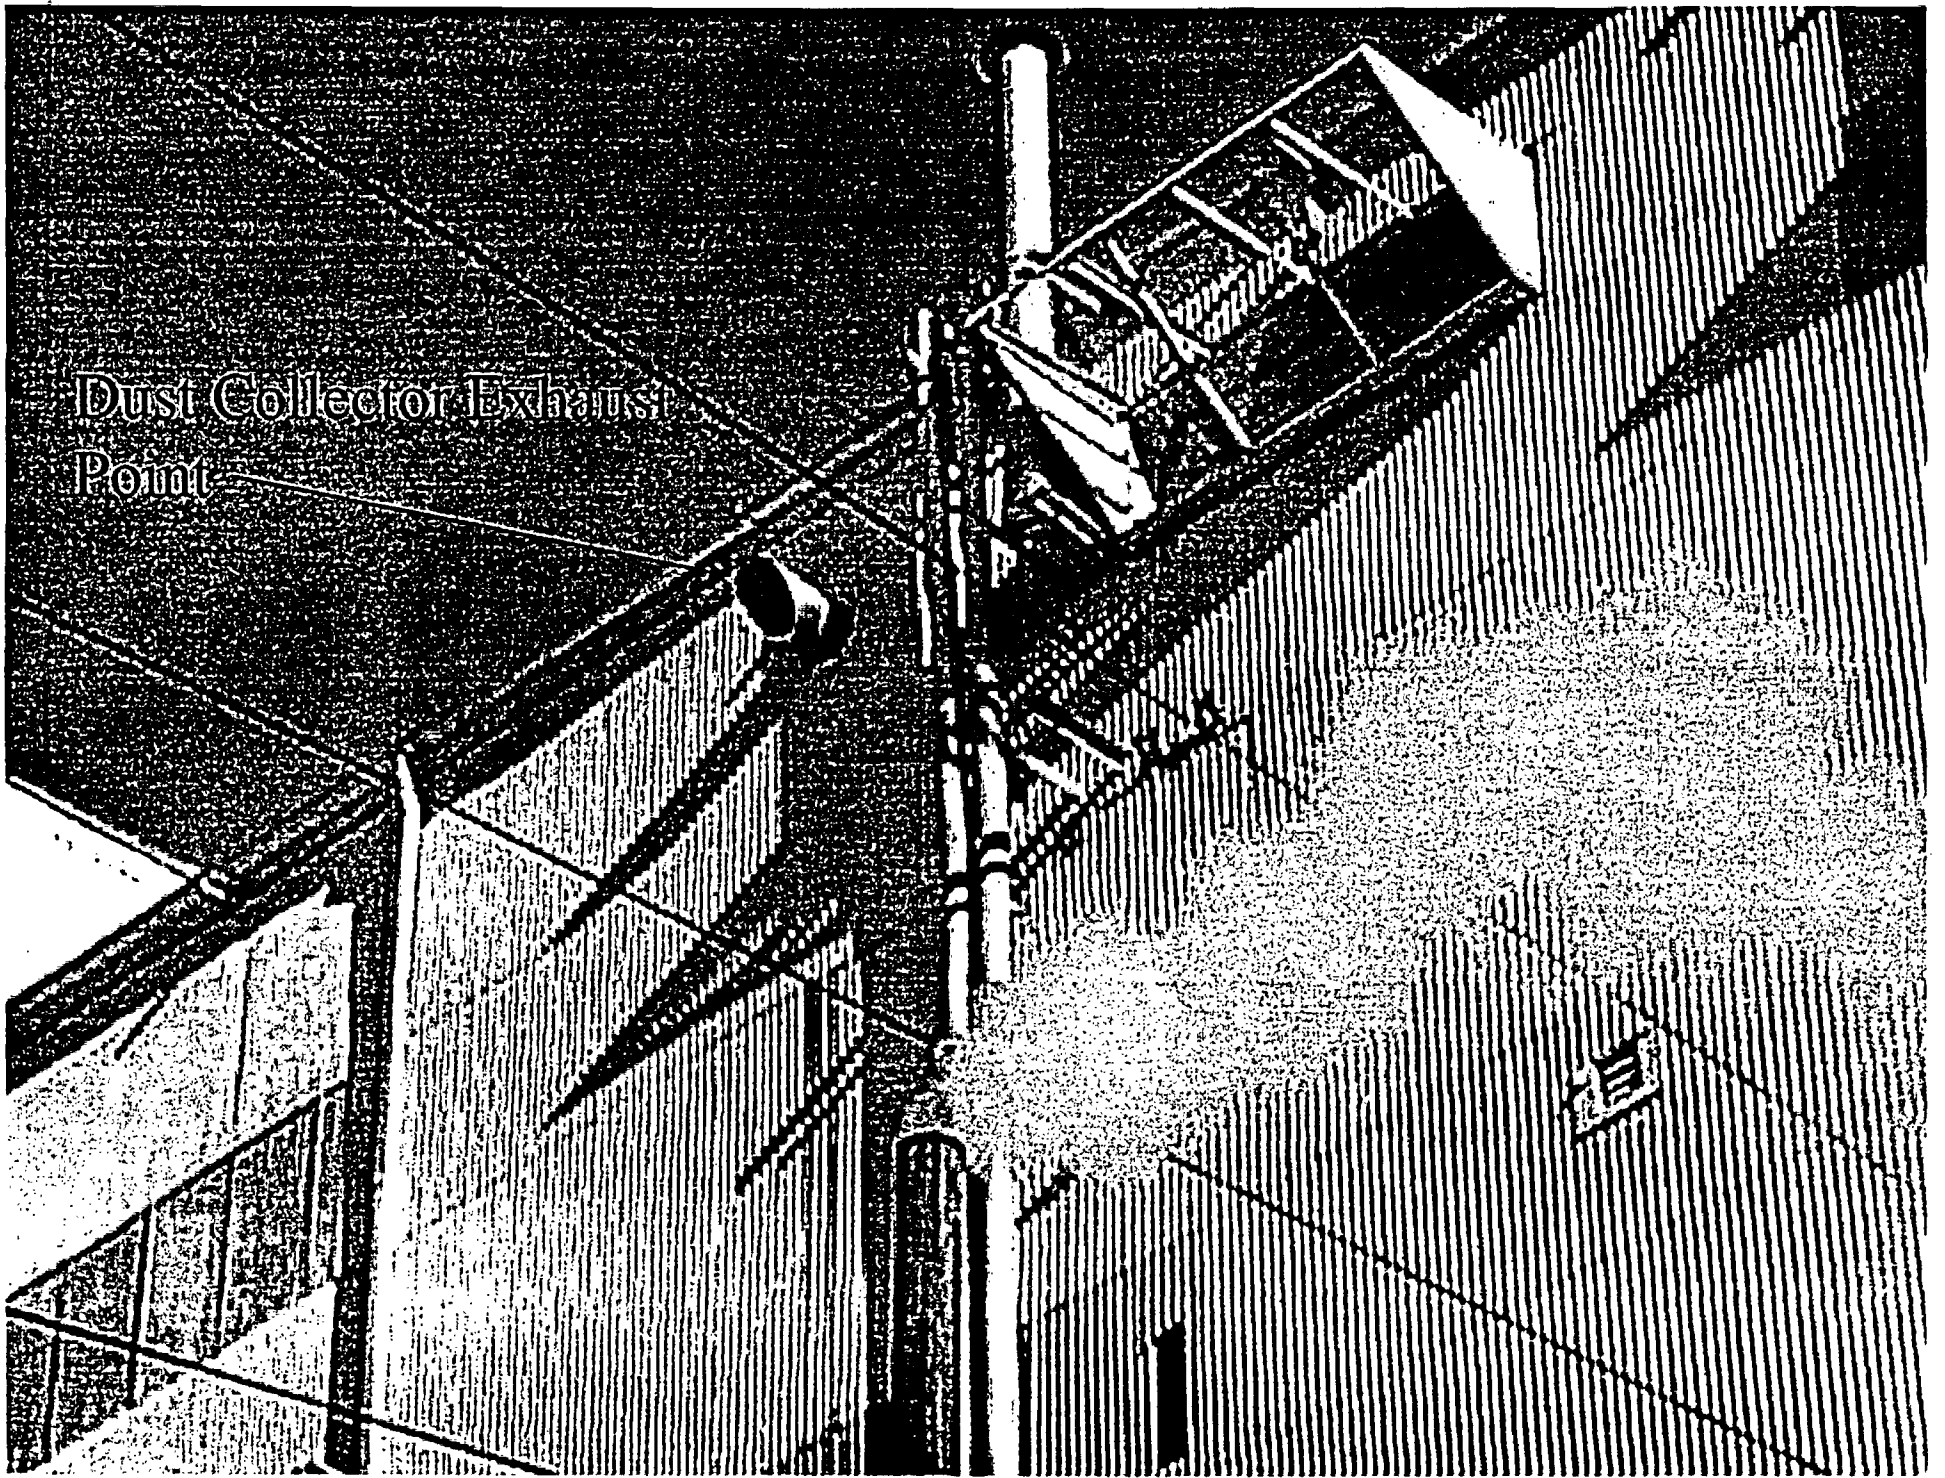
- The initial UF6 leak was from the C-minus control valve
- The release to the environment occurred when the dust collector valves were opened and the UF6 under pressure in the system exited through the dust collectors and out a horizontal exhaust stack on the southwest side of the Feed Materials Building (86 ft above ground level)

C-minus control valve that
began to leak UF_6

← Dust Collector Piping
(Valve on other side)

↙ C-minus Valve
Removed from here

← C-train System Valve

Dust Collector Exhaust
Point
