# U. S. Nuclear Regulatory Commission

Augmented Inspection Team

Inspection of Honeywell Uranium  
Hexafluoride (UF<sub>6</sub>) Release

December 22, 2003

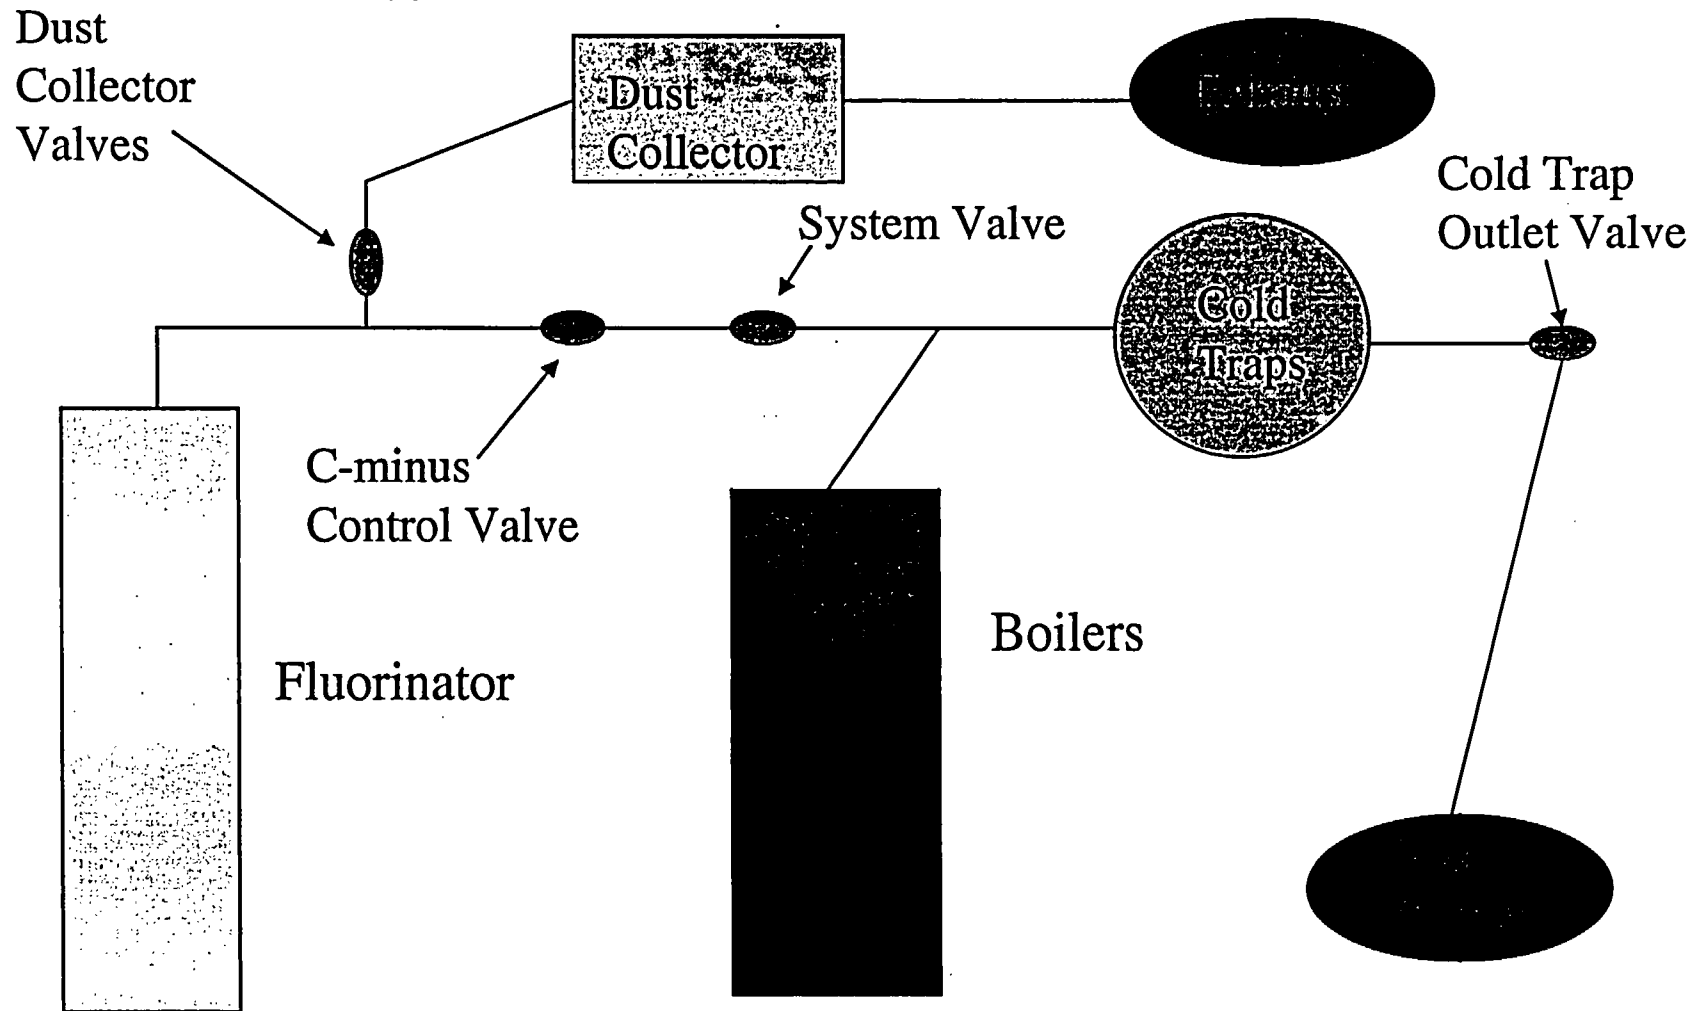
# Simplified Process Drawing

- The initial UF<sub>6</sub> leak was from the C-minus control valve
- The release to the environment occurred when the dust collector valves were opened and the UF<sub>6</sub> under pressure in the system exited through the dust collectors and out a horizontal exhaust stack on the southwest side of the Feed Materials Building (86 ft above ground level)

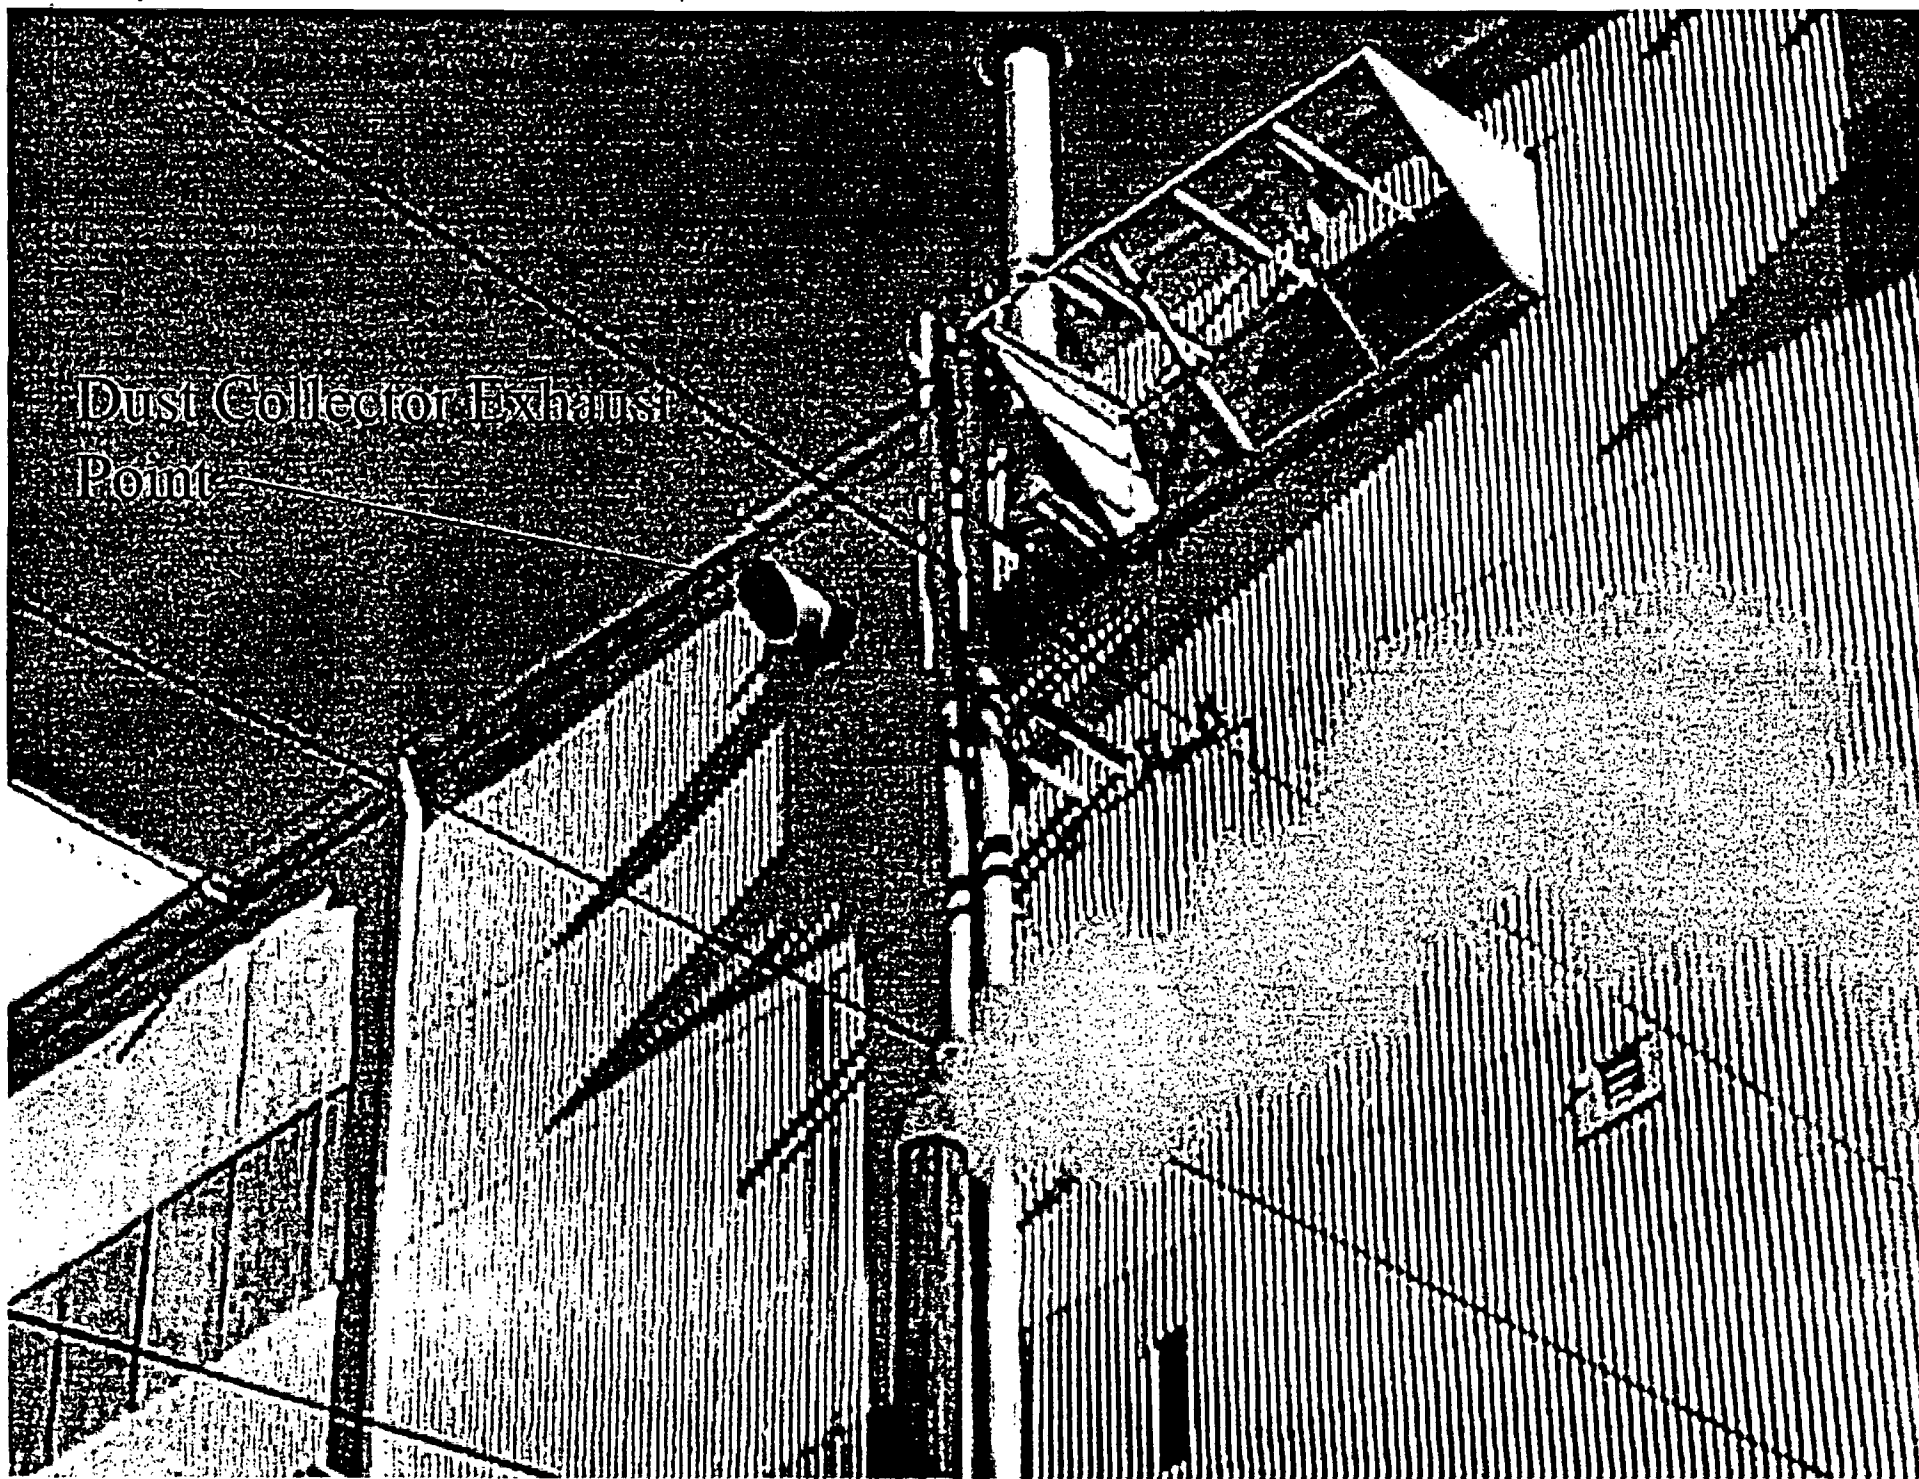
C-minus control valve that  
began to leak  $\text{UF}_6$

← Dust Collector Piping  
(Valve on other side)

↙ C-minus Valve  
Removed from here

← C-train System Valve

Dust Collector Exhaust  
Point
