RE: Permit to Mine No. 633
In Situ Uranium Wellfield Release Report

Power Resources, Inc Smith Ranch-Highland Uranium Project URANIUM IN SITU WELLFIELD FLUID RELEASE REPORT

18-INCH FLANGE LEAK AT MANHOLE IN MINE UNIT-15

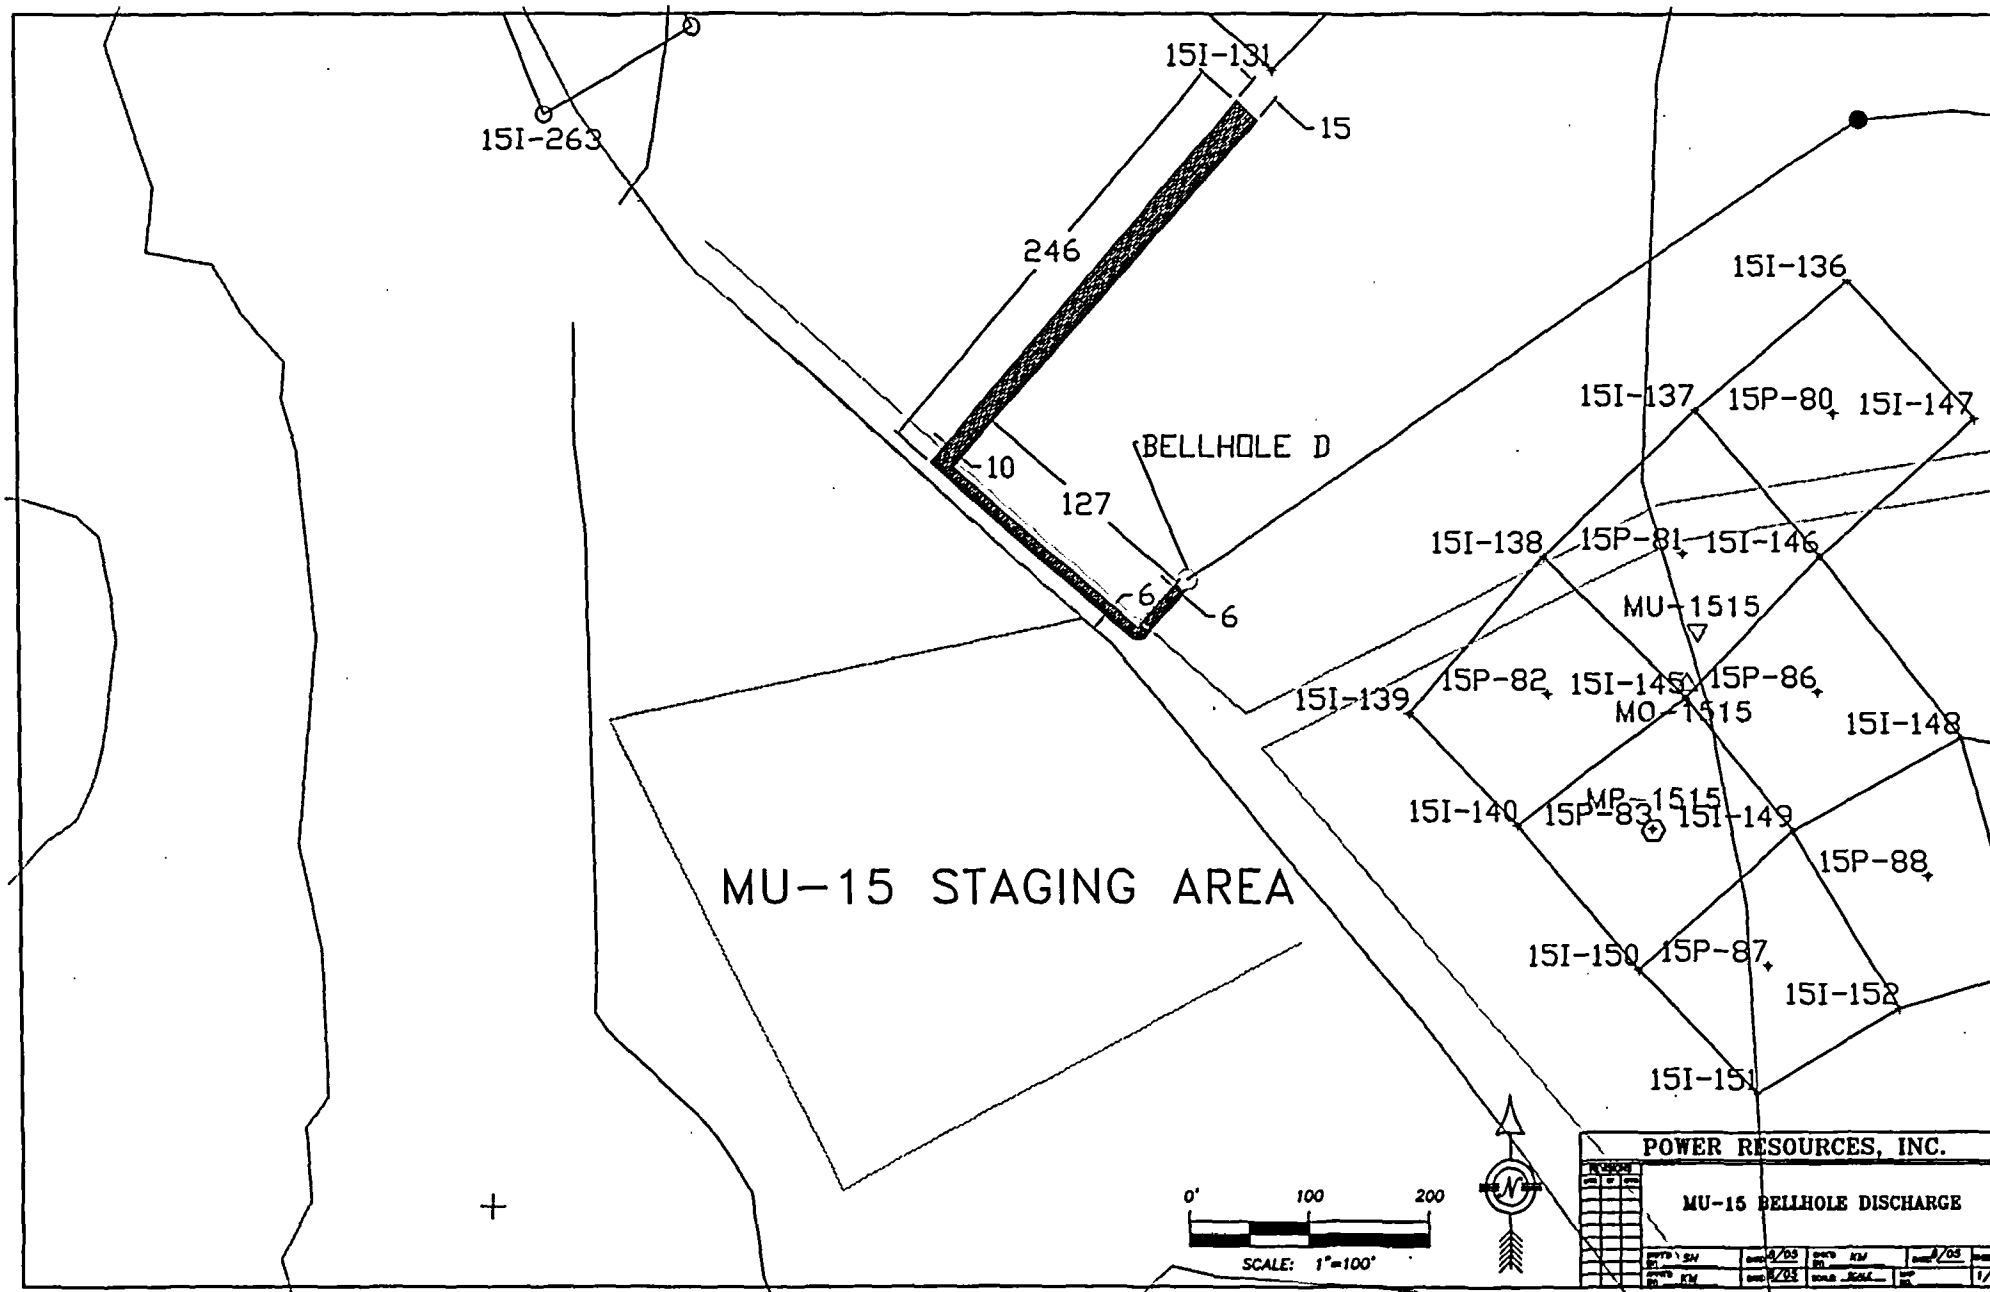
The release occurred in the SW ¼, SE ¼, Section 10, T35N, R74W and affected approximately 0.1 acres. The exact location and extent of the spill is shown on the attached map.
