Honeywell Metropolis Works

**Investigation Report of
Uranium Hexafluoride Release
on December 22, 2003**

Date of Report
February 6, 2004

Investigation Report of Uranium Hexafluoride Release on December 22, 2003

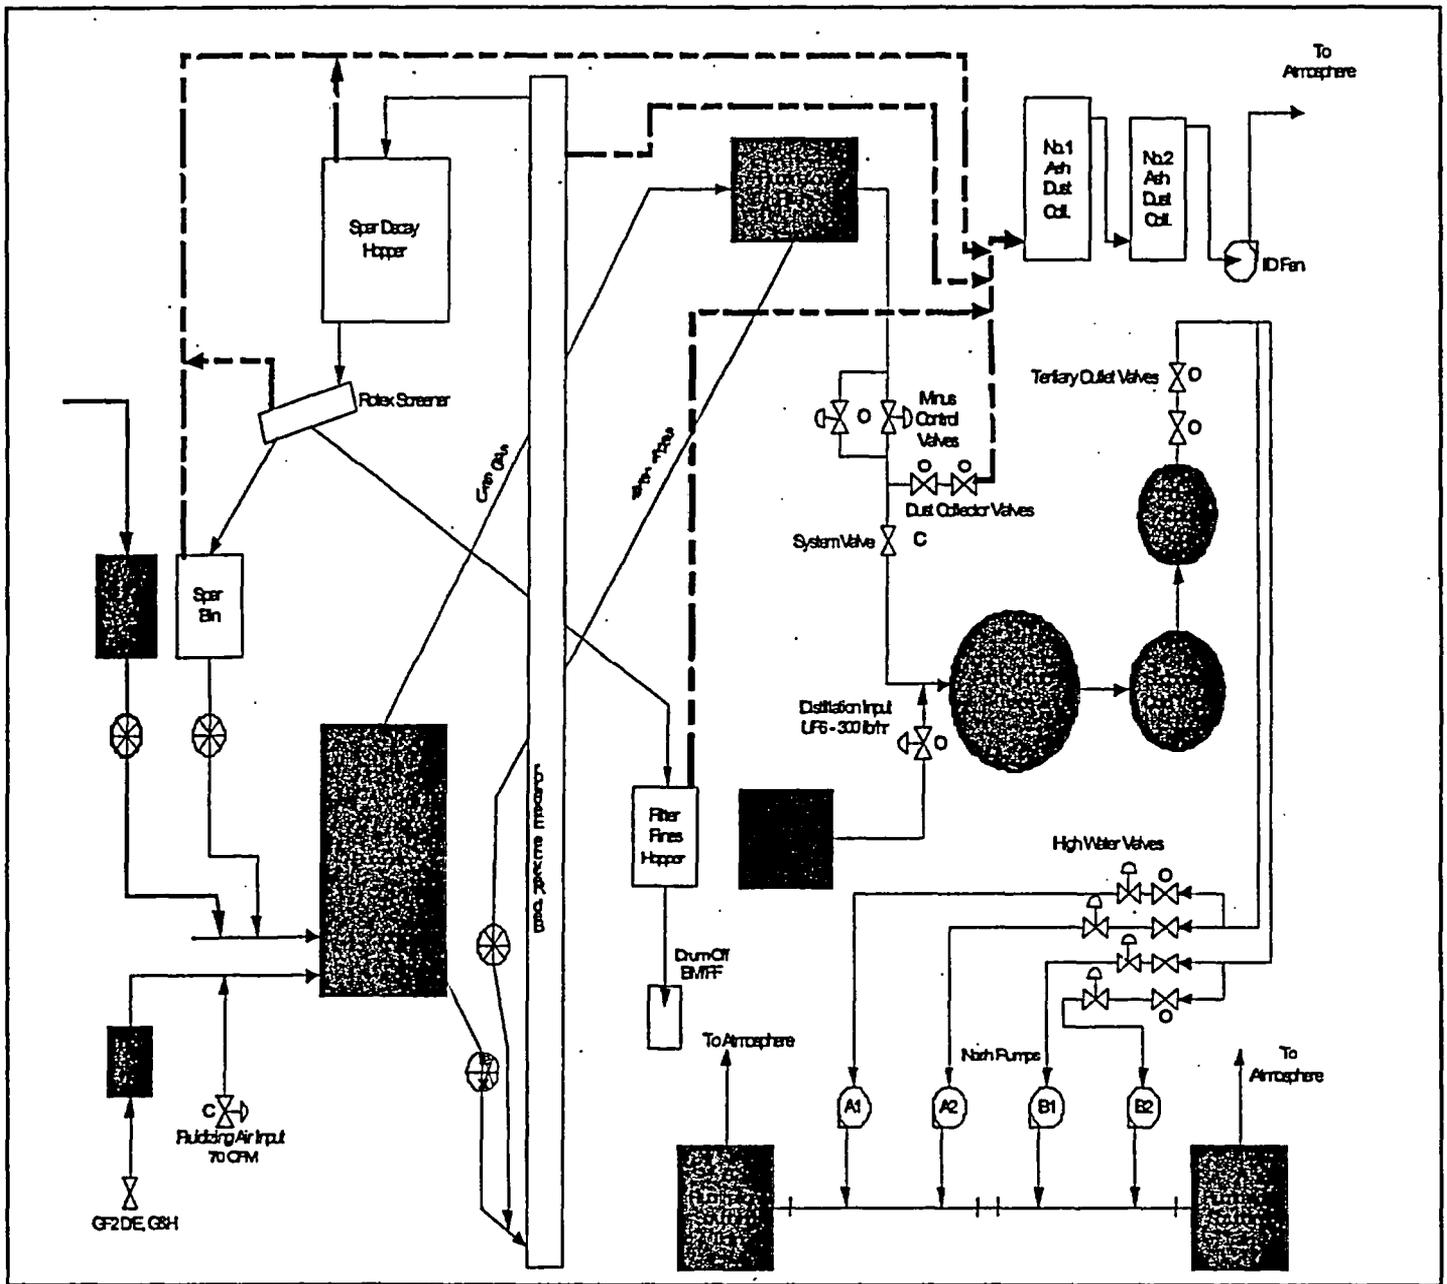
Figure 5 Process When Release Terminated

At 0305 hours, the Nash vacuum pump was restarted and sub-atmospheric pressure was established at 0313 hours. The time to restore sub-atmospheric pressure and thereby terminate the release was extended by the complexity of the lockout, the high level of personal protection necessary for the HAZMAT Response Team, and by the unexpected equipment failure in the Nash vacuum pumps. (See Appendix 2, Figure 5 for valving configuration.)

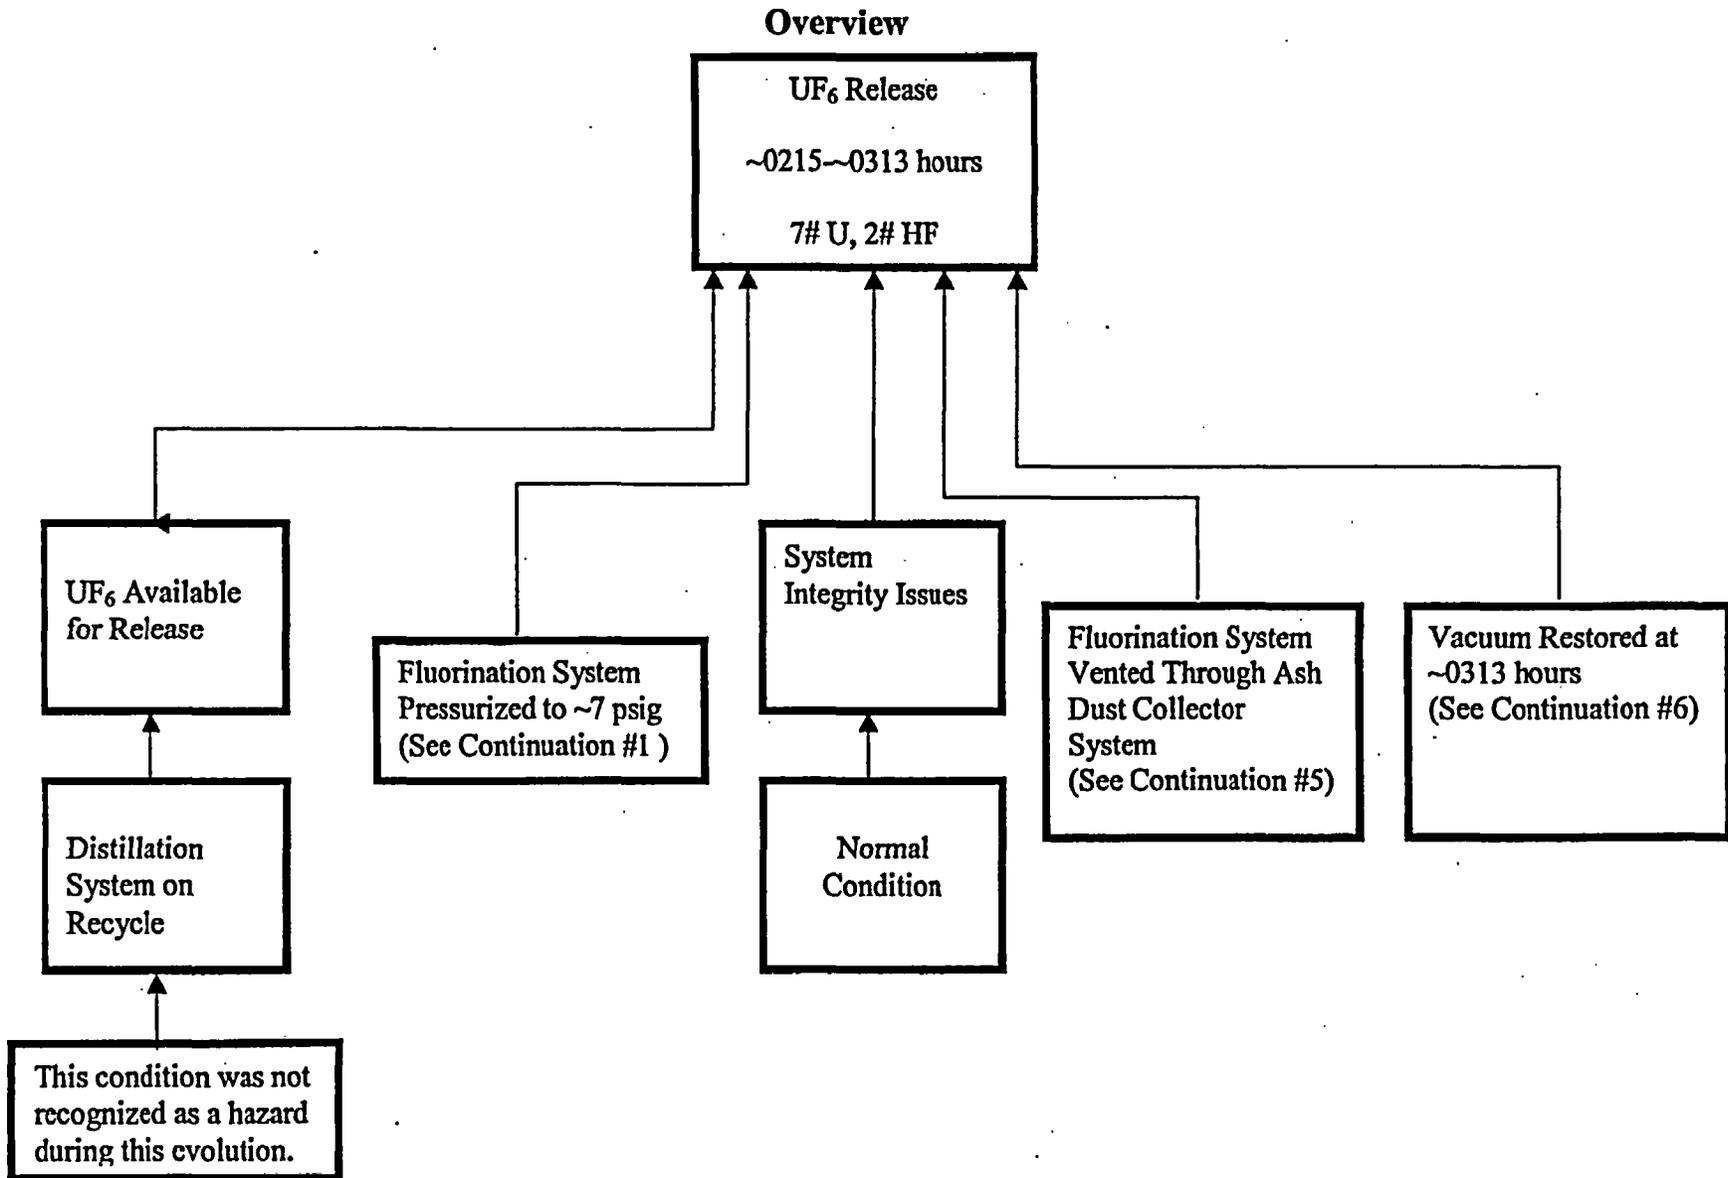
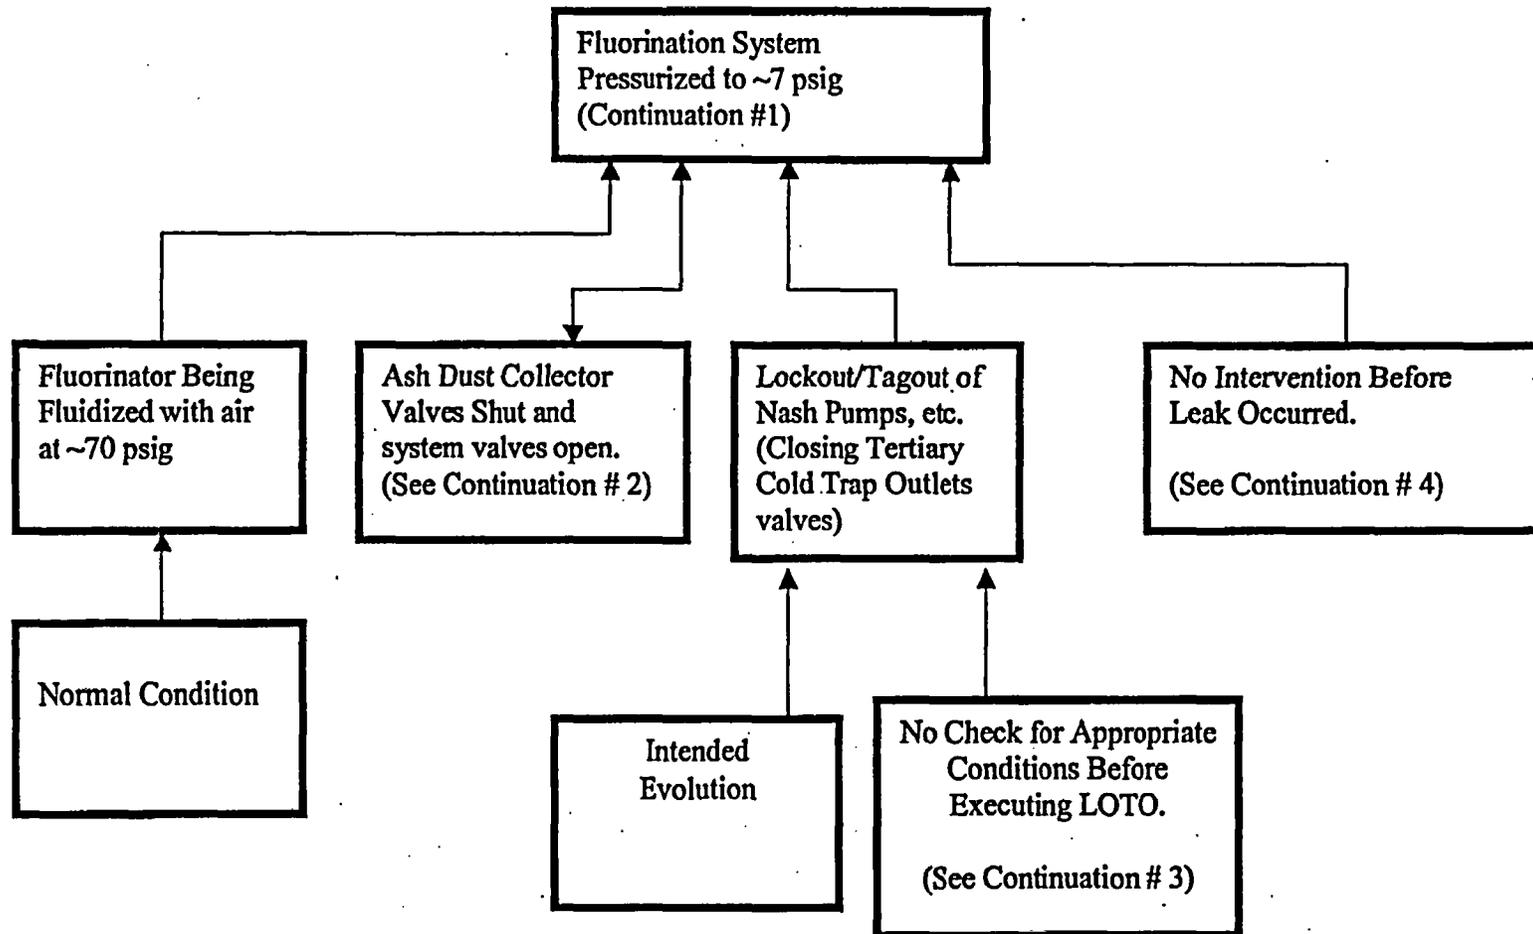
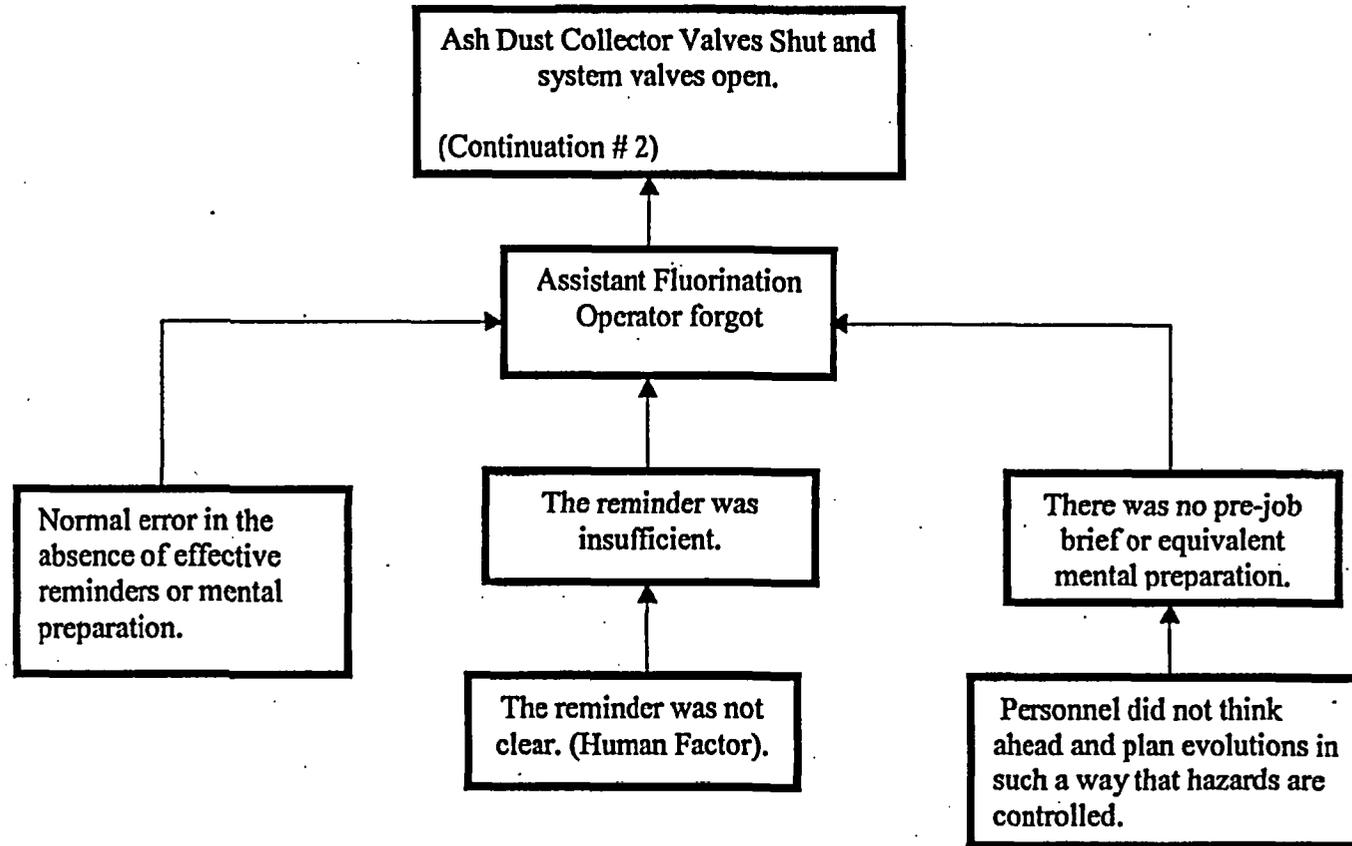
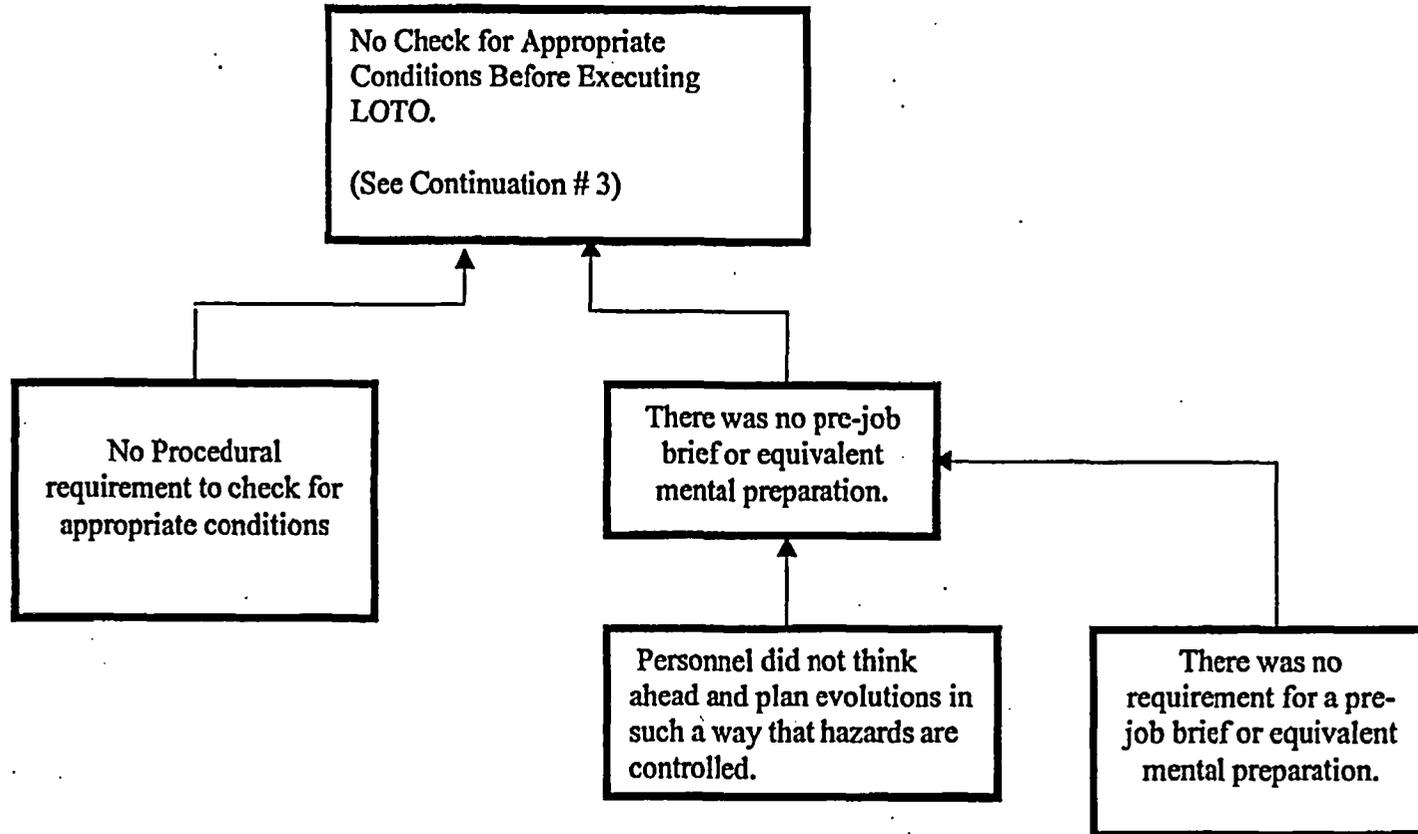
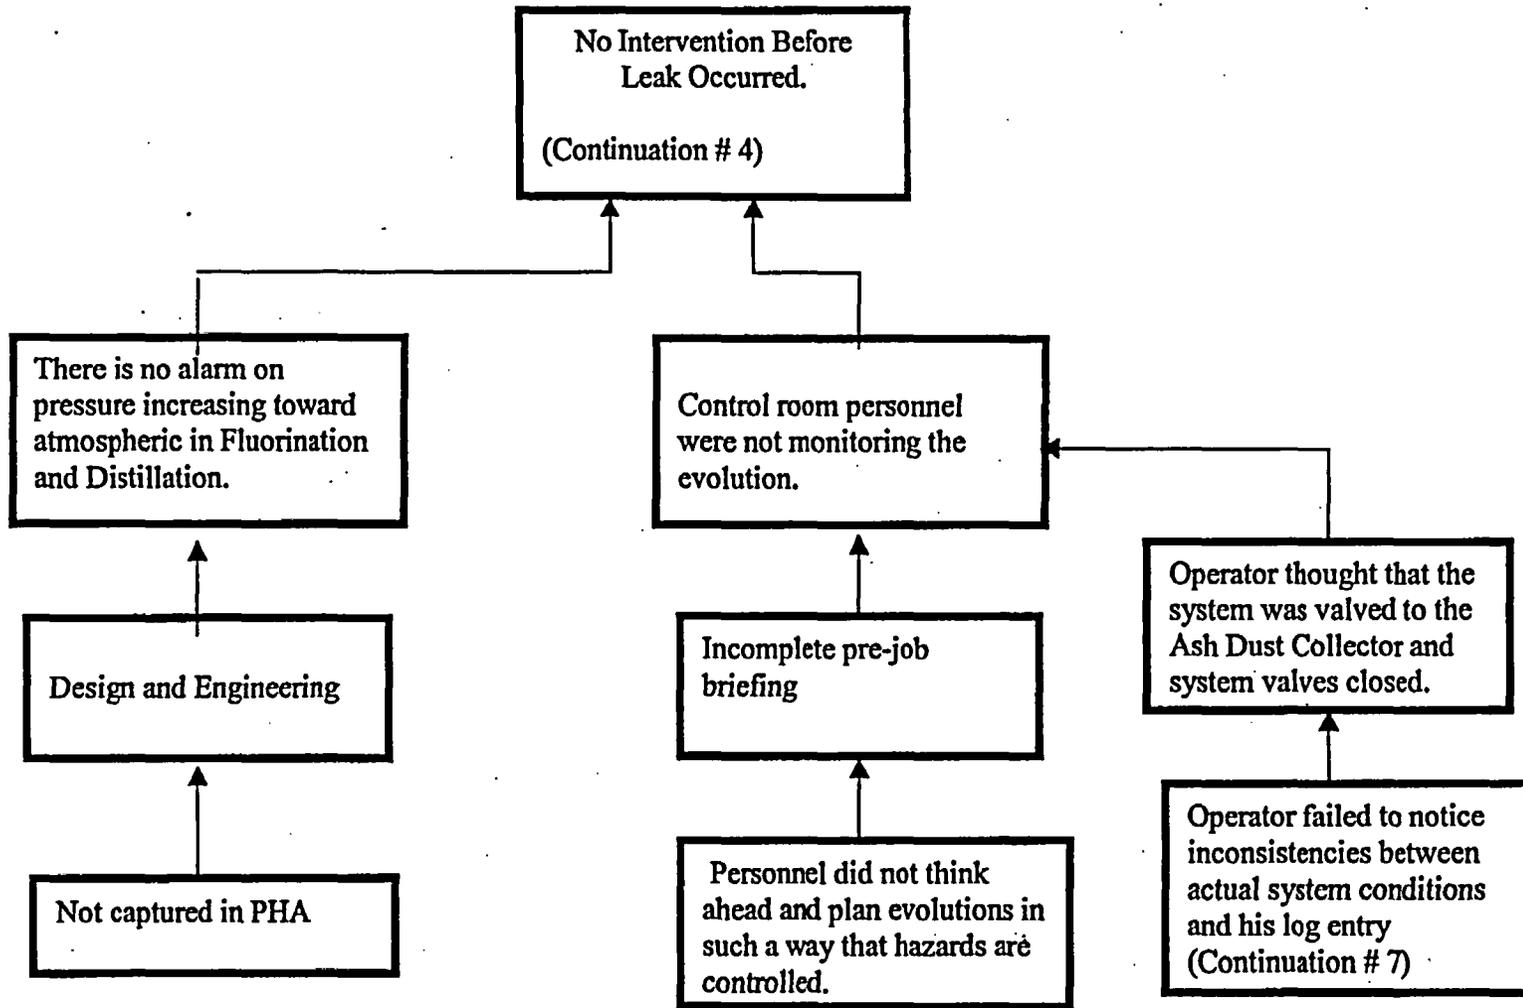
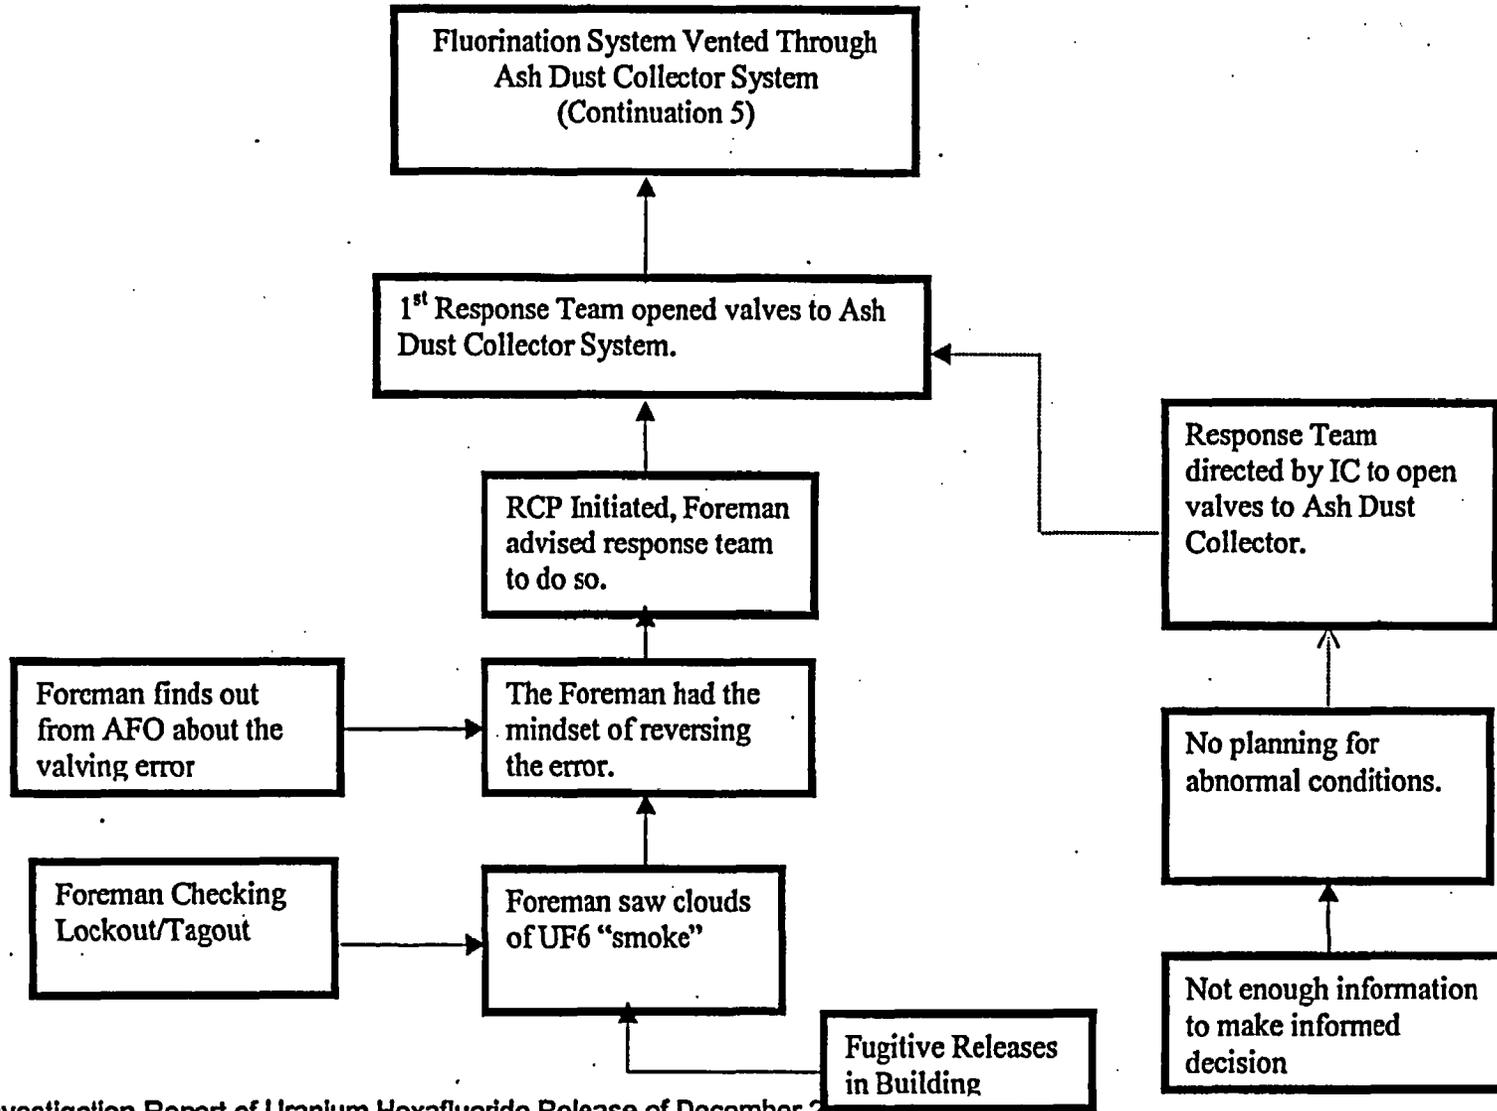
Appendix 5: Why Staircase Tree for Release

The causal factors for the release are more fully explained in a graphic format in the "Why Staircase" contained in Appendix 5.
