Report No. 10CFR21-0090
Rev. 0: 09/16/05

10CFR21 REPORTING OF DEFECTS AND NON-COMPLIANCE

COMPONENT: Governor Drive Coupling Element
P/N AK-007-001

SYSTEM: Enterprise Emergency Diesel Generator Sets

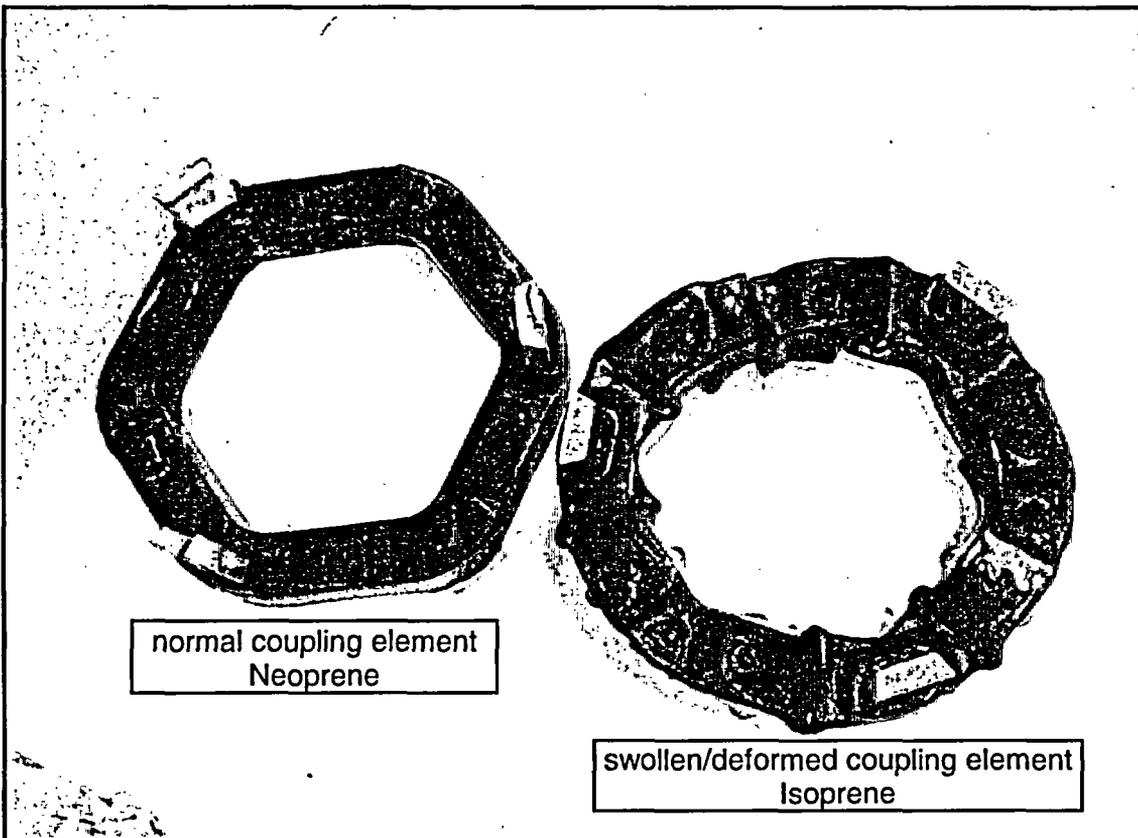
In June 2005, the Shearon Harris plant had reportedly removed a coupling element from their diesel engine and observed the material to be swollen and deformed (see Figure 1 below). A subsequent technical report provided by the site's Materials Services Section found the material composition of the element to be isoprene (natural rubber). The current design of the coupling specifies the material to be polychloroprene (neoprene).

FIGURE 1 A photograph of two governor couplings removed from an emergency diesel generator at the Harris Nuclear Plant. There are supposedly identical components that have been exposed to the same service environment. Note that the coupling on the right is swollen and deformed compared to the one on the left.

The results of ESI's internal investigation revealed that several utilities have been supplied coupling elements made from isoprene. The isoprene material is not suitable for the high temperature, oil rich environment of the engine gear case and is susceptible to failure after prolonged exposure (the condition reported at Shearon Harris was noted after being installed on the engine for 16 months).

1. Review their inventory for suspect elements listed in Table 1. Any suspect elements should be removed from inventory and replaced.
2. Determine if suspect elements listed in Table 1 have been installed on the engine. ESI has not been able to determine an expected service life of isoprene coupling elements when exposed to the high temperature, oil rich environment of the engine gear case. Therefore, our recommendation is to replace any installed suspect elements as soon as possible.
