# ENGINE SYSTEMS, INC.

Report No. 10CFR21-0090  
Rev. 0: 09/16/05

## 10CFR21 REPORTING OF DEFECTS AND NON-COMPLIANCE

COMPONENT: Governor Drive Coupling Element  
P/N AK-007-001

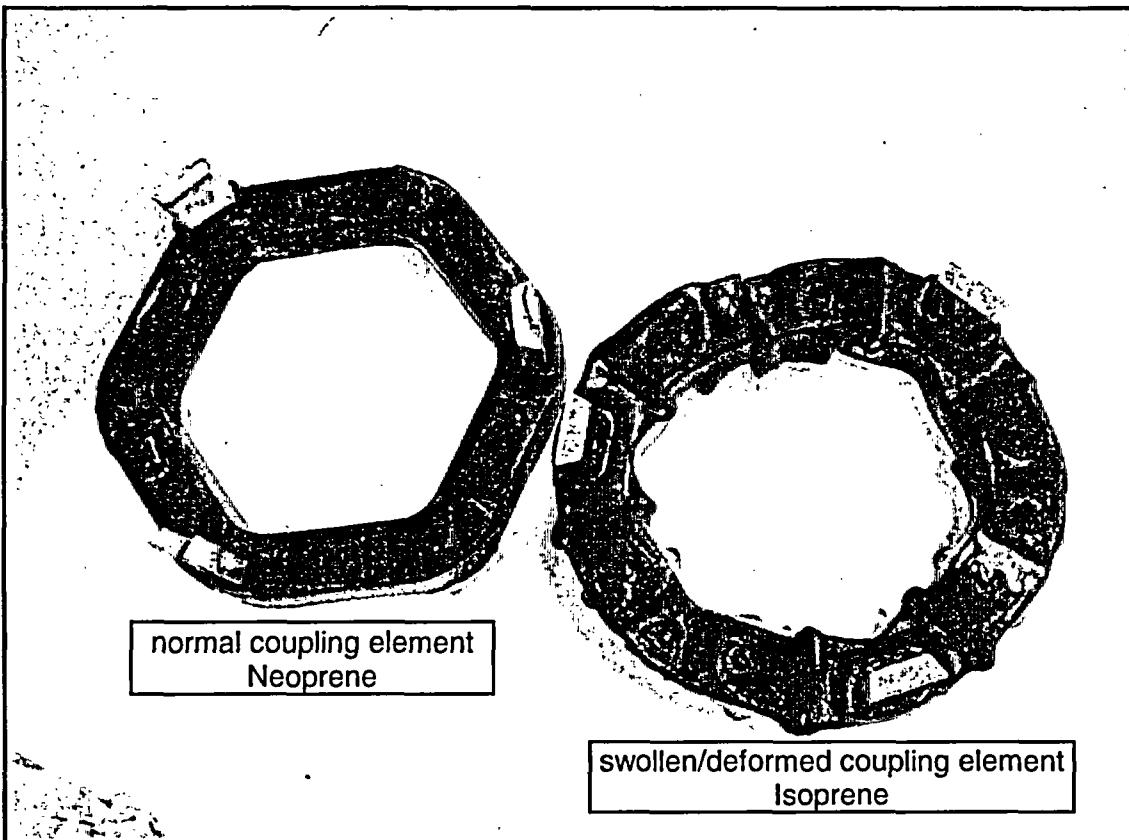
In June 2005, the Shearon Harris plant had reportedly removed a coupling element from their diesel engine and observed the material to be swollen and deformed (see Figure 1 below). A subsequent technical report provided by the site's Materials Services Section found the material composition of the element to be isoprene (natural rubber). The current design of the coupling specifies the material to be polychloroprene (neoprene).

**FIGURE 1** A photograph of two governor couplings removed from an emergency diesel generator at the Harris Nuclear Plant. There are supposedly identical components that have been exposed to the same service environment. Note that the coupling on the right is swollen and deformed compared to the one on the left.

The results of ESI's internal investigation revealed that several utilities have been supplied coupling elements made from isoprene. The isoprene material is not suitable for the high temperature, oil rich environment of the engine gear case and is susceptible to failure after prolonged exposure (the condition reported at Shearon Harris was noted after being installed on the engine for 16 months).

1. Review their inventory for suspect elements listed in Table 1. Any suspect elements should be removed from inventory and replaced.
2. Determine if suspect elements listed in Table 1 have been installed on the engine. ESI has not been able to determine an expected service life of isoprene coupling elements when exposed to the high temperature, oil rich environment of the engine gear case. Therefore, our recommendation is to replace any installed suspect elements as soon as possible.
