U.S. Army Corps of Engineers
Mobile District

SUBJECT: Removal Action at LaGarde Park, Phase II.

1. **LOCATION:** Anniston, Alabama
2. **CONTRACT NO.:** DACA01-01-D-0007
DELIVERY ORDER NO.: 0009
3. **PREPARED FOR:** U.S. Army Corps of Engineers-Mobile District (USACE-Mobile)
4. **ATTENDEES:** Solutions To Environmental Problems, Inc. (STEP)
Explosive Ordnance Disposal Technology (EODT)
MHF Logistical Solutions (MHF)
Damon Young, Geologist, USACE-Mobile District
5. **PURPOSE:** For the continued removal of all contaminated areas exceeding the Nuclear Regulatory Commission (NRC) Residential Surface Soil Screening Levels and areas three-times background (6,040 counts per minute) levels of Cobalt⁶⁰ and Cesium¹³⁷.
6. **DISCUSSION:**

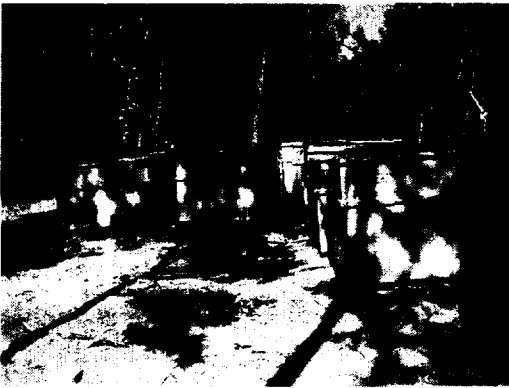
Overall: The U.S. Army Corps of Engineers, Mobile District (USACE-Mobile) contracted Solutions To Environmental Problems, Inc. (STEP) to perform a removal action of radioactive material at LaGarde Park in Anniston, Alabama. The initial removal consisted of approximately 30yds³ of radioactive contaminated soils, confirmation/closure sampling, transportation and disposal of radioactive waste, and restoration of the site. The original site investigation revealed several areas within the "hot spot" zone from soil and tree root samples with the presence of Cobalt⁶⁰ and Cesium¹³⁷. Due to the known levels above the derived concentration guideline levels (DCGL), the Alabama Department of Public Health requested that all soil be excavated and removed. For the removal action, contaminated areas exceeding the Nuclear Regulatory Commission (NRC) Residential Surface Soil Screening Levels and areas three-times background (6,040 counts per minute) were excavated and placed in approved storage containers (i.e. IPI-90-SC, Gasket Sealed, 12-Gauge Carbon Steel, 90 ft³), for shipping offsite (see Figure 1).

Figure 1: IPI-90-SC, Gasket Sealed, 12-Gauge Carbon Steel, 90 ft³.

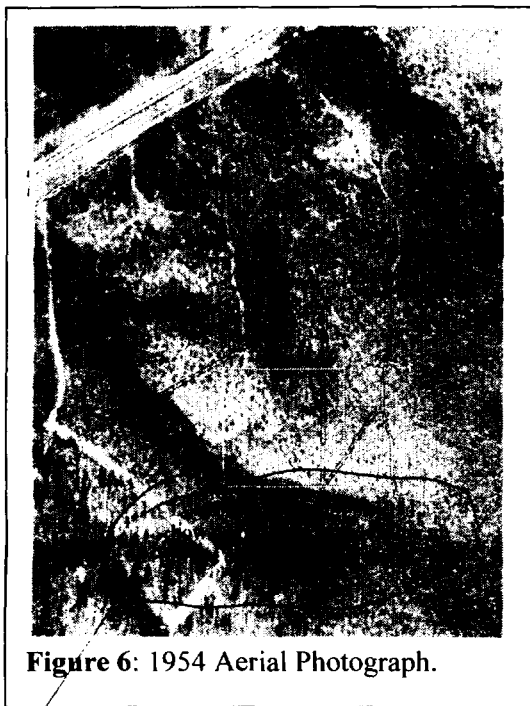
LOCATION NOT PRESENT in 1954
HOWEVER THE ROADWAY LEADING
UP TO THE CURRENT SITE
IS PRESENT.

SITE APPROXIMATELY 180 FEET
FROM ROADWAY

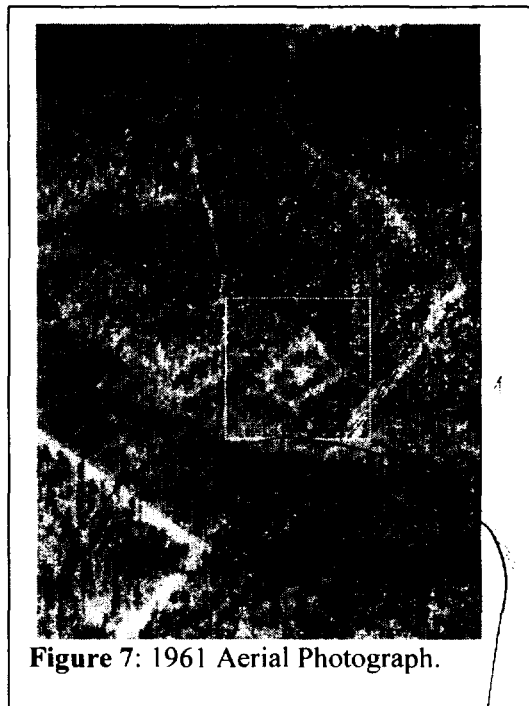
USACE personnel continued with an inquiry on Thursday, 9 Oct 2003. Following a safety meeting with Foster Wheeler, SHAW, JPA and TF team, USACE viewed several Aerial Photographs of Area 1 within LaGarde Park. These photographs give a good indication that the actual site was approximately 0.75 acres to 1-acre in size. This would include almost the entire fenced in area of the site. Photographs taken in 1954 do not show any indication of a disturbed area within the now LaGarde Park. However a road leading up to the site can be seen (see Figure 6). Photographs taken in both 1961 and 1969 show the site in plain view from above (see Figure 7 and Figure 8).

SITE STILL
SEEN IN 1969,
7 YEARS BEFORE
TRAPPING OVER
TO THE CITY
OF ANNISTON
