Appendix B

SEM/EDS Data for Test-2 Day-30 Corrosion Products

For ICET tests, one process of interest is the corrosion effect on metal and concrete coupons. One means of understanding the corrosion process is through direct examination of the corrosion products after the test is completed. For this purpose, corrosion products were collected when Test #2 was shut down (March 7, 2005). These corrosion products included (1) fine powders on a vertical piece of the submerged CPVC rack, (2) white residue on a horizontal piece of the submerged CPVC rack, (3) corrosion products on a submerged galvanized steel coupon, and (4) corrosion products on a submerged aluminum coupon.

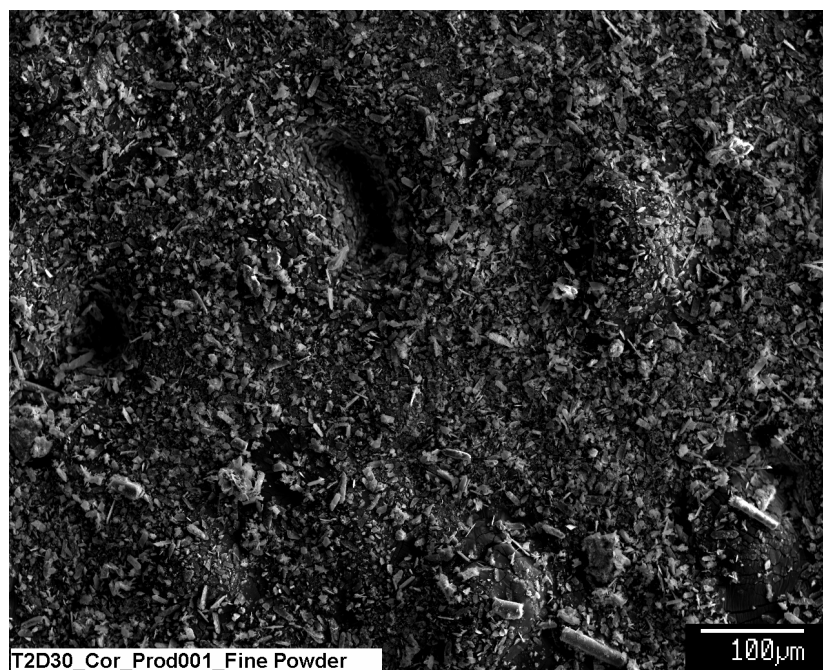
Figure B-1. SEM image (150×) for a Test-2 Day-30 sample of fine powder on a vertical piece of the submerged PVC rack (T2D30_Cor_Prod001_Fine Powder).

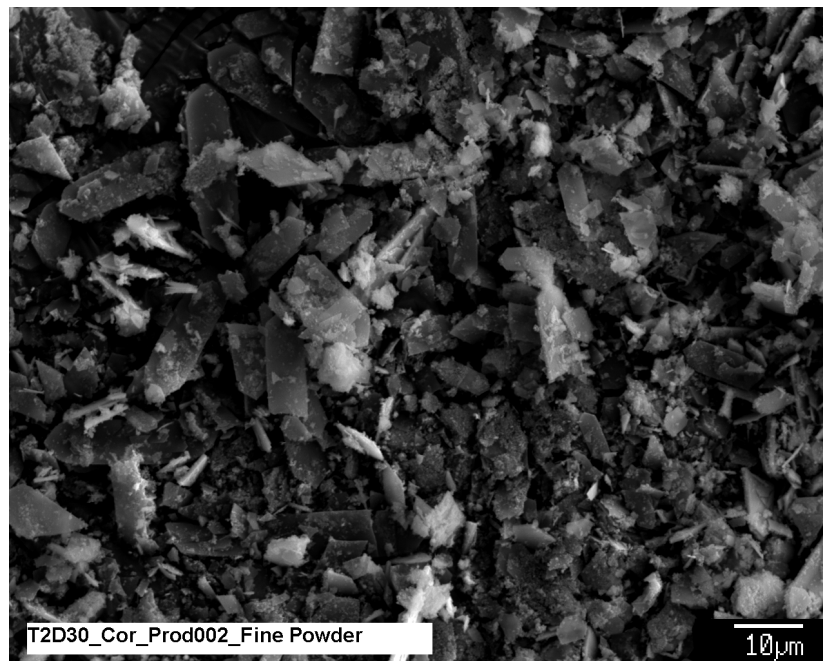
Figure B-2. SEM image at 1000× magnification for a Test-2 Day-30 sample of fine powder on a vertical piece of the submerged PVC rack (T2D30_Cor_Prod002_Fine Powder).

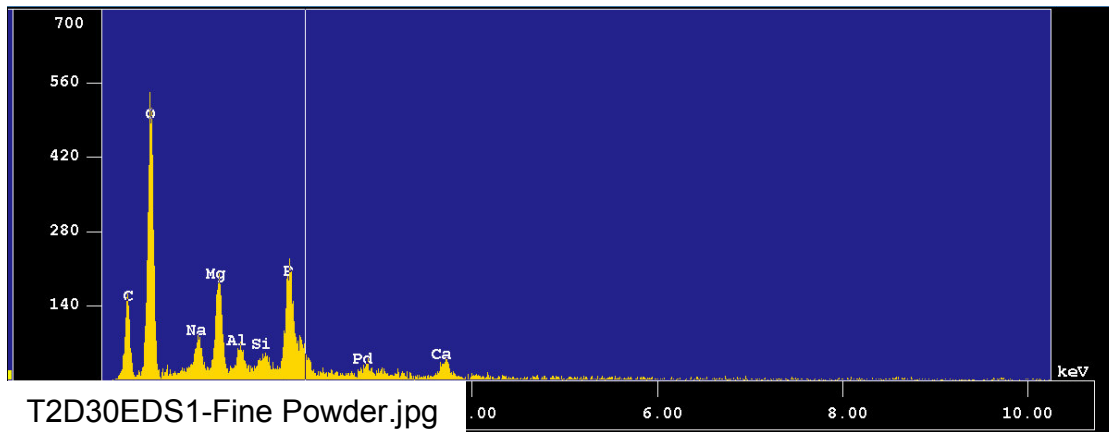
Figure B-3. EDS counting spectrum for the SEM image shown in Figure B-2 suggesting that the fine powder may contain Mg salts (MgCO_3 and/or $\text{Mg}_3(\text{PO}_4)_2$) (T2D30EDS1-Fine Powder)

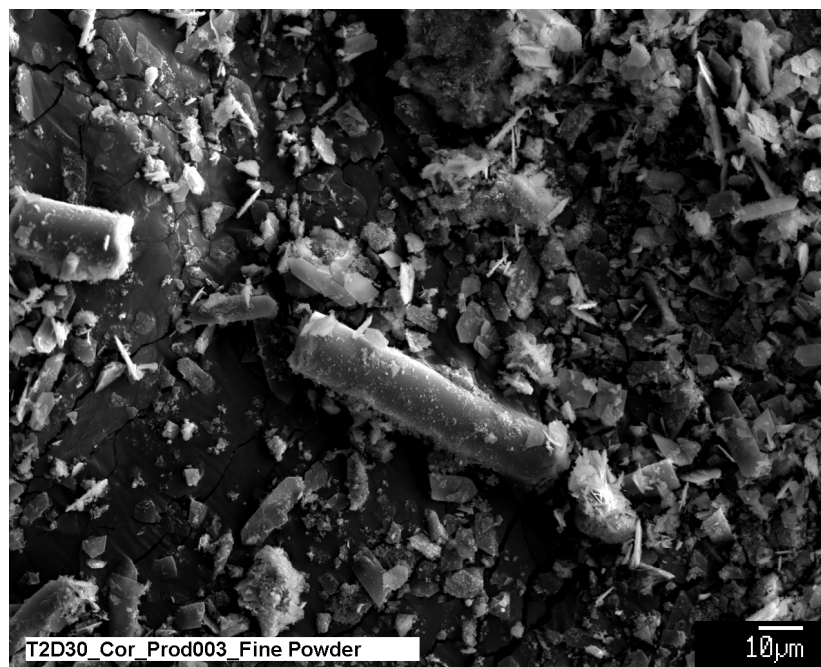
Figure B-4. Another SEM image at 650 \times magnification for a Test-2 Day-30 sample of fine powder on a vertical piece of the submerged PVC rack. The cylinder shaped debris is likely to be fiberglass (T2D30_Cor_Prod003_Fine Powder).

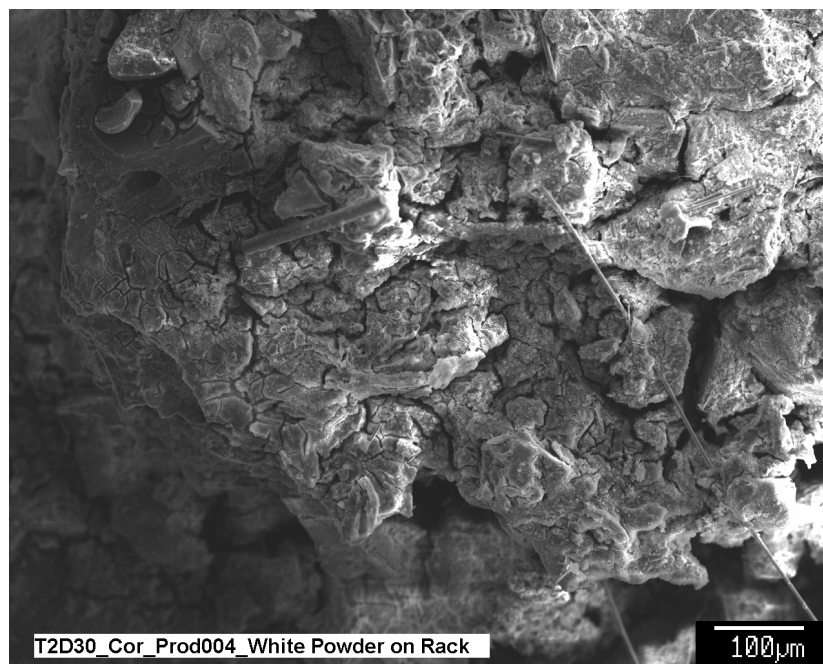
Figure B-5. SEM image (130×) for a Test-2 Day-30 sample of white residue on a horizontal piece of the submerged CPVC rack (T2D30_Cor_Prod004_White Powder on Rack).

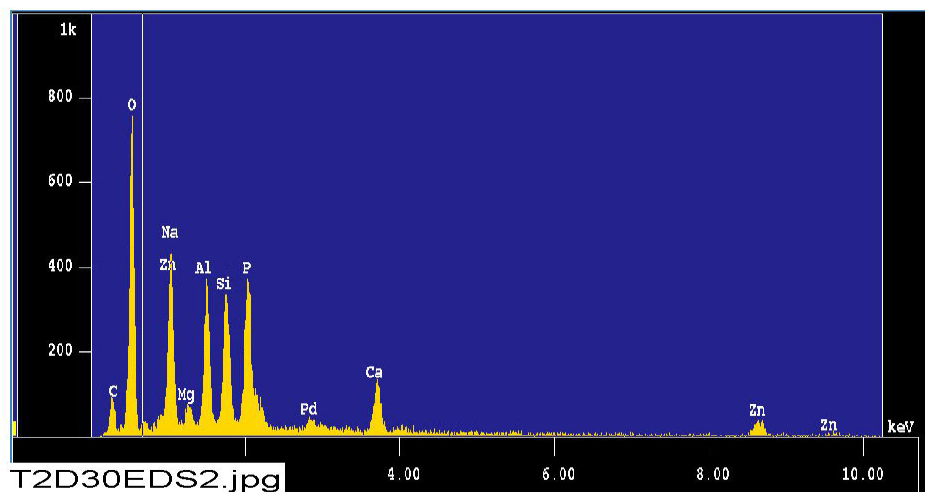
Figure B-6. EDS counting spectrum collected on the field of view at 130× magnification for the white residue shown in Figure B-5(T2D30EDS2).

Element	Mass%	Atomic%	ZAF	Z	A	F
C	6.592	11.4056	4.4054	1.0018	4.3976	1.0000
O	51.610	67.0354	0.9885	0.9553	1.0347	1.0000
Na	2.469	2.2320	1.4313	0.9592	1.4903	1.0012
Al	6.884	5.3019	1.3736	0.9668	1.4225	0.9988
Si	6.586	4.8732	1.2700	0.9548	1.3302	0.9999
Ca	4.631	2.4012	0.9637	0.9664	0.9977	0.9995
Fe	0.055	0.0205	0.9310	0.9595	1.0014	0.9689
Zn	21.171	6.7302	1.2474	1.2511	0.9971	1.0000

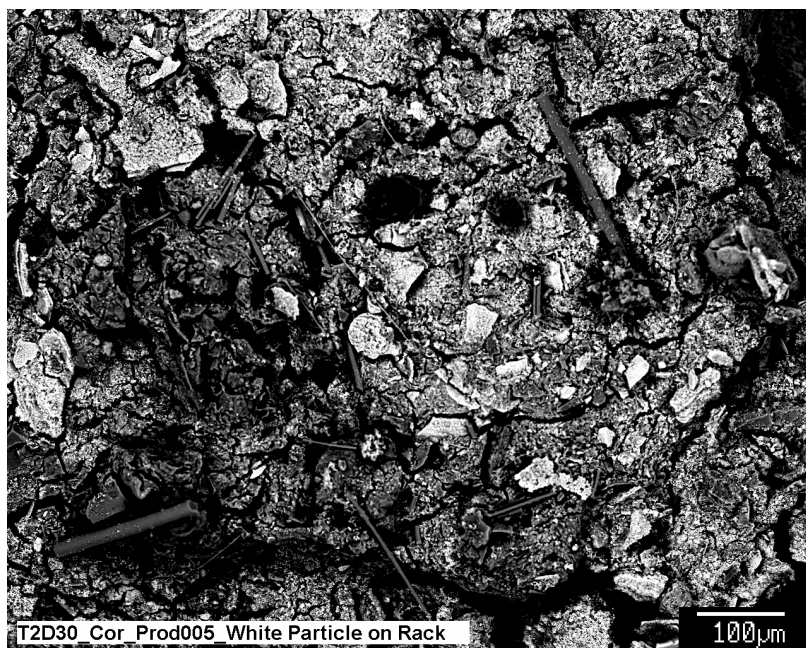
Figure B-7. Backscattered SEM image at 130× magnification for a Test-2 Day-30 sample of white residue on a horizontal piece of the submerged PVC rack (T2D30_Cor_Prod005_White Particle on Rack).

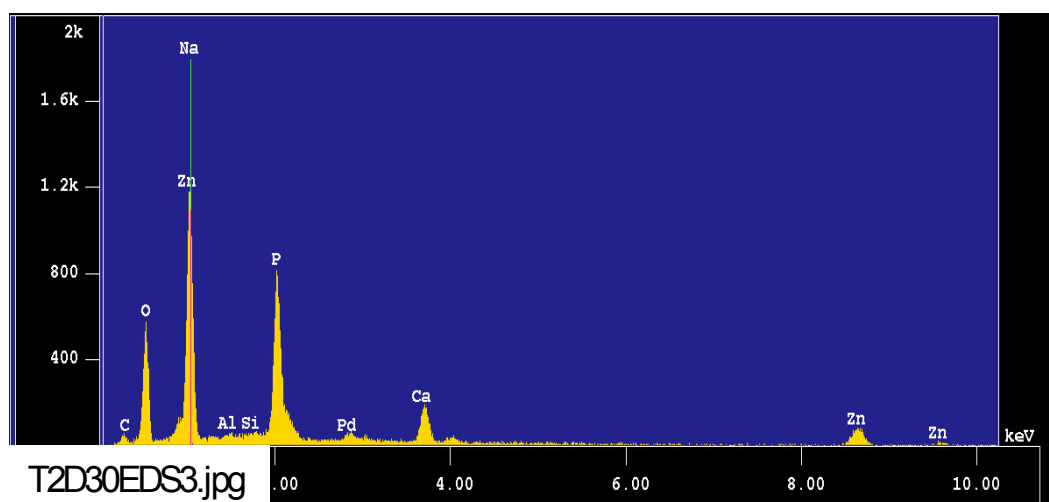
Figure B-8. EDS counting spectrum collected on the bright particles shown in Figure B-7 (T2D30EDS3).

Element	Mass%	Atomic%	ZAF	Z	A	F
O	35.902	61.6543	1.1175	0.9205	1.2141	1.0000
P	21.205	18.8094	0.9435	1.1063	0.8530	0.9998
Ca	5.687	3.8987	0.9558	0.9266	1.0321	0.9994
Zn	37.206	15.6376	1.1870	1.1878	0.9993	1.0000

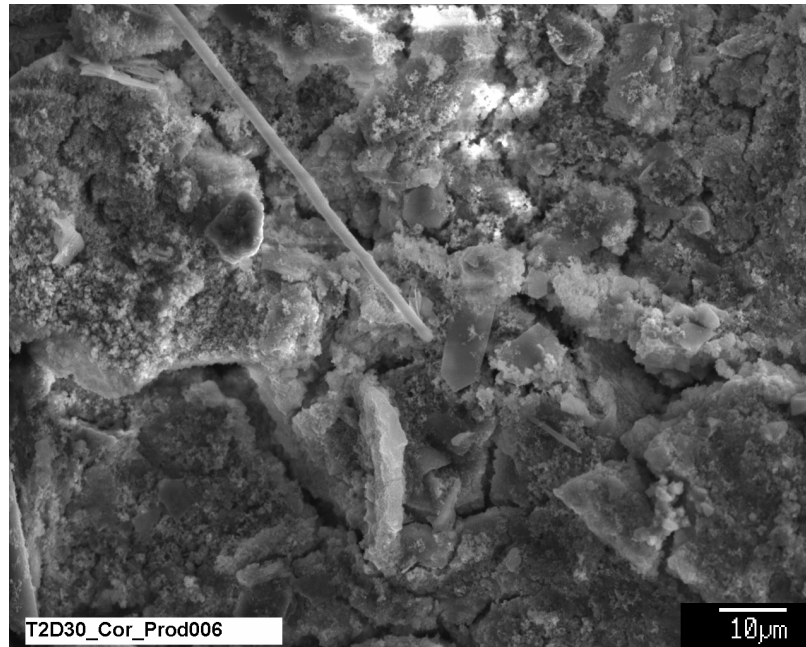
Figure B-9. SEM image at 1000× magnification for a Test-2 Day-30 sample of white residue on the horizontal piece of the submerged PVC rack (T2D30_Cor_Prod006).

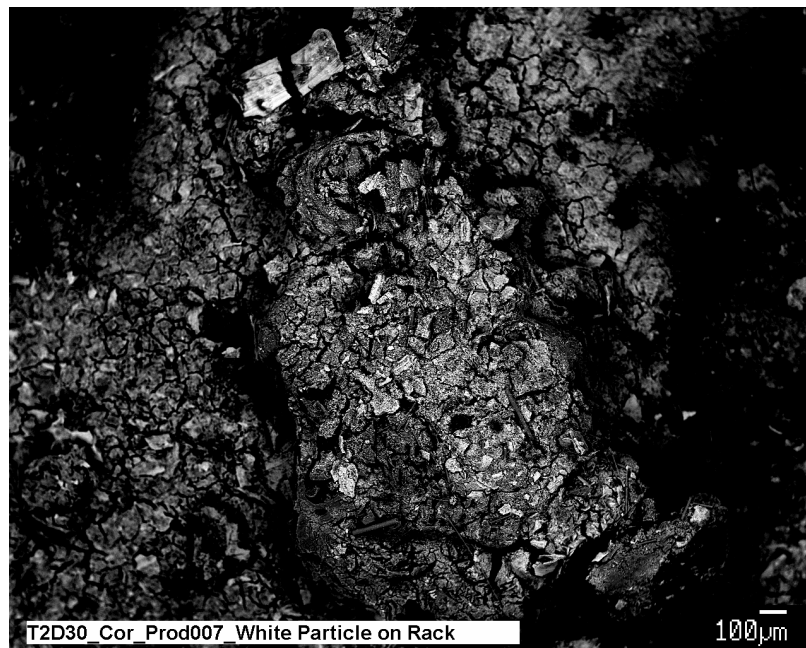
Figure B-10. Backscatter SEM overview at 40× magnification of a Test-2 Day-30 sample of white residue on the horizontal piece of the submerged CPVC rack. (Looks similar to the corrosion product on galvanized steel) (T2D30_Cor_Prod007_ White Particle on Rack).

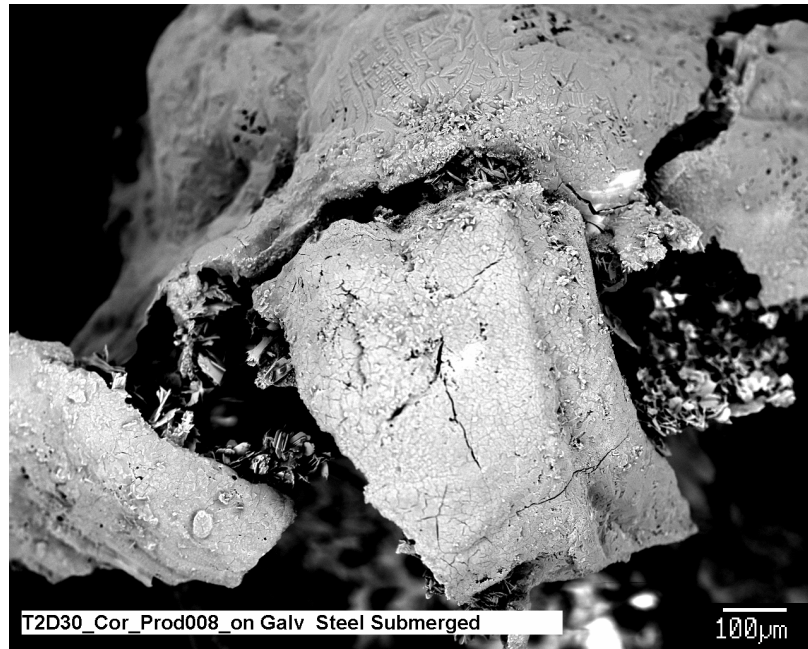
Figure B-11. Backscatter SEM image at 95× magnification of a Test-2 Day-30 sample of corrosion products on a submerged galvanized steel coupon (T2D30_Cor_Prod008_on Galv Steel Submerged).

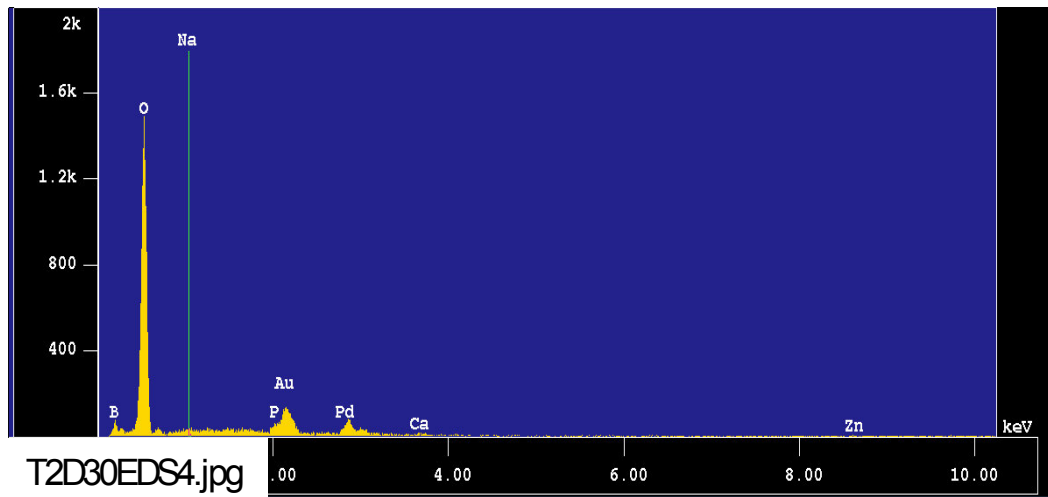
Figure B-12. EDS counting spectrum collected from the center of the SEM image shown in Figure B-11 (T2D30EDS4).

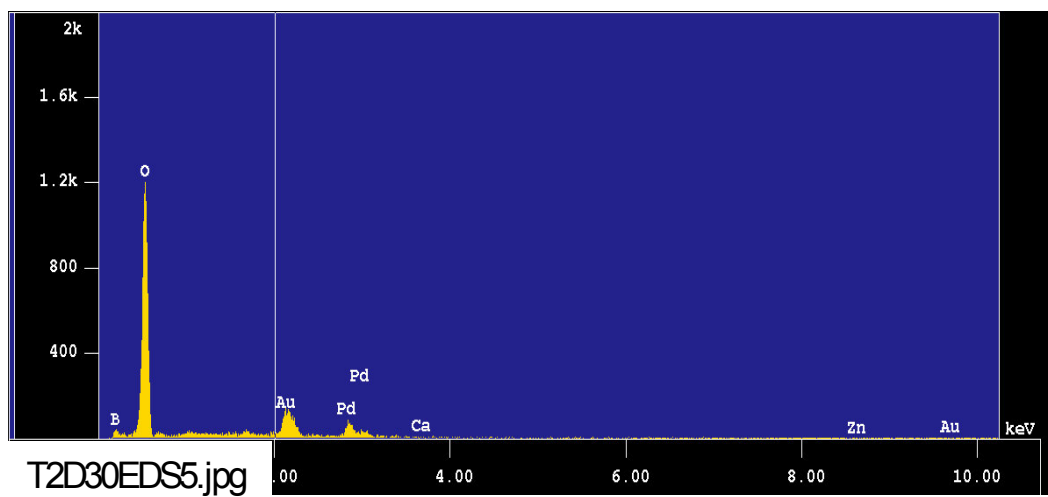
Figure B-13. EDS counting spectrum collected from the upper part of the SEM image shown in Figure B-11 (T2D30EDS5).

Element	Mass%	Atomic%	ZAF	Z	A	F
B	20.212	27.2669	4.4701	1.1295	3.9577	1.0000
O	79.788	72.7331	0.6494	0.9731	0.6673	1.0000
Zn	0.000	0.0000	1.2952	1.3038	0.9934	1.0000

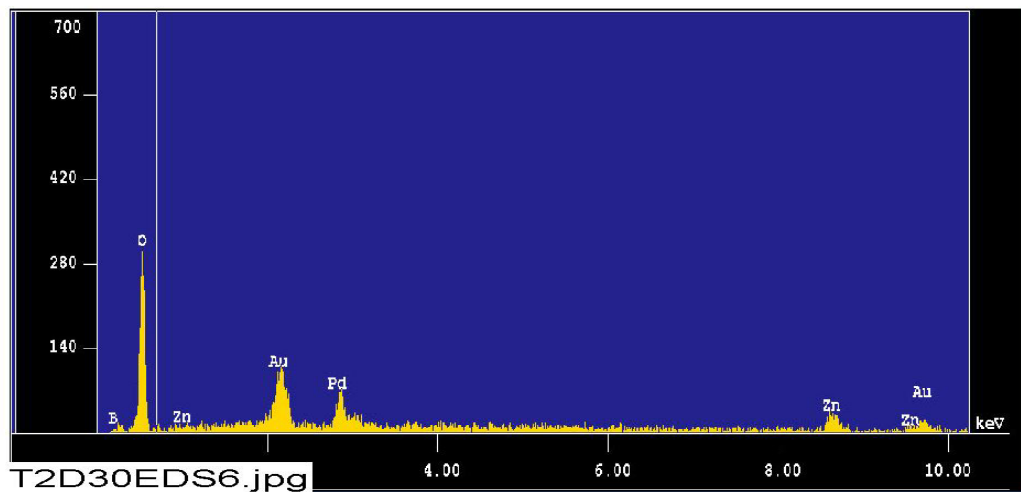
Figure B-14. EDS counting spectrum collected from the center of the SEM image shown in Figure B-11 but using a 25-kV beam voltage (T2D30EDS6).

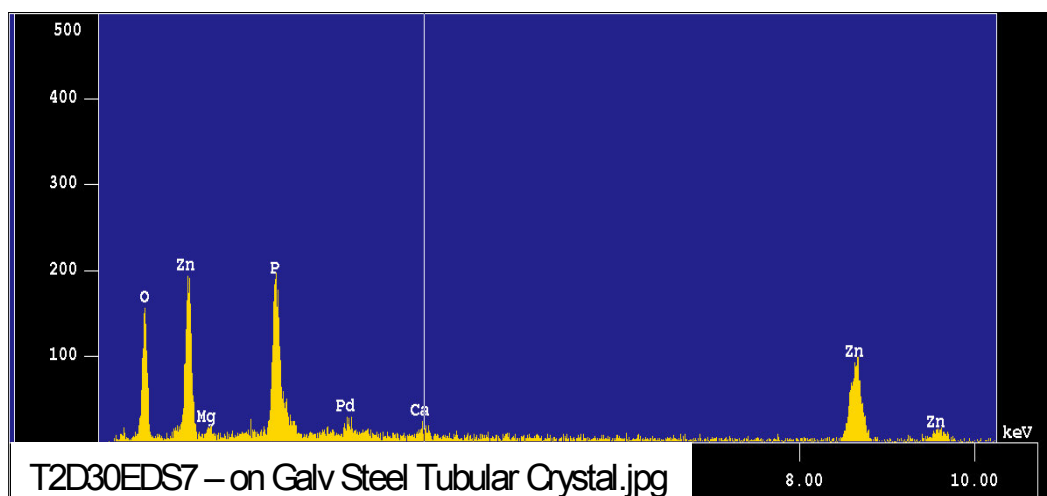
Figure B-15. EDS counting spectrum for small tubular crystals in Figure B-11 suggesting that the corrosion products of galvanized steel are rich in Zn, P, and O (possible presence of $\text{Zn}_3(\text{PO}_4)_2$).

Element	Mass%	Atomic%	ZAF	Z	A	F
O	33.841	61.7575	0.9431	0.9116	1.0346	0.9999
Mg	1.528	1.8349	3.6762	0.9047	4.0654	0.9996
P	15.204	14.3319	0.9525	1.0778	0.8837	1.0001
Zn	49.426	22.0757	1.1331	1.1370	0.9966	1.0000

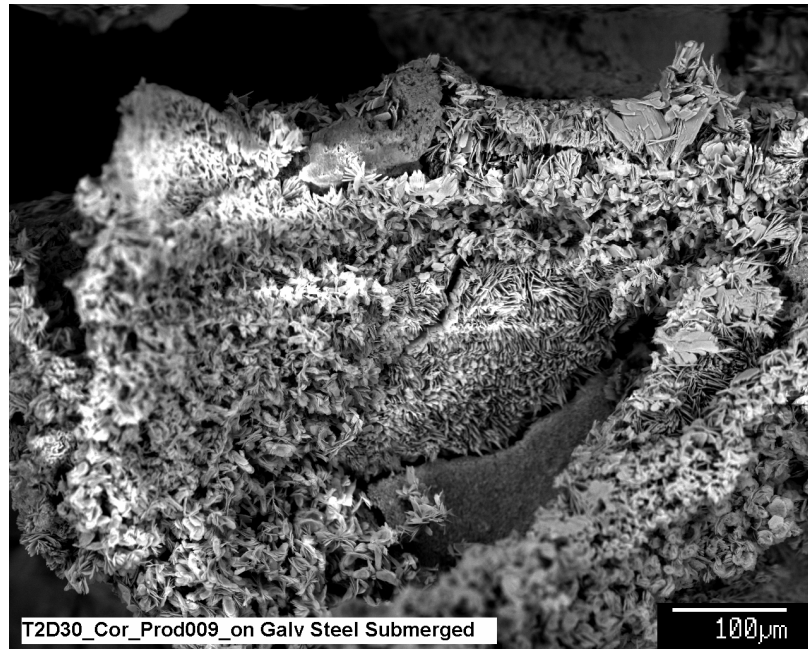
Figure B-16. Backscatter SEM image at 120× magnification for a Test-2 Day-30 sample of corrosion products on a submerged galvanized steel coupon (T2D30_Cor_Prod009_on Galv Steel Submerged).

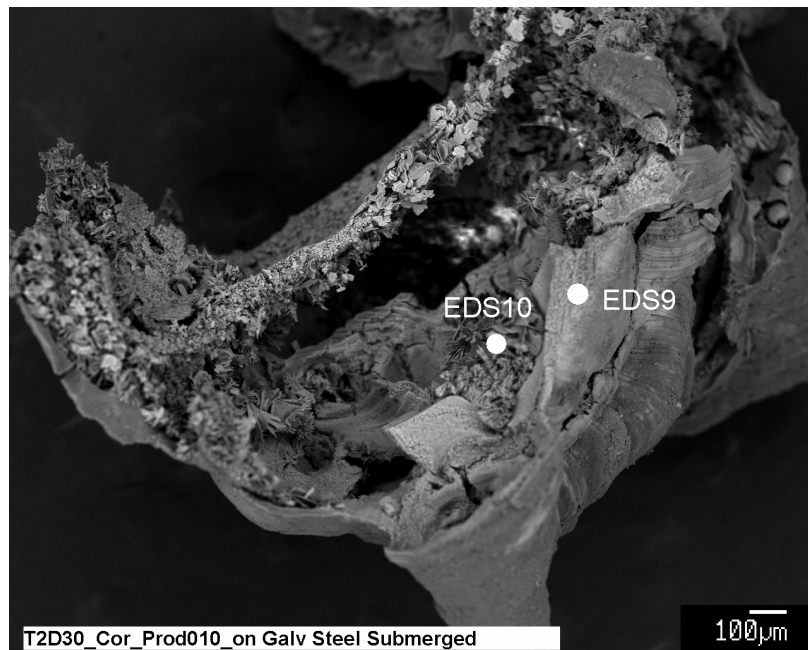
Figure B-17. Backscatter SEM image at 55× magnification for a Test-2 Day-30 sample of corrosion products on a submerged galvanized steel coupon, annotated to show EDS sample locations (T2D30_Cor_Prod010_on Galv Steel Submerged).

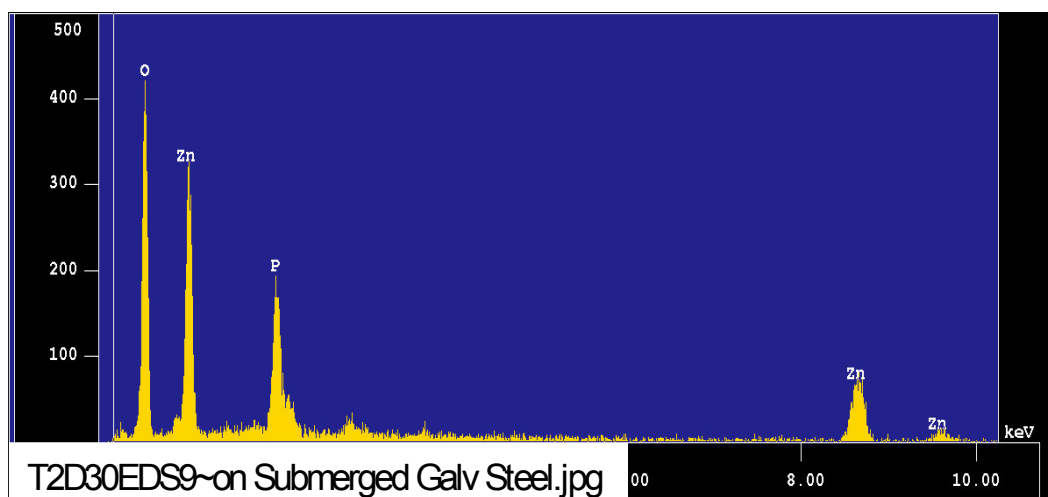
Figure B-18. EDS counting spectrum collected from the spot EDS9 indicated in Figure B-17 (T2D30EDS9~on Submerged Galv Steel).

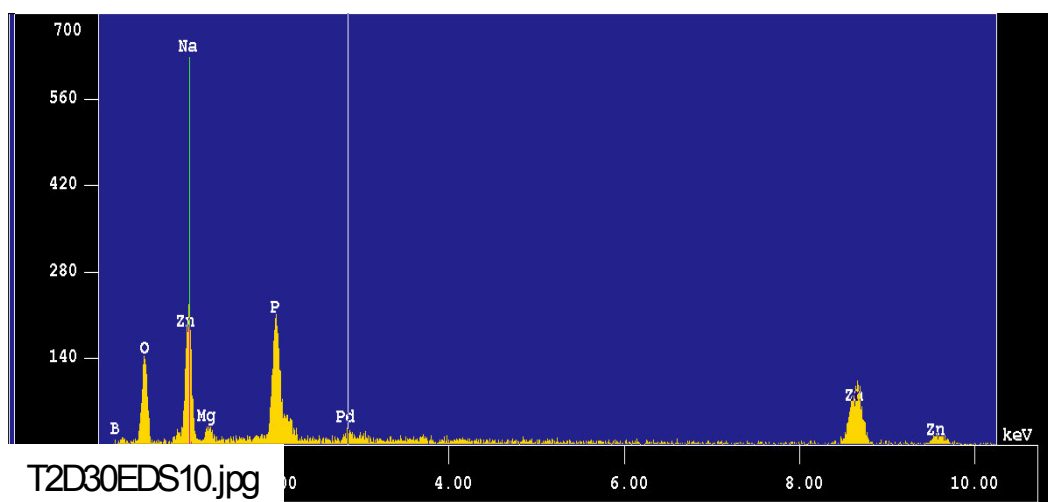
Figure B-19. EDS counting spectrum collected from the spot EDS10 indicated in Figure B-17 (T2D30EDS10).

Element	Mass%	Atomic%	ZAF	Z	A	F
O	31.348	58.5209	0.9613	0.9101	1.0564	0.9999
Zn	50.152	22.9142	1.1308	1.1343	0.9969	1.0000
P	15.751	15.1883	0.9584	1.0759	0.8907	1.0001
Na	0.000	0.0000	2.6509	0.9564	2.7714	1.0001
Mg	2.749	3.3766	3.6685	0.9031	4.0639	0.9995

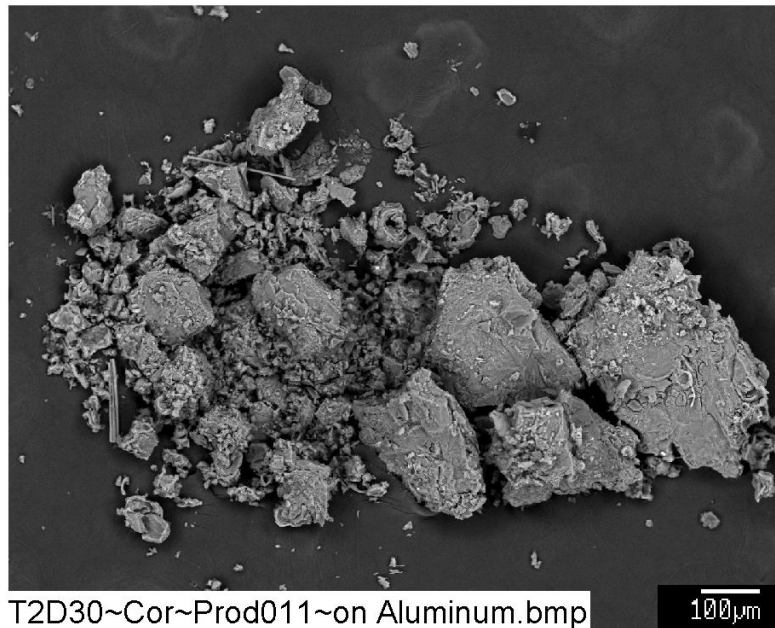
Figure B-20. Backscatter SEM image at 90× magnification for a Test-2 Day-30 sample of corrosion products on a submerged aluminum coupon (T2D30_Cor_Prod011_on Aluminum).

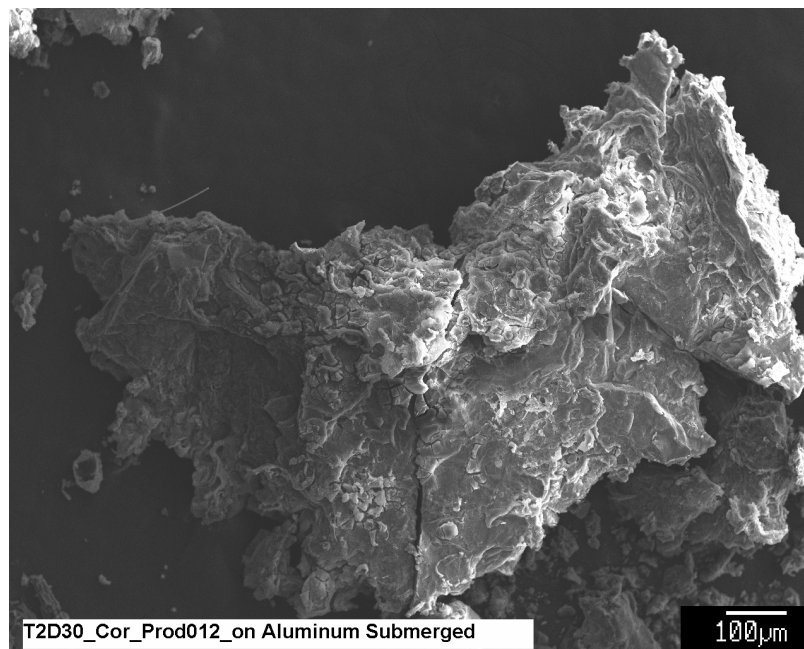
Figure B-21. SEM image at 90× magnification on another area of a Test-2 Day-30 sample of corrosion products on a submerged aluminum coupon (T2D30_Cor_Prod012_on Aluminum Submerged).

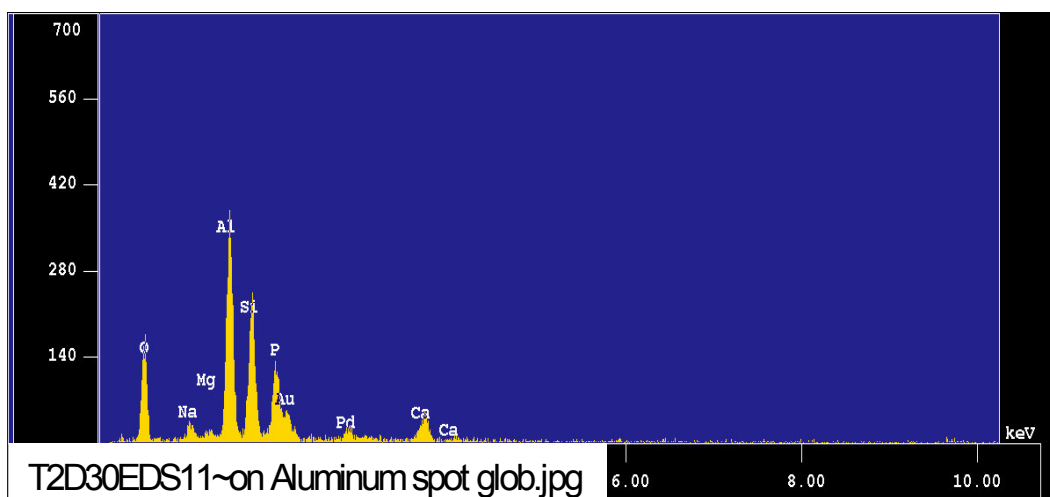
Figure B-22. EDS counting spectrum for upper right spot in Figure B-21 suggesting that the corrosion products of aluminum are rich in Al, Si, P, and O (T2D30EDS11~on Aluminum spot glob).

Element	Mass%	Atomic%	ZAF	Z	A	F
O	48.106	62.3021	1.1060	0.9888	1.1186	1.0000
Na	2.567	2.3135	1.3661	1.0402	1.3156	0.9983
Al	20.029	15.3810	1.3514	1.0145	1.3391	0.9947
Si	15.288	11.2788	1.5231	0.9905	1.5420	0.9972
Ca	4.262	2.2032	1.0486	1.0096	1.0387	1.0000
P	9.748	6.5213	0.9641	1.1723	0.8226	0.9999

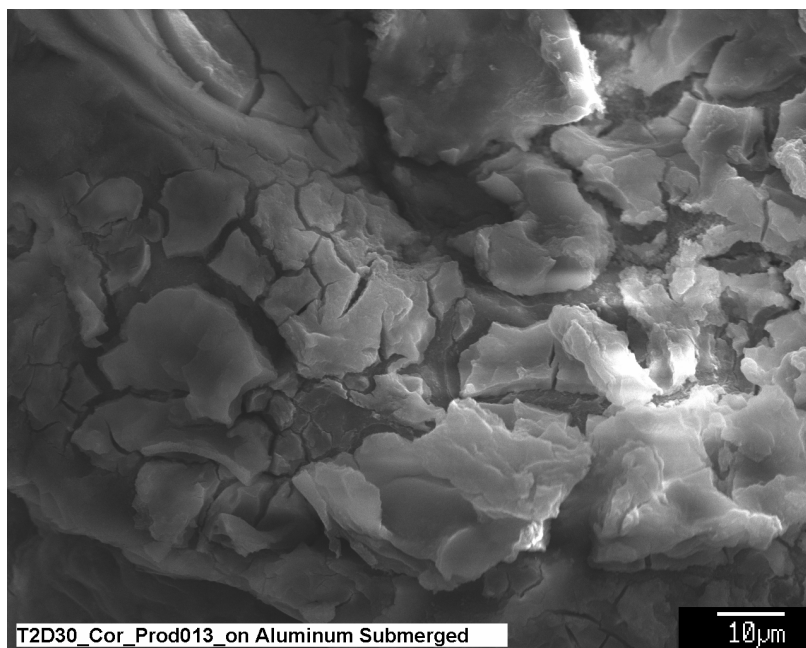
Figure B-23. SEM image at 1000× magnification of a Test-2 Day-30 sample of corrosion products on a submerged aluminum coupon (T2D30_Cor_Prod013_on Aluminum Submerged).

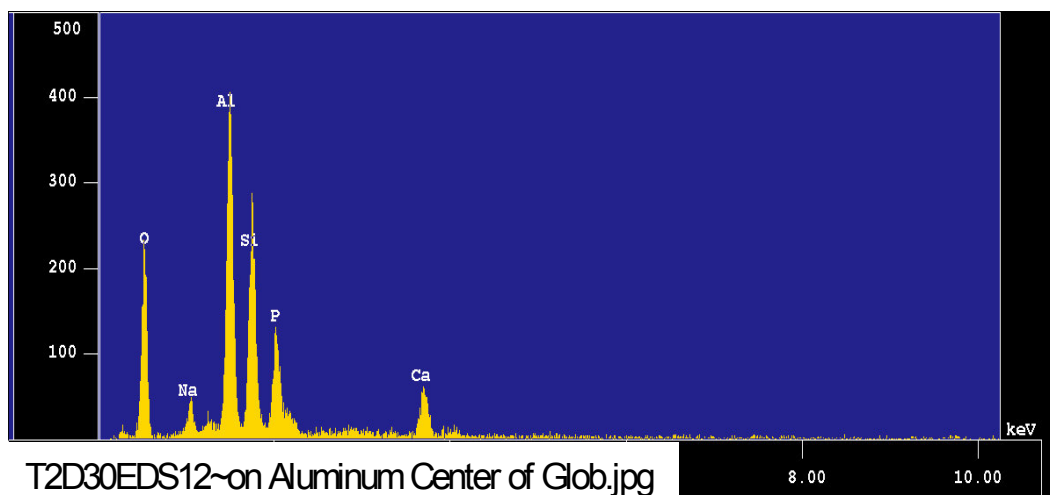
Figure B-24. EDS counting spectrum on the center of Figure B-23 suggesting that the corrosion products of aluminum are rich in Al, Si, P, and O (T2D30EDS12~on Aluminum Center of Glob).

Element	Mass%	Atomic%	ZAF	Z	A	F
O	50.761	64.8096	1.0876	0.9891	1.0996	1.0000
Na	3.268	2.9041	1.4045	1.0406	1.3517	0.9985
Al	18.215	13.7895	1.3837	1.0150	1.3700	0.9951
Si	14.298	10.3989	1.5122	0.9909	1.5297	0.9976
Ca	5.190	2.6450	1.0411	1.0101	1.0306	1.0000
P	8.269	5.4530	0.9502	1.1728	0.8104	0.9998
