Appendix C2

SEM/EDS Data for Unused and Test-2 Day-30 Copper Coupons

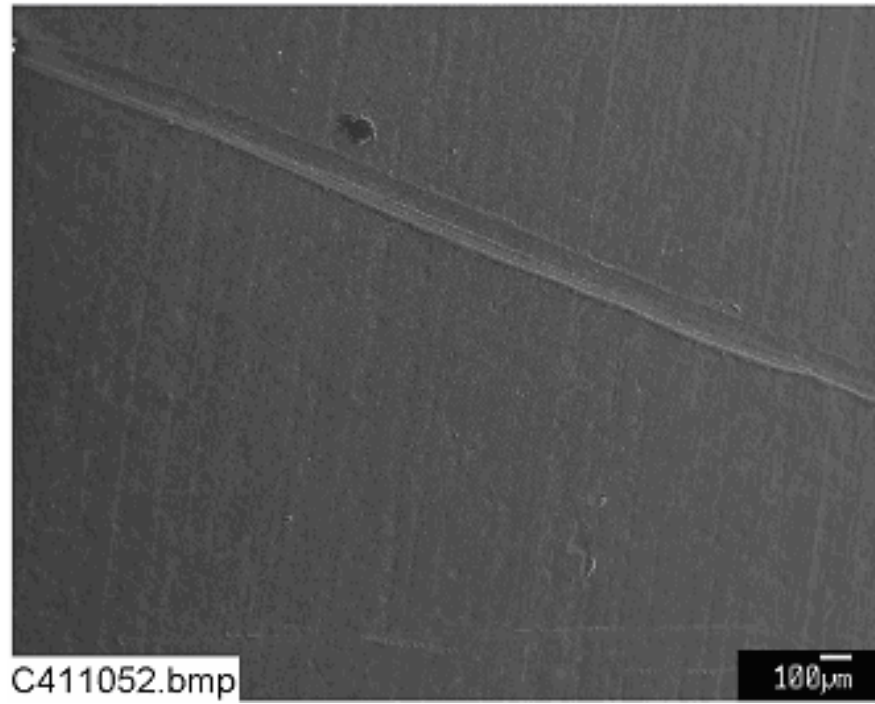
Figure C2-1. SEM image for an unused copper coupon (C411052).

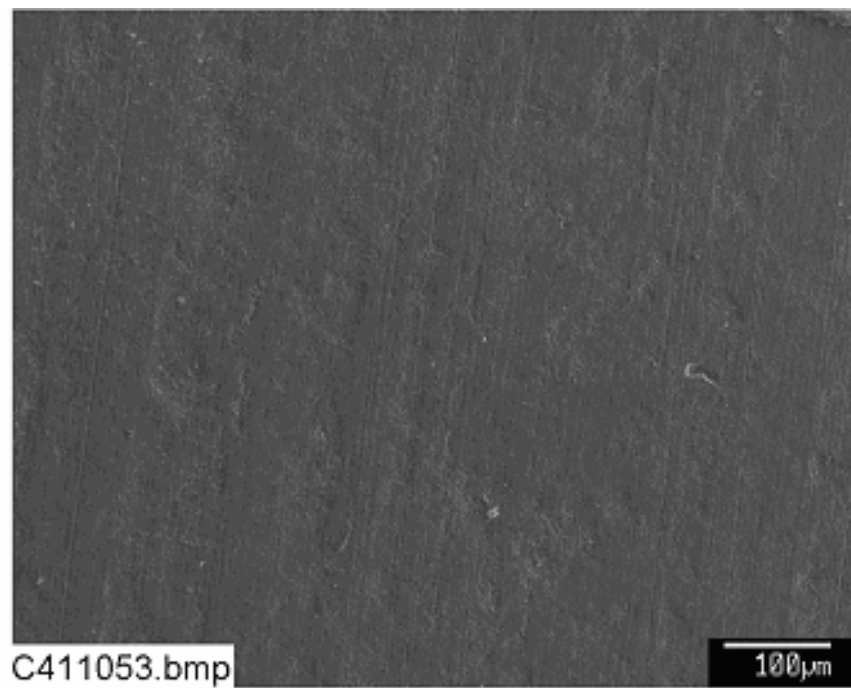
Figure C2-2. SEM image for an unused copper coupon (C411053).

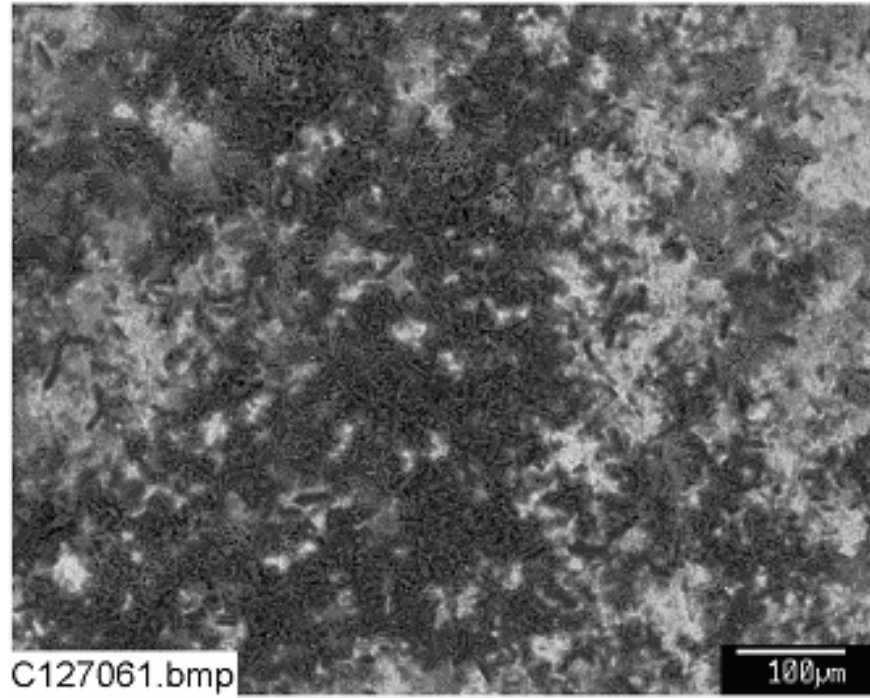
Figure C2-11. Backscattered SEM image for a Test-2 Day-30 submerged copper coupon (C127061).

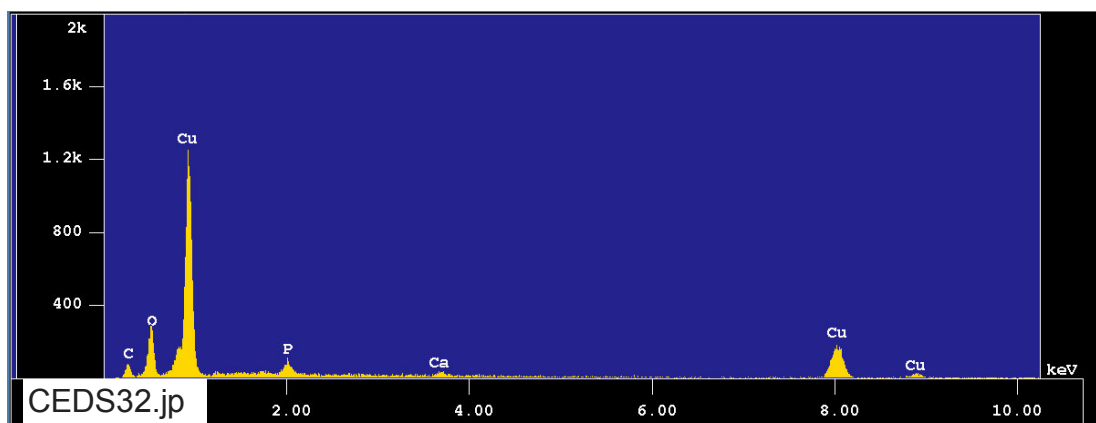
Figure C2-14. EDS counting spectrum for the light patches shown in Figure C2-11 (CEDS32).

The results from the chemical composition analysis for CEDS32 are given in Table C2-2.

Element	Mass%	Atomic%	ZAF	Z	A	F
O	16.042	42.1700	0.8549	0.8436	1.0136	0.9998
P	2.528	3.4327	1.0005	1.0112	0.9894	1.0000
Ca	1.293	1.3565	0.8912	0.8542	1.0459	0.9975
Cu	80.137	53.0408	1.0634	1.0641	0.9994	1.0000

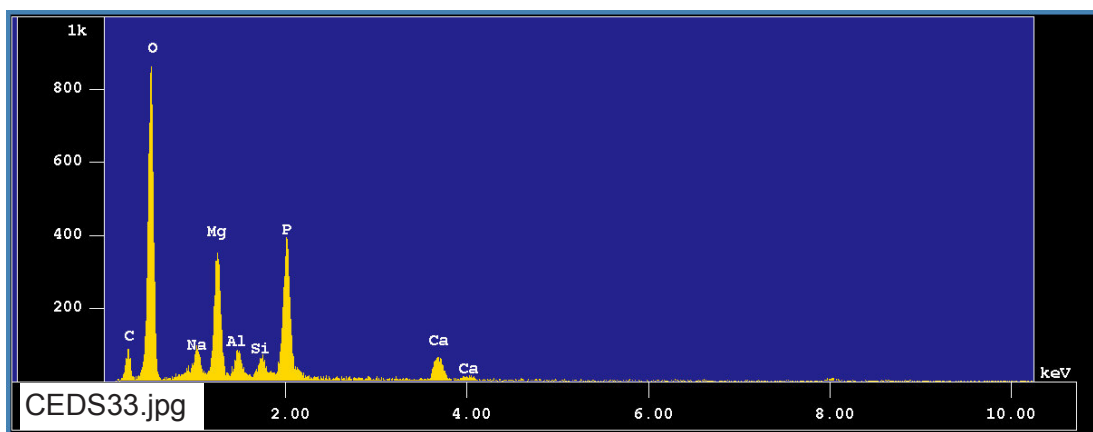
Figure C2-15. EDS counting spectrum for the lathlike crystals shown in Figure C2-12 (CEDs33).
