Appendix C4

SEM/EDS Data for Unused and Test-2 Day-30 Steel Coupons

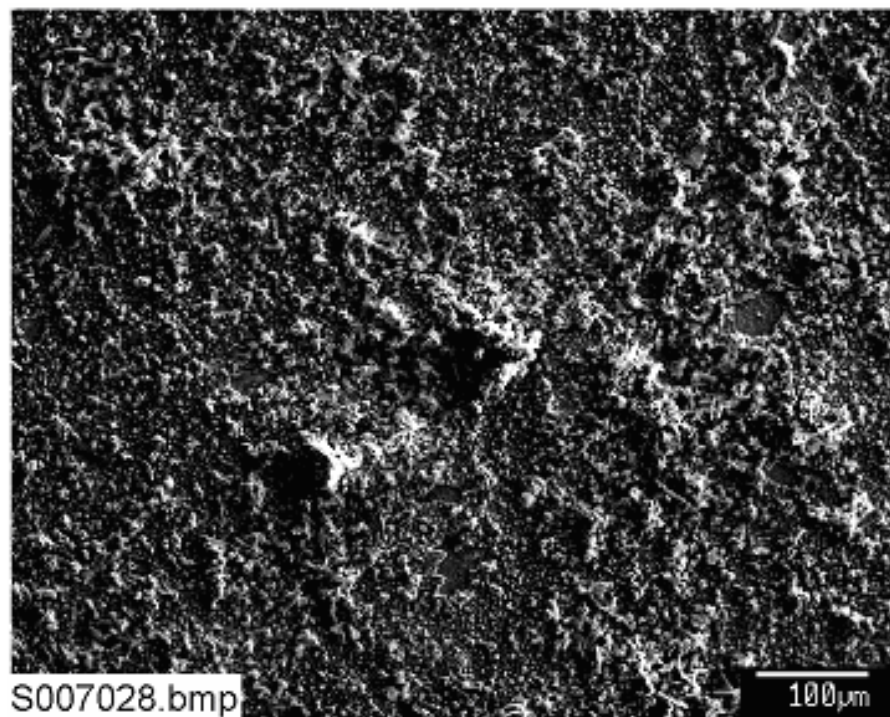
| Image: | S007028 | 150 × | SEI corroded surface | Figure C4-6 |

Figure C4-6. SEM image for a Test-2 Day-30 submerged steel coupon (S007028).

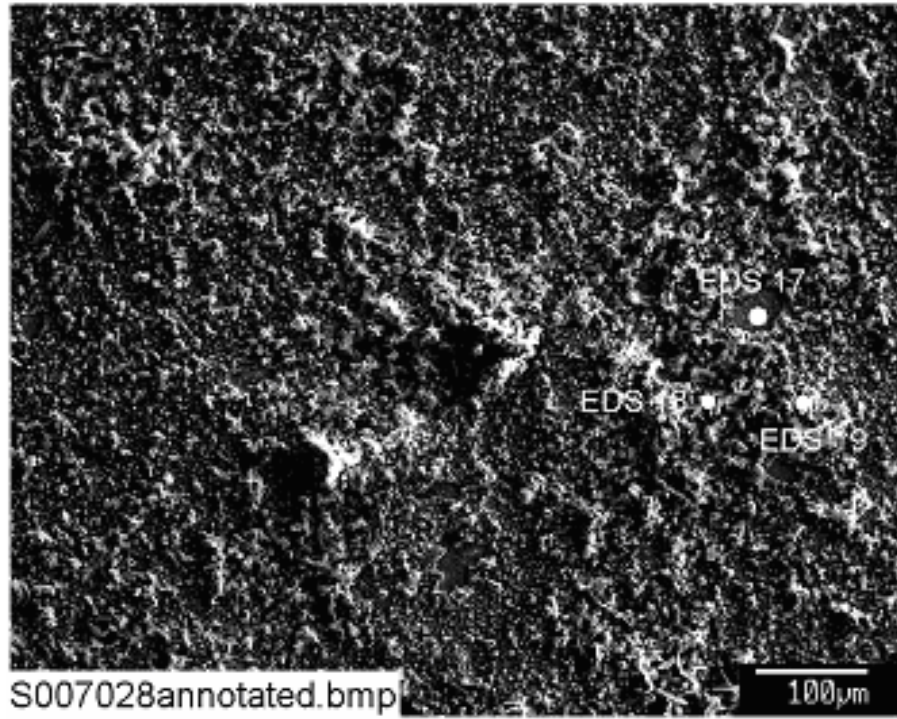
| | S007028annotated | 150 × | EDS spots 17–19 | Figure C4-7 |

Figure C4-7. SEM image for the corrosion surface of a Test-2 Day-30 submerged steel coupon (S007028annotated).

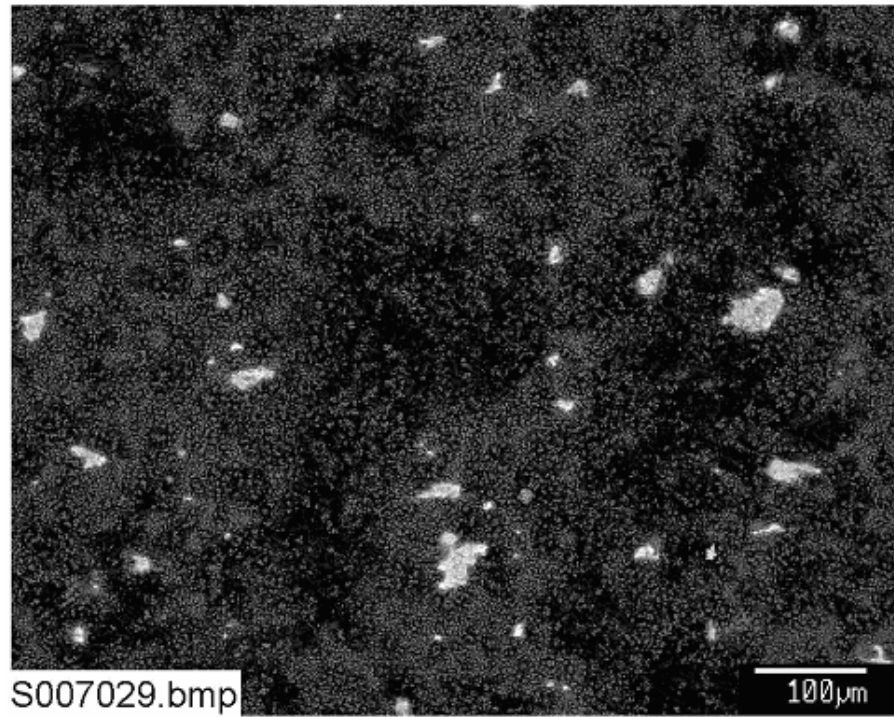
| | S007029 | 150 × | BEI same place | Figure C4-8 |

Figure C4-8. Backscattered SEM image for a Test-2 Day-30 submerged steel coupon (S007029).

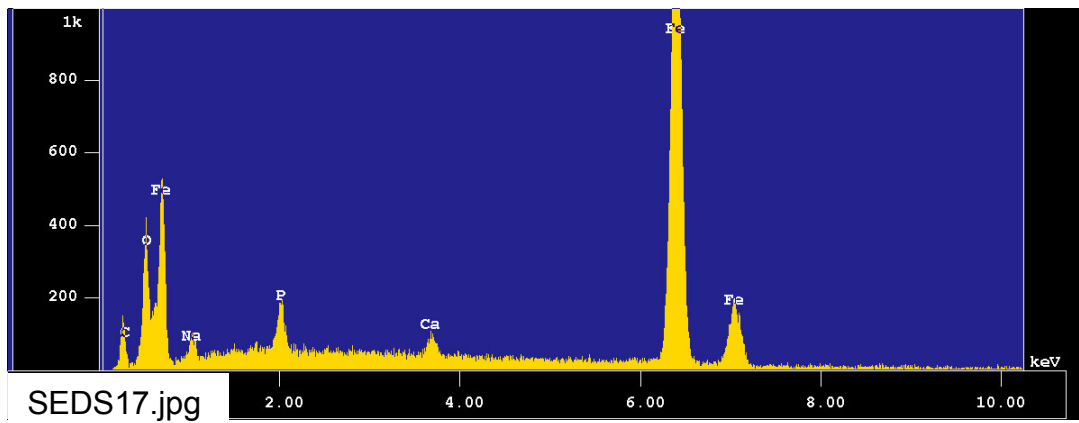
| EDS: | SEDS17 | | Light area in image 029 | Figure C4-9 |

Figure C4-9. EDS counting spectrum for the light spot shown in Figure C4-8 (SEDs17).

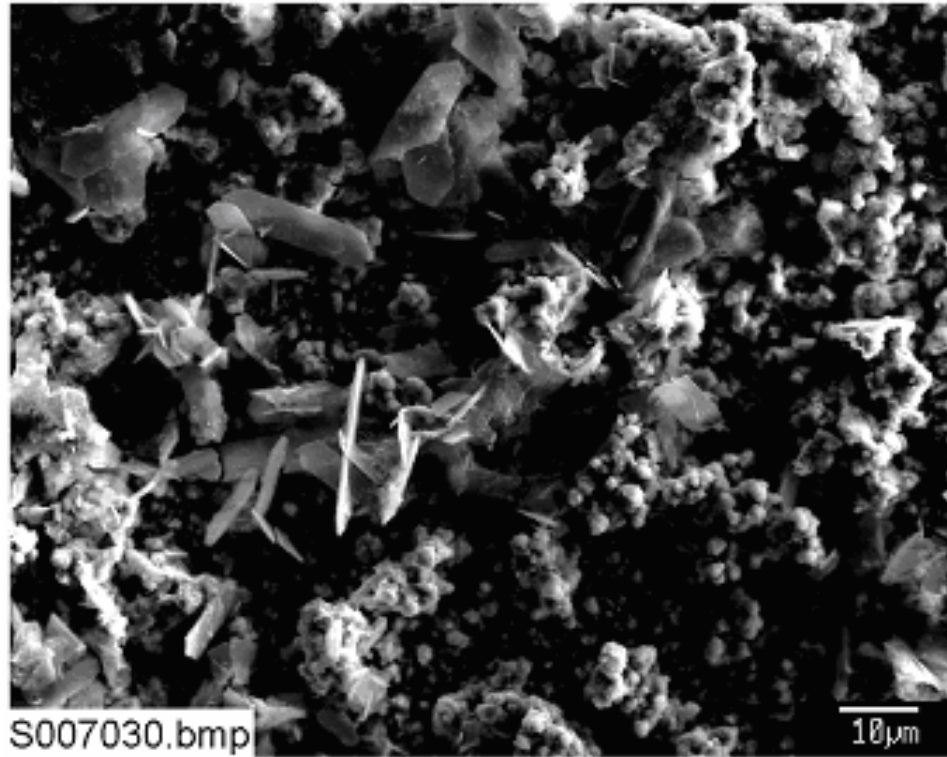
| Image: | S007030 | 1000 × | SEI on corrosion surface | Figure C4-10 |

Figure C4-10. SEM image for the corrosion surface of a Test-2 Day-30 submerged steel coupon (S007030).

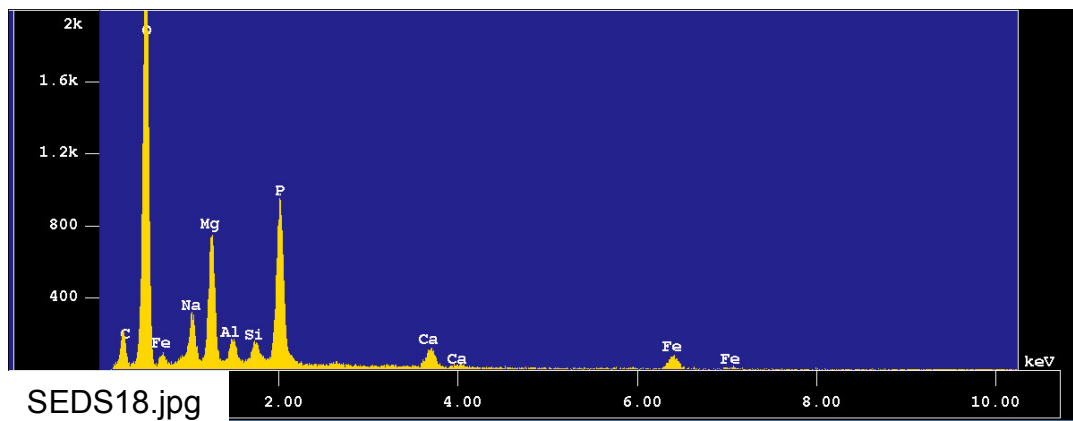
| EDS: | SEDS18 | | Crystals on corroded steel (see image 030) | Figure C4-11 |

Figure C4-11. EDS counting spectrum for the thin crystals shown in Figure C4-10 (SEDS18).

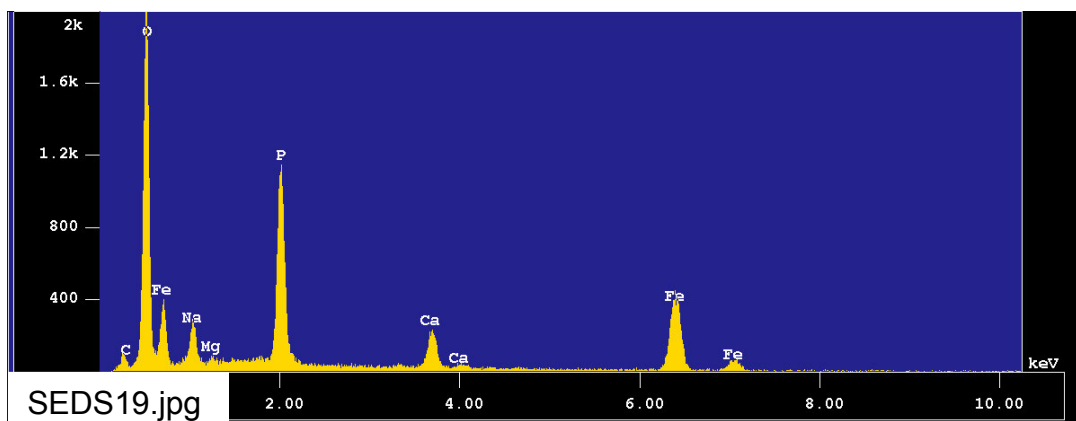
| | SEDS19 | | Clump of corrosion product | Figure C4-12 |

Figure C4-12. EDS counting spectrum for the clumps surrounding crystals shown in Figure C4-10 (SEDS19).

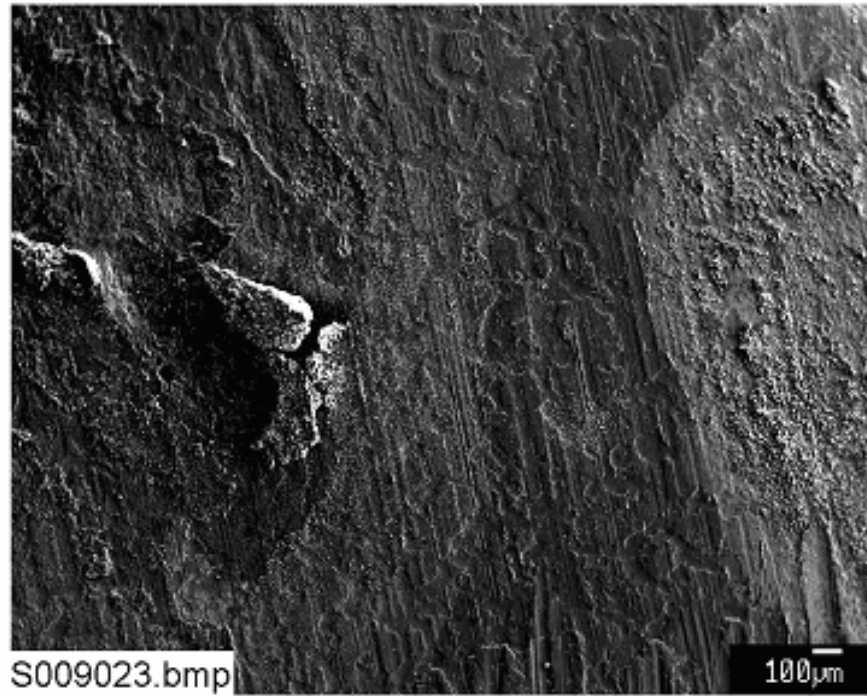
| Image: | S009023 | 40 × | SEI overview of corroded & noncorroded surface | Figure C4-13 |

Figure C4-13. SEM image for a Test-2 Day-30 unsubmerged steel coupon (S009023).

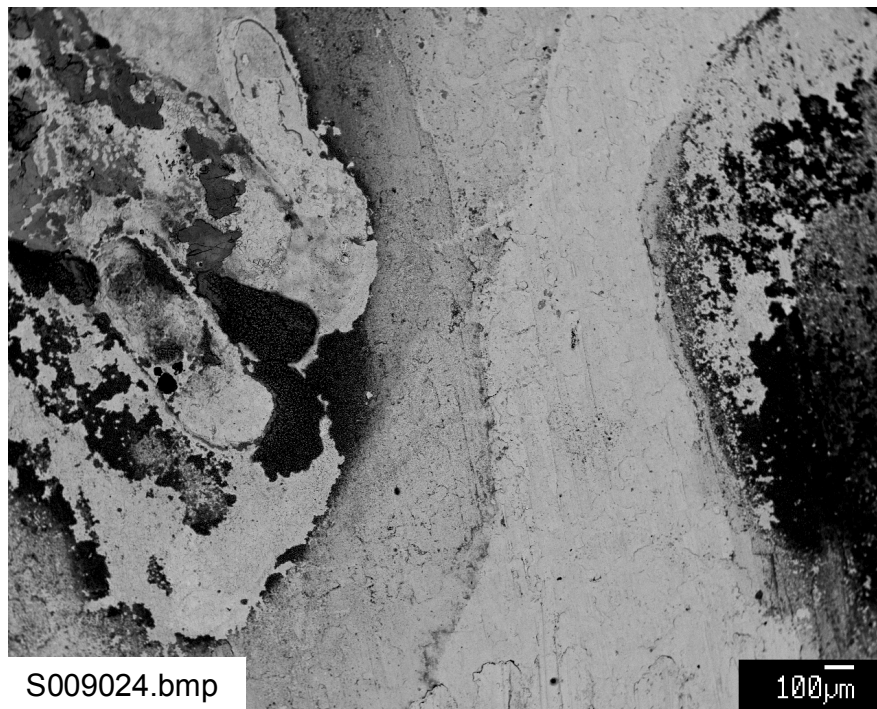
| | S009024 | 40 × | BEI same area | Figure C4-14 |

Figure C4-14. Backscattered SEM image for a Test-2 Day-30 unsubmerged steel coupon (S009024).

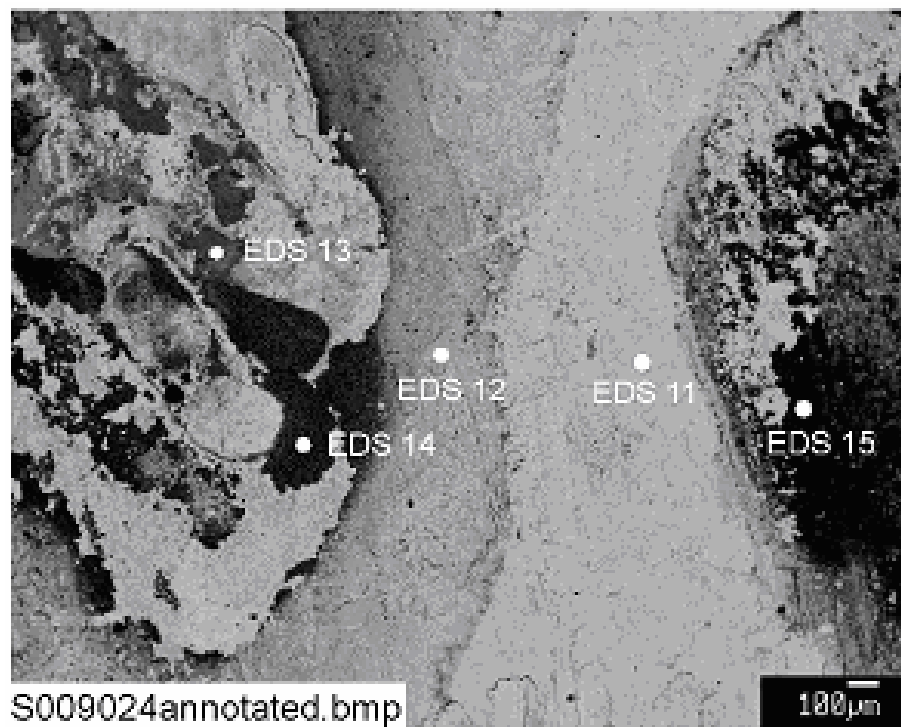
| | S009024annotated | 40 × | EDS spots 11–15 | Figure C4-15 |

Figure C4-15. Annotated backscattered SEM image for a Test-2 Day-30 unsubmerged steel coupon (S009024annotated).

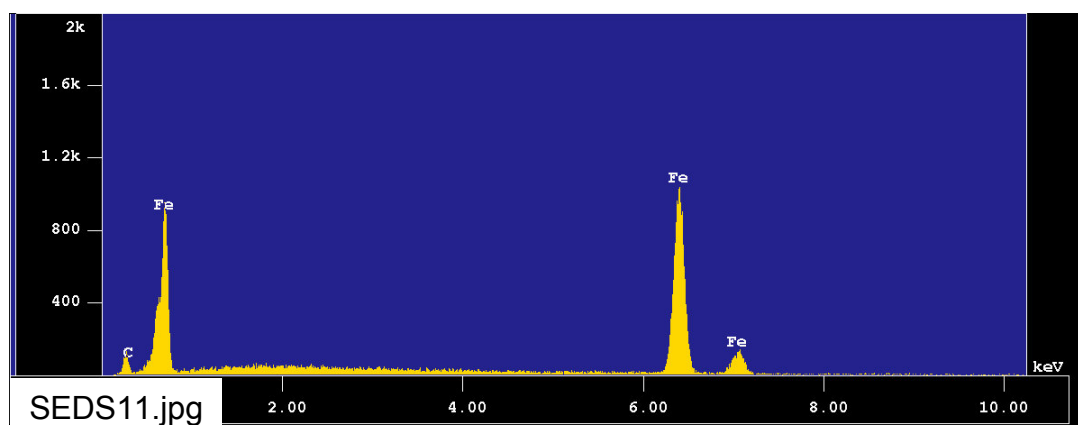
| EDS: | SEDS11 | | Steel surface- light (in image 024) | Figure C4-16 |

Figure C4-16. EDS counting spectrum for the light streak (EDS-11) shown in Figure C4-15 (SEDS11).

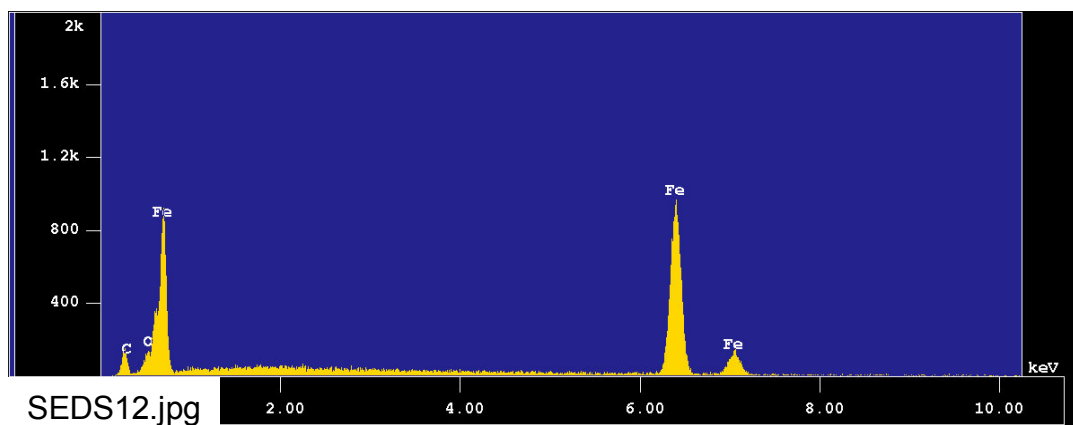
| | SEDS12 | | Steel—light gray in BSE | Figure C4-17 |

Figure C4-17. EDS counting spectrum for the light grey streak (EDS-12) shown in Figure C4-15 (SEDs12).

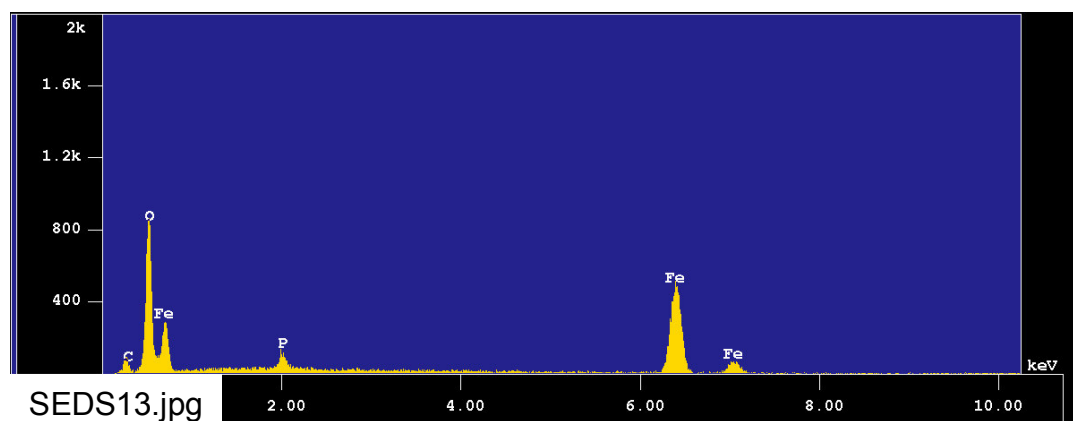
| | SEDS13 | | Medium gray corrosion on steel | Figure C4-18 |

Figure C4-18. EDS counting spectrum for the medium grey spot (EDS-13) shown in Figure C4-15 (SEDs13).

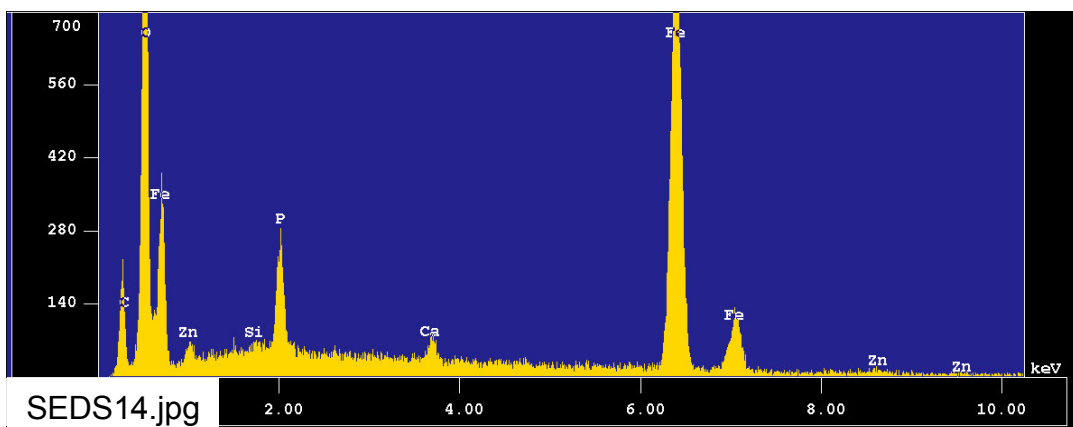
| | SEDS14 | | Dark gray corrosion | Figure C4-19 |

Figure C4-19. EDS counting spectrum for the dark grey spot (EDS-14) shown in Figure C4-15 (SEDs14).

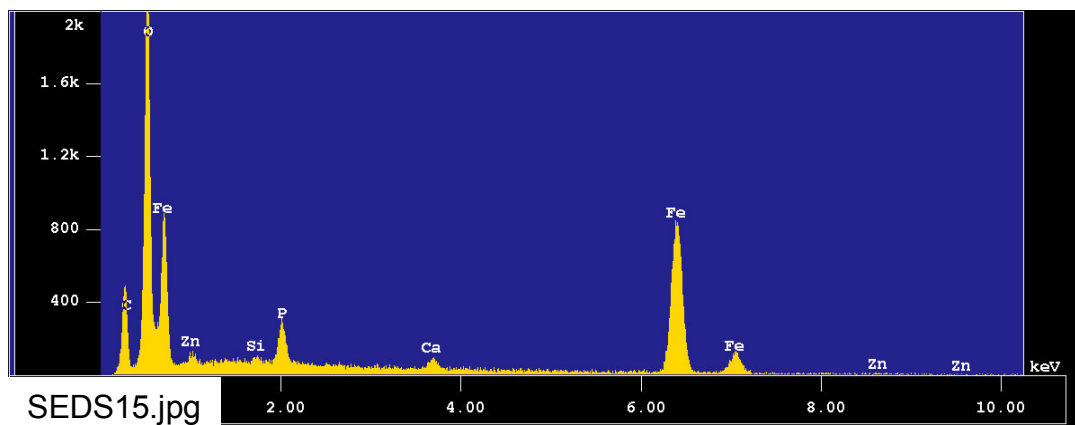
| | SEDS15 | | Dark gray corrosion | Figure C4-20 |

Figure C4-20. EDS counting spectrum for the dark spot (EDS-15) shown in Figure C4-15 (SEDS15).

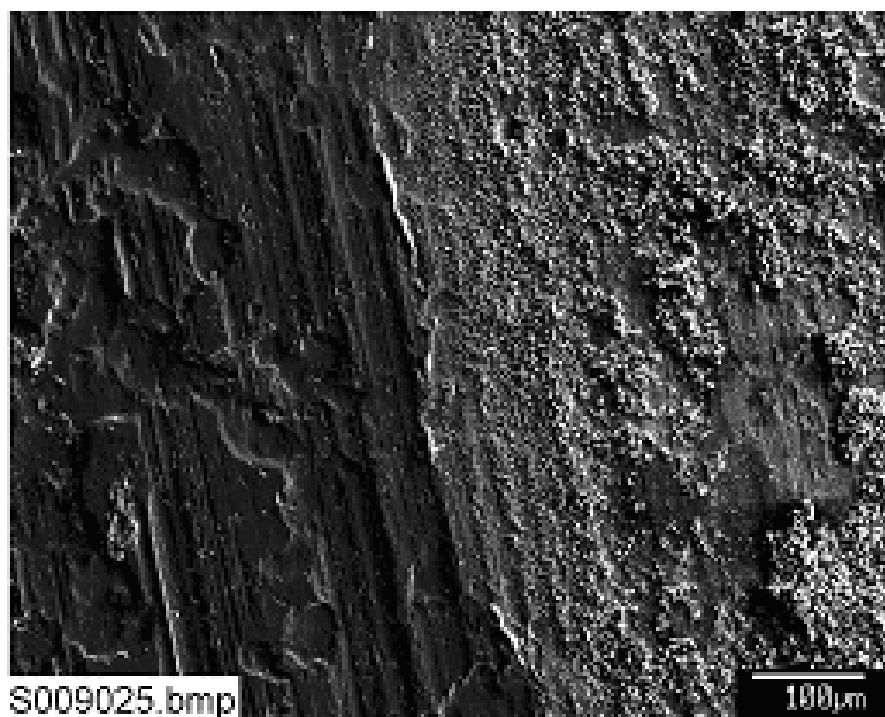
| Image: | S009025 | 150 × | SE at interface between badly corroded & less corroded surface | Figure C4-21 |

Figure C4-21. SEM image for a Test-2 Day-30 unsubmerged steel coupon (S009025). The image shows the interface between badly corroded (right) and less corroded surface (left).

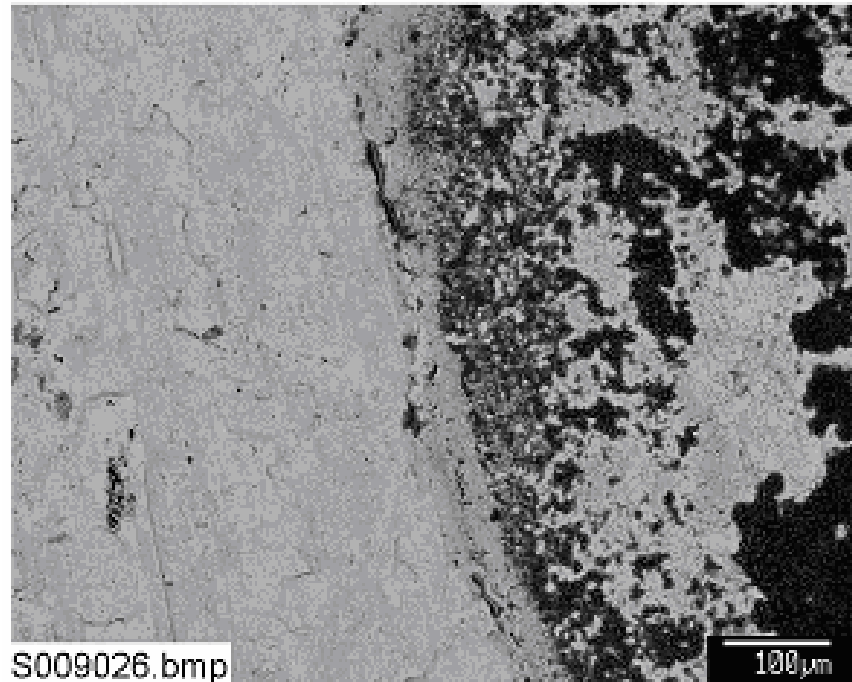
| | S009026 | 150 × | BSE same area | Figure C4-22 |

Figure C4-22. Backscattered SEM image for a Test-2 Day-30 unsubmerged steel coupon (S009026). It shows the same area as shown in Figure C4-21.

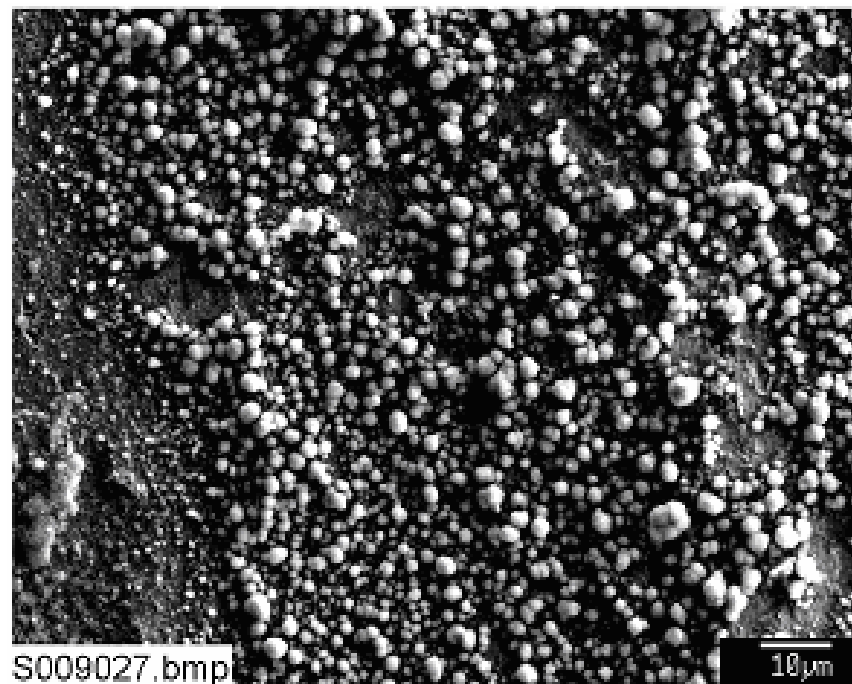
| | S009027 | 1000 × | SE corroded area | Figure C4-23 |

Figure C4-23. SEM image for a corroded area of a Test-2 Day-30 unsubmerged steel coupon (S009027).

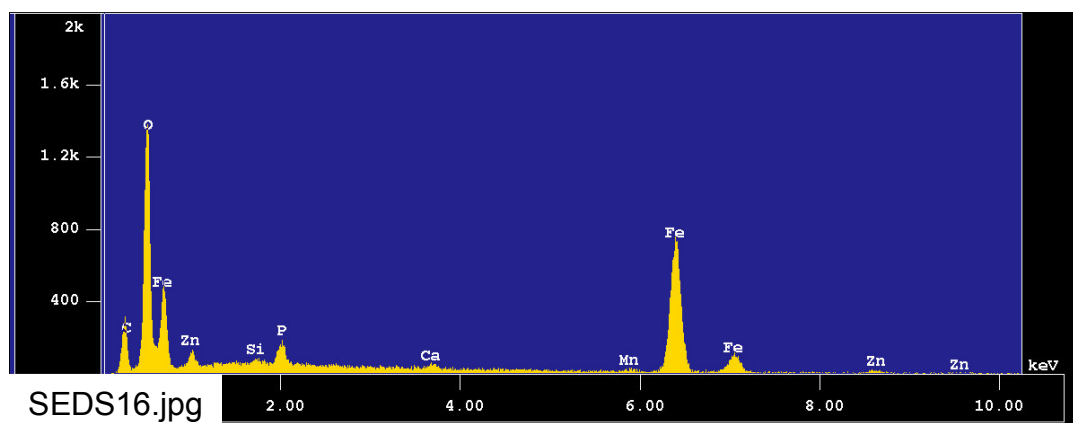
| EDS: | SEDS16 | | Clump of rounded corrosion crystals | Figure C4-24 |

Figure C4-24. EDS counting spectrum for a clump of round corrosion crystals shown in Figure C4-23 (SEDS16).
