Appendix D3

ESEM and SEM/EDS Data for Test-2 Day-30 Drain Collar Fiberglass

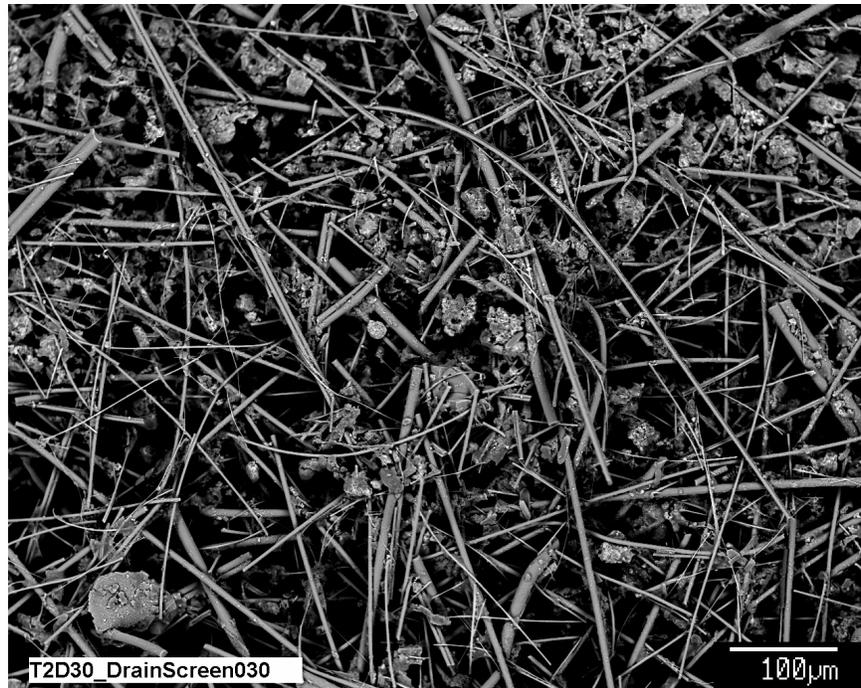
Figure D3-2. Backscattered SEM image for a Test-2 Day-30 fiberglass sample on the drain collar next to the drain screen, illustrating that deposits have a similar atomic number to fiberglass (T2D30_DrainScreen030).

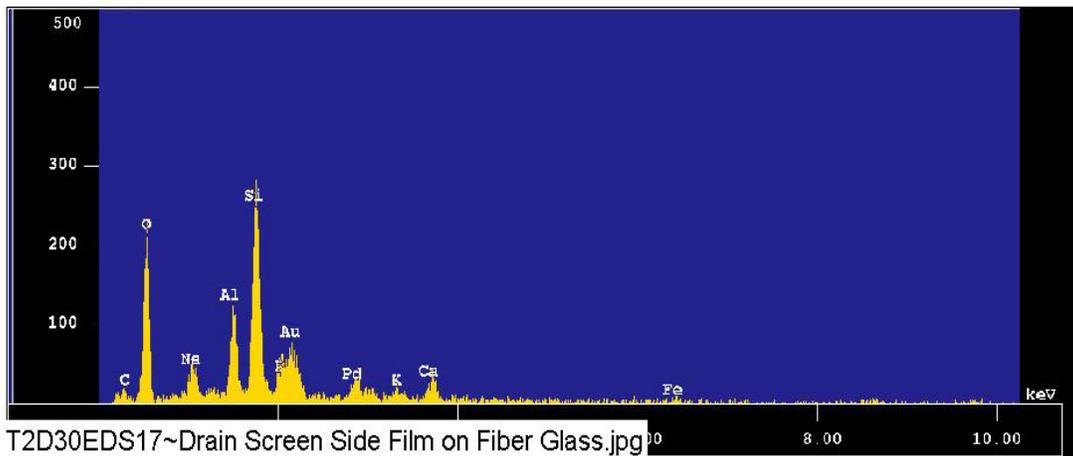
Figure D3-6. EDS counting spectrum for the film between fibers shown in Figure D3-4. The film is rich in Si, O, Al, Na, and Ca (T2D30EDS17~Drain Screen Side Film on Fiber Glass).

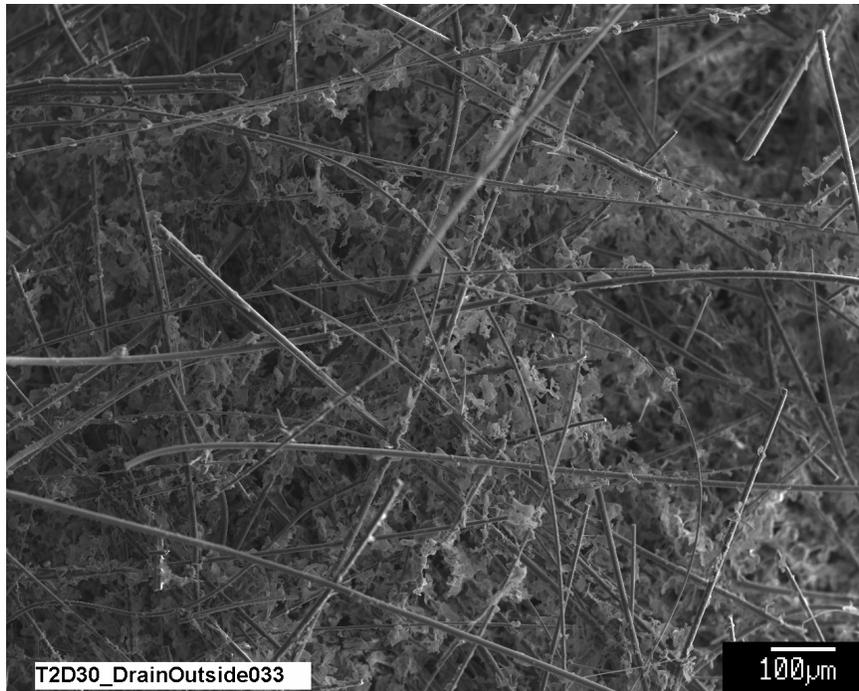
Figure D3-7. SEM image for a Test-2 Day-30 exterior fiberglass sample on the drain collar (away from the drain screen) showing deposits or growth on fiberglass (T2D30_DrainOutside033).

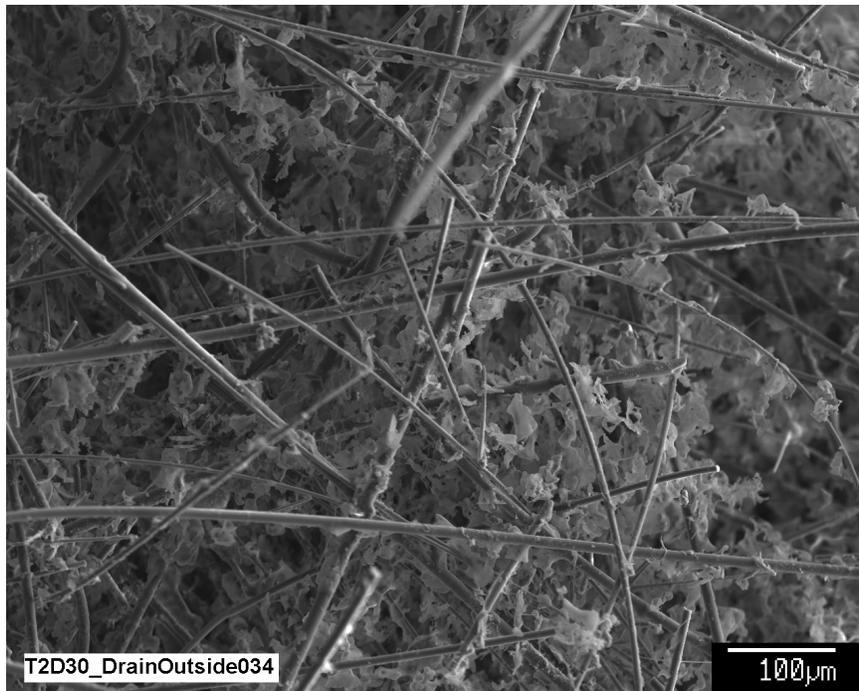
Figure D3-8. SEM image for a Test-2 Day-30 exterior fiberglass sample on the drain collar showing deposits or growth on fiberglass (T2D30_DrainOutside034).

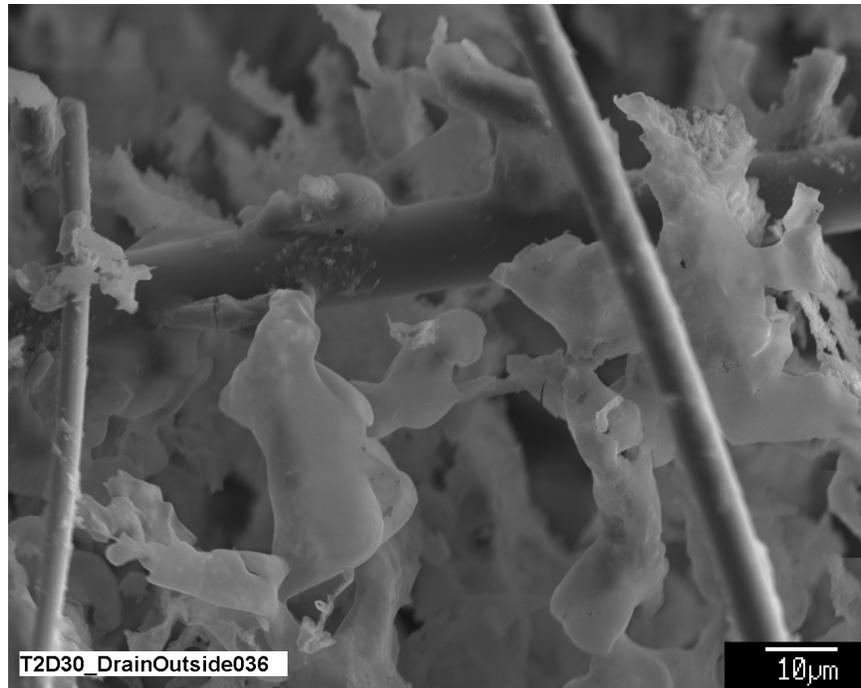
Figure D3-10. SEM image at a higher magnification for a Test-2 Day-30 exterior fiberglass sample on the drain collar showing deposits or growth on fiberglass (T2D30_DrainOutside036).

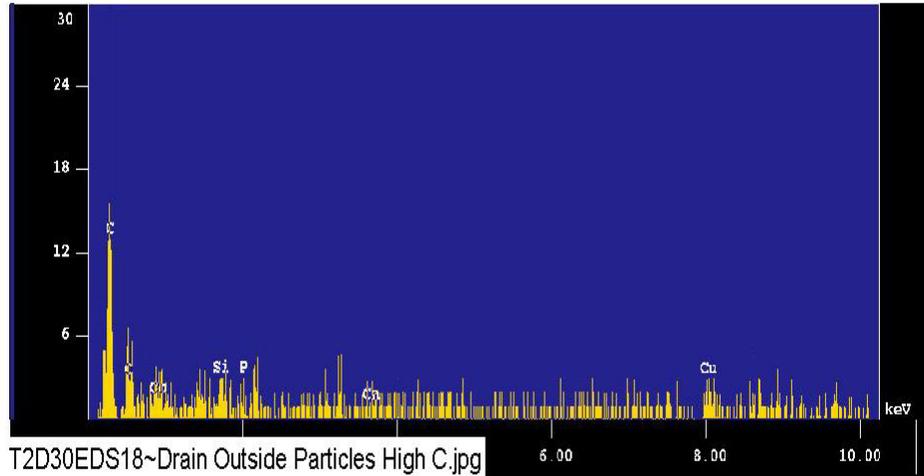
Note: *Very difficult to get EDS spectrum of particles. The particles are very thin and react under the beam. EDS18 and EDS19 are simply replicates at slightly different sample locations.

Figure D3-11. EDS counting spectrum for deposits or growth on fiberglass. The deposits contain a significant amount of C (T2D30EDS18~Drain Outside Particles High C).

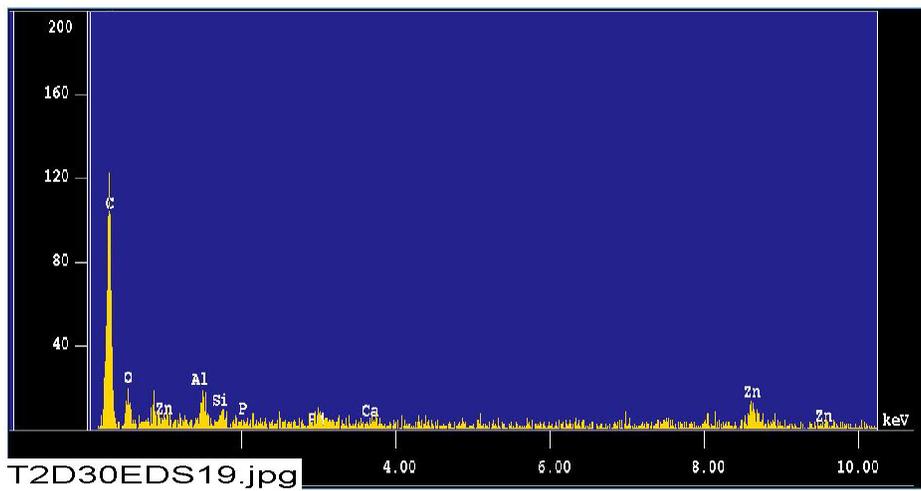
Figure D3-12. EDS counting spectrum for a deposit or growth on fiberglass. The deposit contains a significant amount of C (T2D30EDS19).

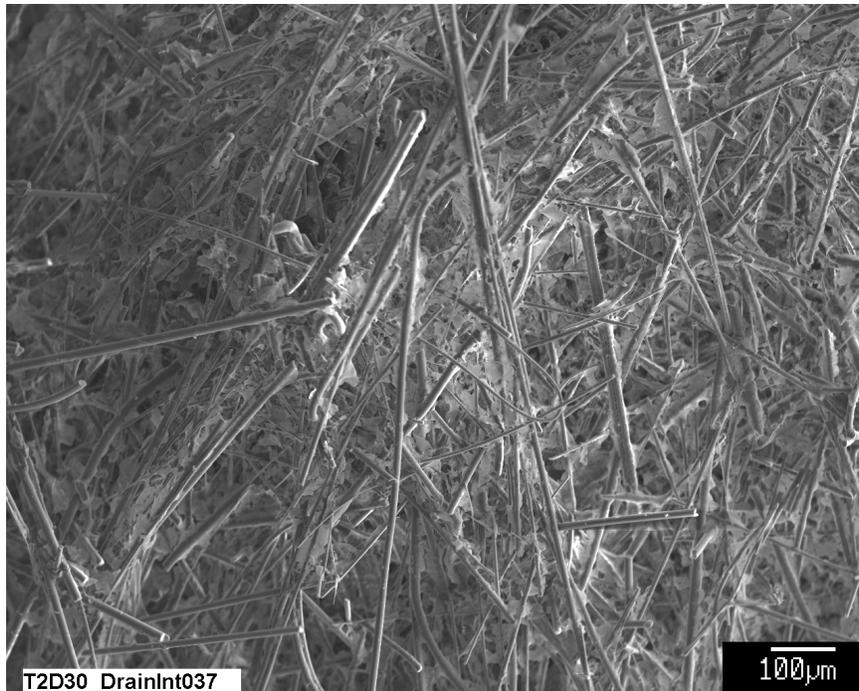
Figure D3-13. SEM image for a Test-2 Day-30 interior fiberglass sample on the drain collar. Image shows deposits or growth on fiberglass (T2D30_DrainInt037).

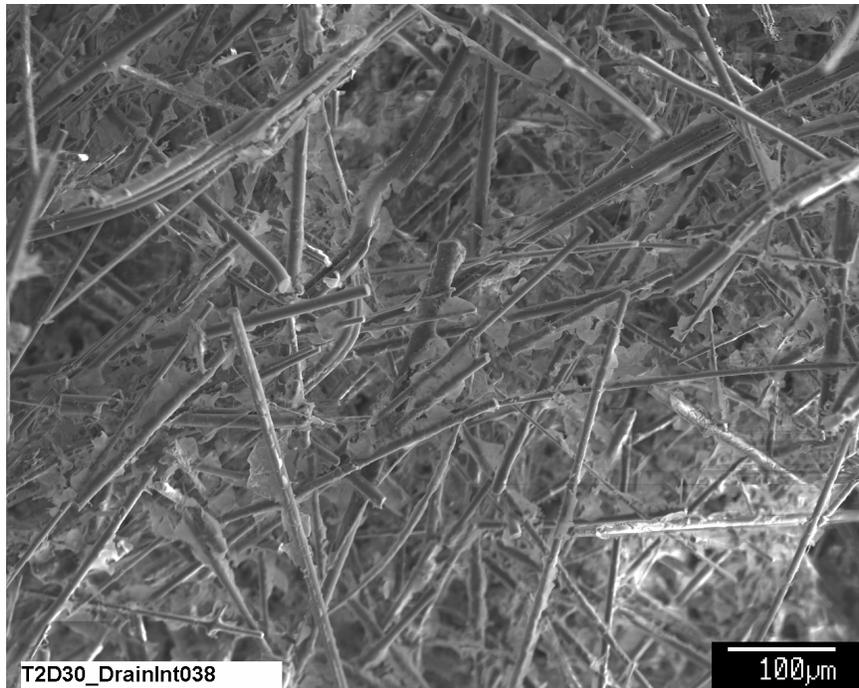
Figure D3-14. SEM image for a Test-2 Day-30 interior fiberglass sample on the drain collar. Image shows deposits or growth on fiberglass (T2D30_DrainInt038).

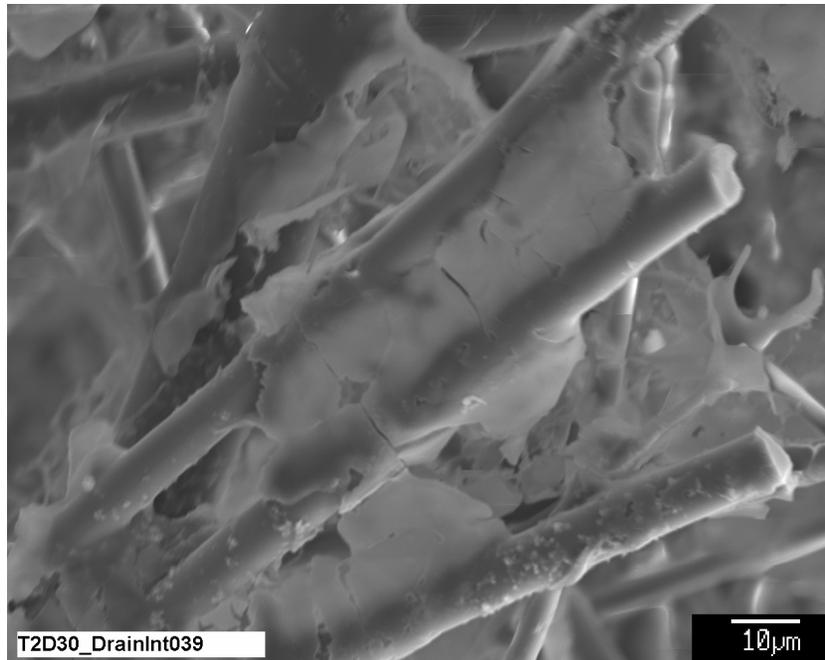
Figure D3-15. SEM image of a higher magnification for a Test-2 Day-30 interior fiberglass sample on the drain collar. Image shows deposits or growth on fiberglass (T2D30_DrainInt039).

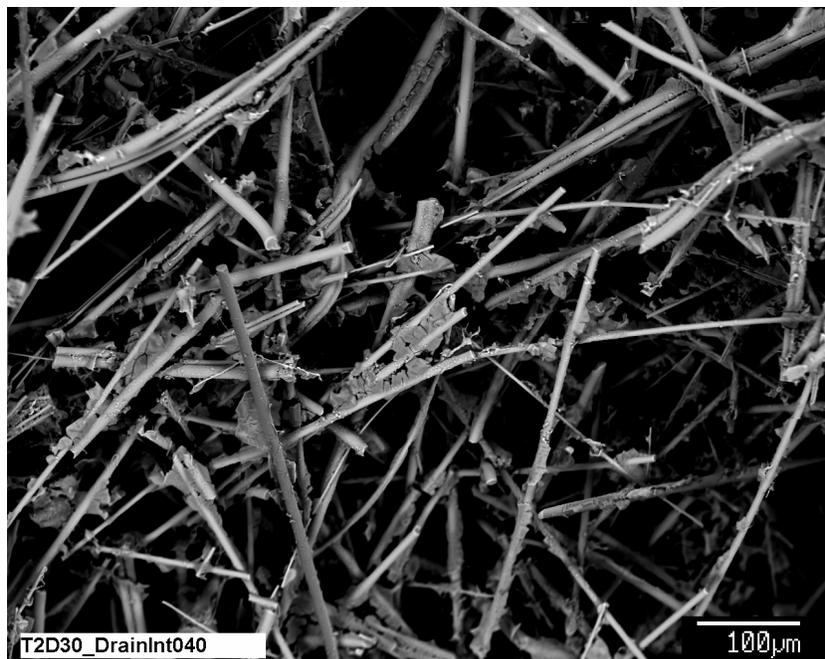
Figure D3-16. Backscattered SEM image for a Test-2 Day-30 interior fiberglass sample on the drain collar. Deposits appear to have a similar or lower atomic number than fiberglass (T2D30_DrainInt040).

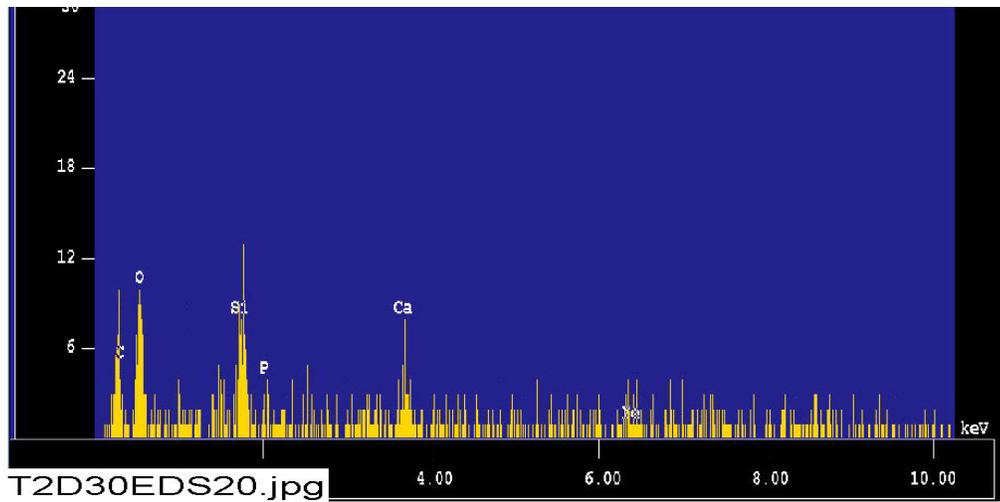
Figure D3-17. EDS counting spectrum for the deposits or growth on fiberglass. The deposits are rich in Si, C, O, and Ca. The deposits are very thin, thus it was difficult to obtain high-quality EDS spectra (T2D30EDS20).

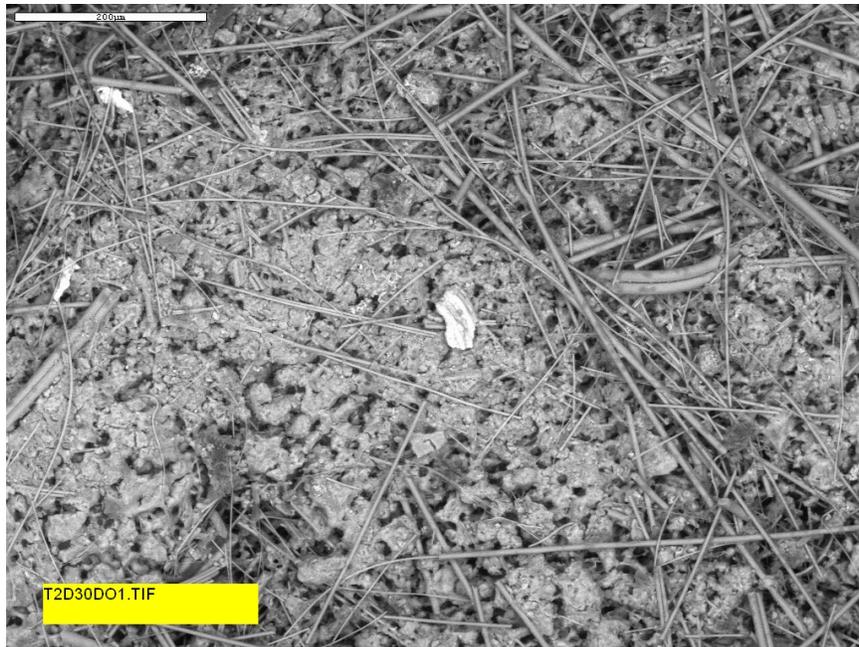
Figure D3-18. ESEM image for a Test-2 Day-30 exterior fiberglass sample on the drain collar. Image shows particulate deposits or growth on fiberglass (T2D30DO1).

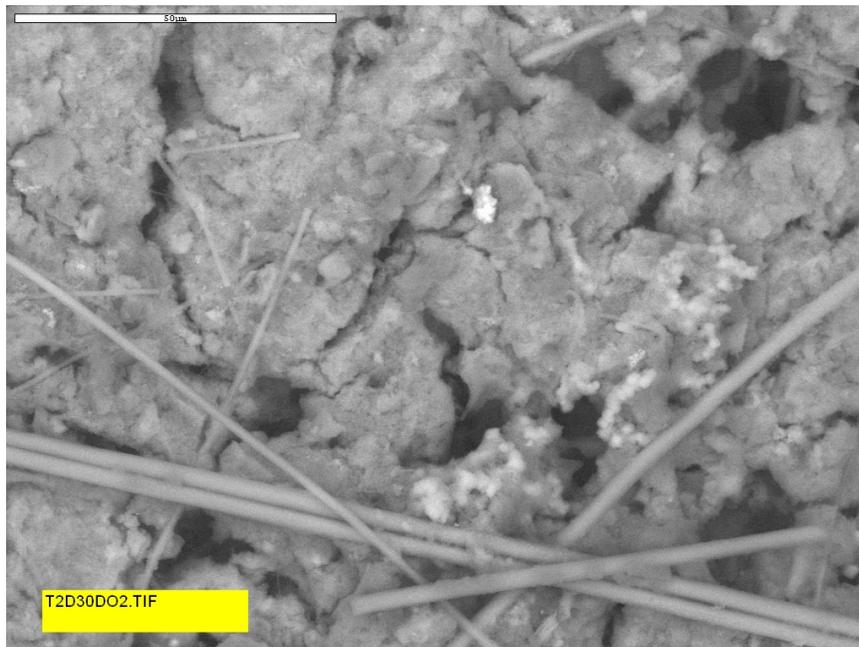
Figure D3-19. ESEM image of a higher magnification for a Test-2 Day-30 exterior fiberglass sample on the drain collar. Image shows particulate deposits or growth on fiberglass (T2D30DO2).

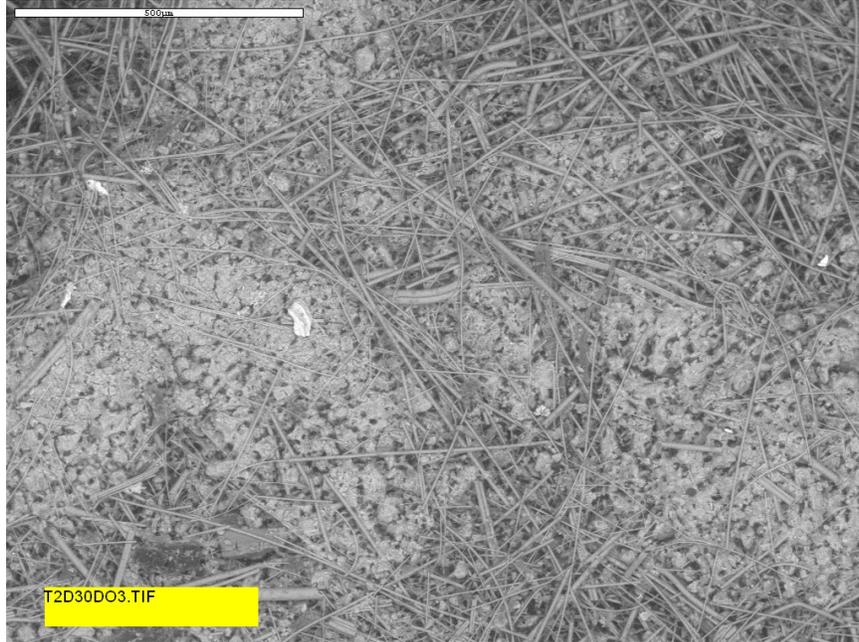
Figure D3-20. ESEM image for a Test-2 Day-30 exterior fiberglass sample on the drain collar. Image shows particulate deposits or growth on fiberglass (T2D30DO3).

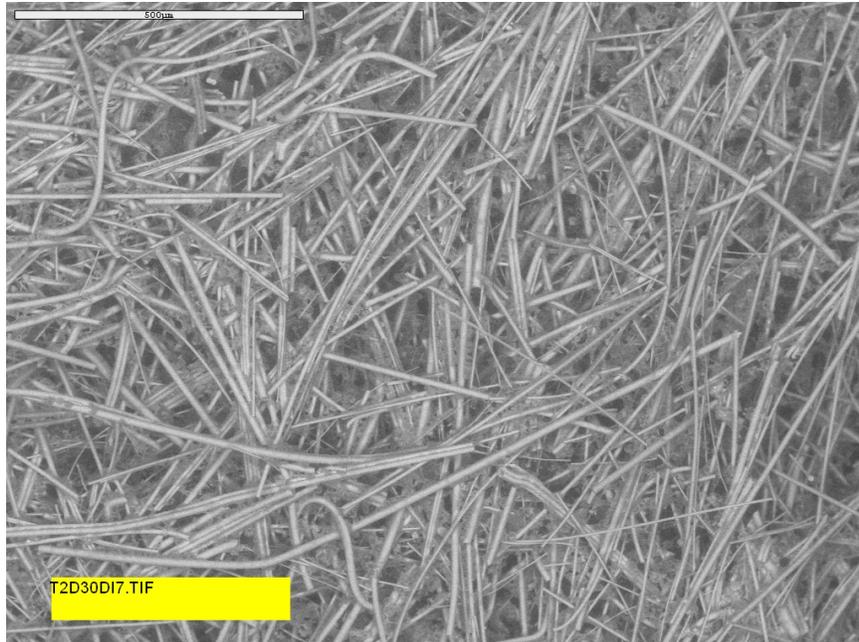
Figure D3-24. ESEM image for a Test-2 Day-30 interior fiberglass sample on the drain collar. Image suggests that interior fiberglass was relatively clean compared to exterior (T2D30DI7).

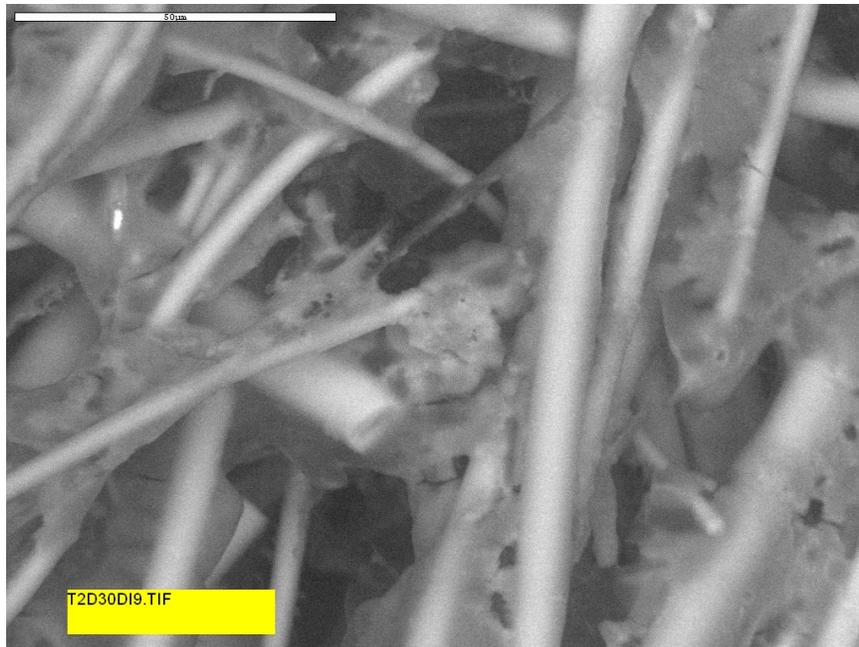
Figure D3-26. ESEM image of a higher magnification for a Test-2 Day-30 interior fiberglass sample on the drain collar. Image shows deposits or growth on the interior fiberglass, although the quantity was less than for exterior samples (T2D30DI9).
