Subject: Turkey Point Nuclear Plant Unit 3
Docket No. 50-250
10 CFR 50.55a Request for Temporary Non-Code Repair
Spent Fuel Pool Cooling Line (Request No. 6)

Florida Power & Light Letter No. L-2005-168
10 CFR 50.55a Request for Temporary Non-Code Repair
Spent Fuel Pool Cooling Line (Request No. 6)
Enclosure 1

TURNKEY POINT NUCLEAR UNIT 3		FLORIDA POWER & LIGHT	
	PIPING ISOMETRIC		DRAWING NUMBER	
	SPENT FUEL PIT COOLING SYSTEM HEAT EXCHANGER 3-E208 DISCHARGE TO SPENT FUEL PIT		5610-P-692	
			DATE	REV
			033	1

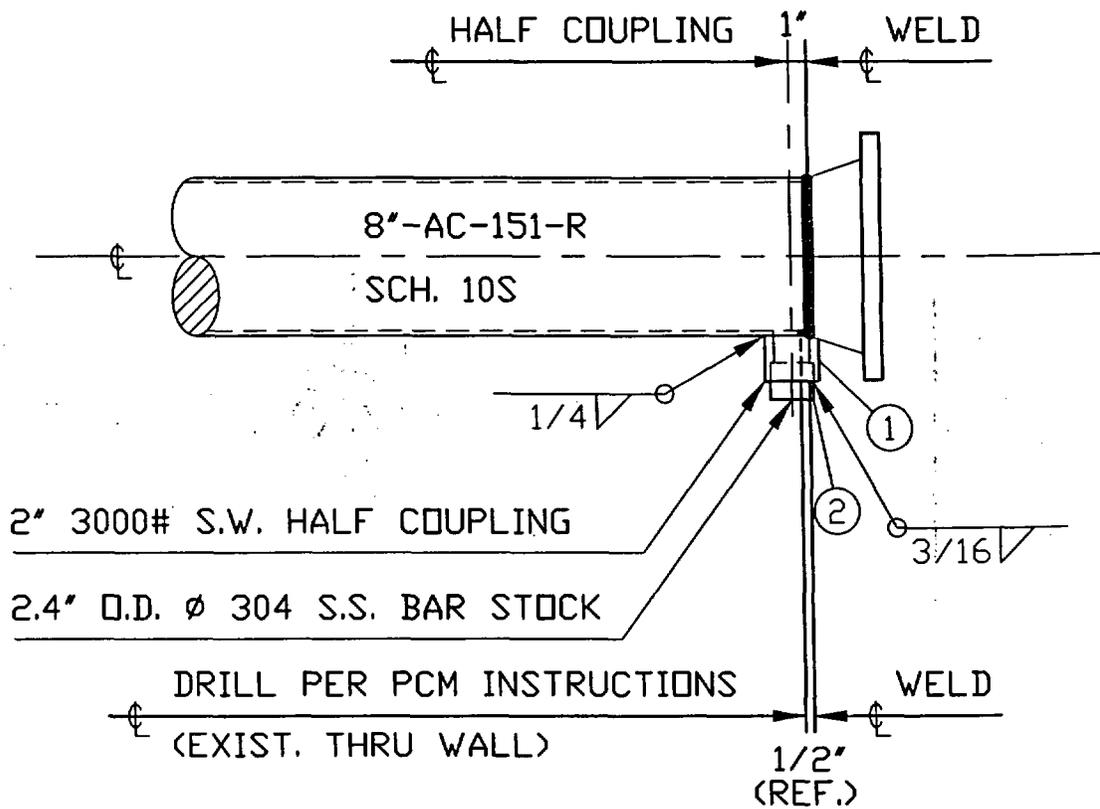
Figure 1

CODE REPAIR – WELDED BRANCH CONNECTION

- 1.1 Option 1 (Figure 1) is to add a 2-inch diameter welded branch connection at the through-wall pinhole leak. The branch connection with a welded plug will act as the new pressure boundary at the attachment profile. All selected materials are compatible with SFP cooling system class and service. The time estimate for completion of this repair option is 20 hours.

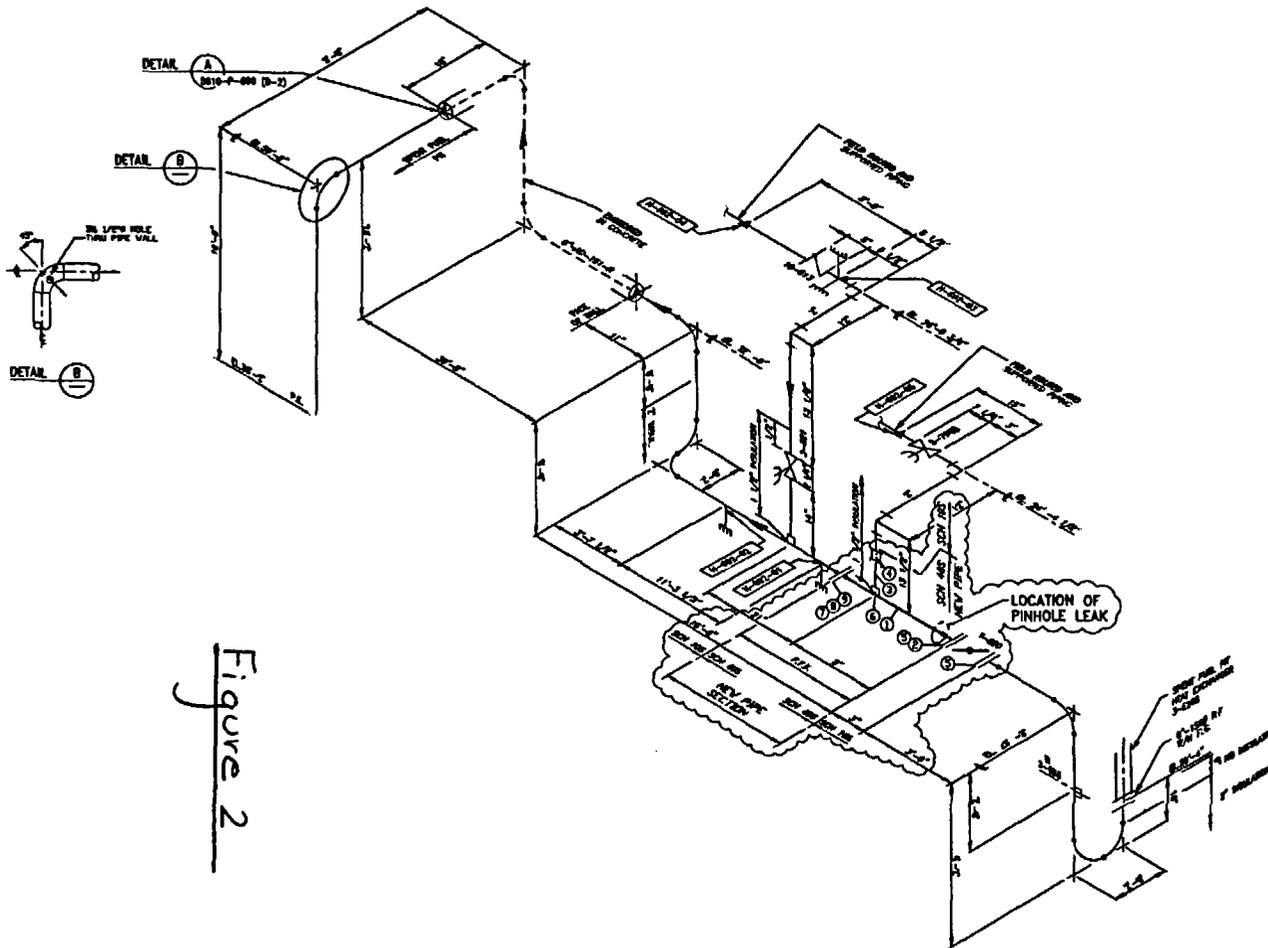
Figure 2

CODE REPAIR REPLACEMENT PIPE SPOOL

- 1.2 Option 2 (Figure 2) is the installation of a pipe spool piece to replace the affected portion of the 8-inch diameter piping. The spool piece will be shop prepared. This replacement section of pipe will be pre-sized and will be designed to minimize required field welding (one slip-on flange). All selected materials are designed to be compatible with SFP cooling system class and service. The time estimate for completion of this repair option is 40 hours.

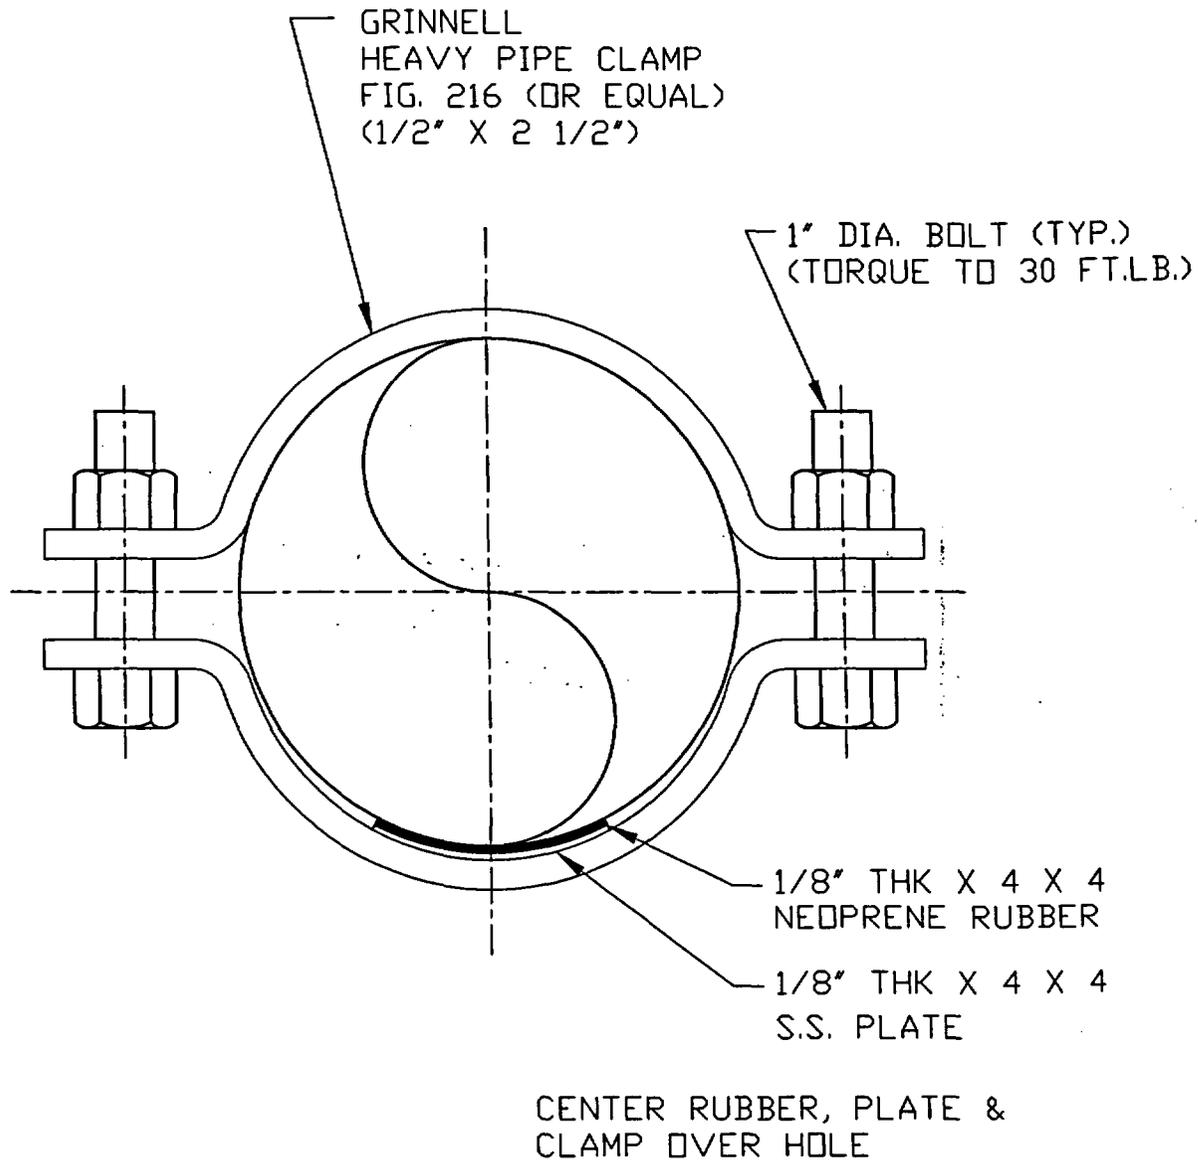
Figure 3

NON-CODE REPAIR PIPE CLAMP

The selected design for the temporary non-Code repair contingency employs commercial grade materials able to withstand expected operating pressure and temperature conditions should a burn-through be created on the Schedule 10S 8-inch diameter stainless steel pipe during welding for the Code repair activity. The non-Code component is a simplified pipe clamp (Figure 3) designed to fit over a through-wall hole. The clamp and bolting material is robust and able to withstand any anticipated operating condition.

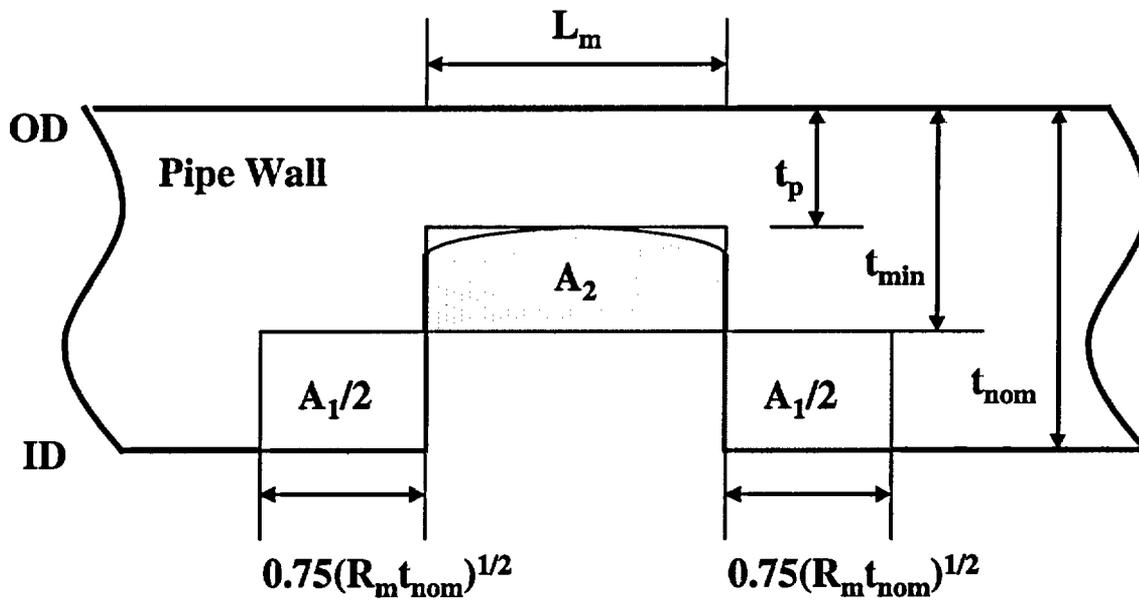
Guidance for evaluation of non-planar through-wall flaws is not provided in Code Case N-513. An alternate wall thinning criteria was developed using the "Limits of Reinforcement" rules in Paragraph NB-3640 of the ASME Code. The model used is illustrated in Figure 4.

Referring to Figure 4, Area A_1 (which is between the thinned area and the limits of reinforcement) should be balanced by Area A_2 (which is within the thinned area) in which case the following equation can be written:

Figure 4: Model for Development of Allowable Non-Planar Flaws

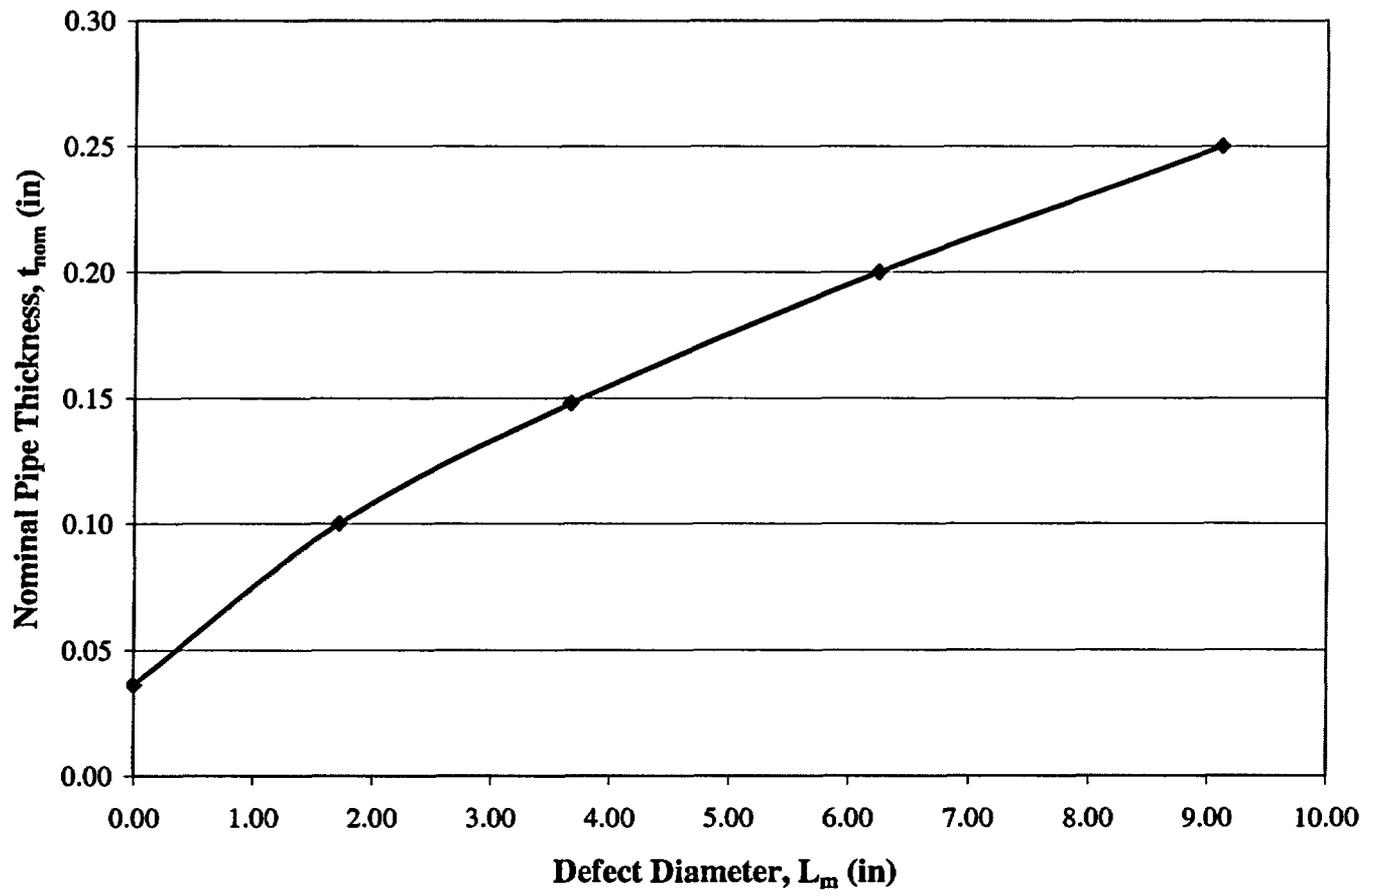
By setting $t_p = 0$ in Equation 2 (through-wall pit), the allowable hole diameter may be determined for a range of nominal pipe wall thicknesses (see Figure 5). It can be seen that through-wall pit sizes up to approximately 3.65 inches in diameter can be tolerated for a nominal pipe thickness of 0.148 inch without exceeding ASME Code margins. This is much greater than the assumed flaw size.

Figure 5: Allowable Non-Planar Flaws for Various Nominal Wall Thicknesses
