**SUBJECT: INSPECTION 03030462/2005002, ECS MID-ATLANTIC, LLC, CHANTILLY,
VIRGINIA SITE AND THE ASHBURN, VIRGINIA SITE**

INSPECTION REPORT

Inspection No. 03030462/2005002
Docket No. 03030462
License No. 45-24974-01
Licensee: ECS Mid-Atlantic, LLC
Address: 14026 Thunderbolt Place, Suite 100
Chantilly, VA 20151
Other Locations Inspected: 44961 LCSA Campus Lane
Ashburn, VA
Inspection Dates: August 9, 2005

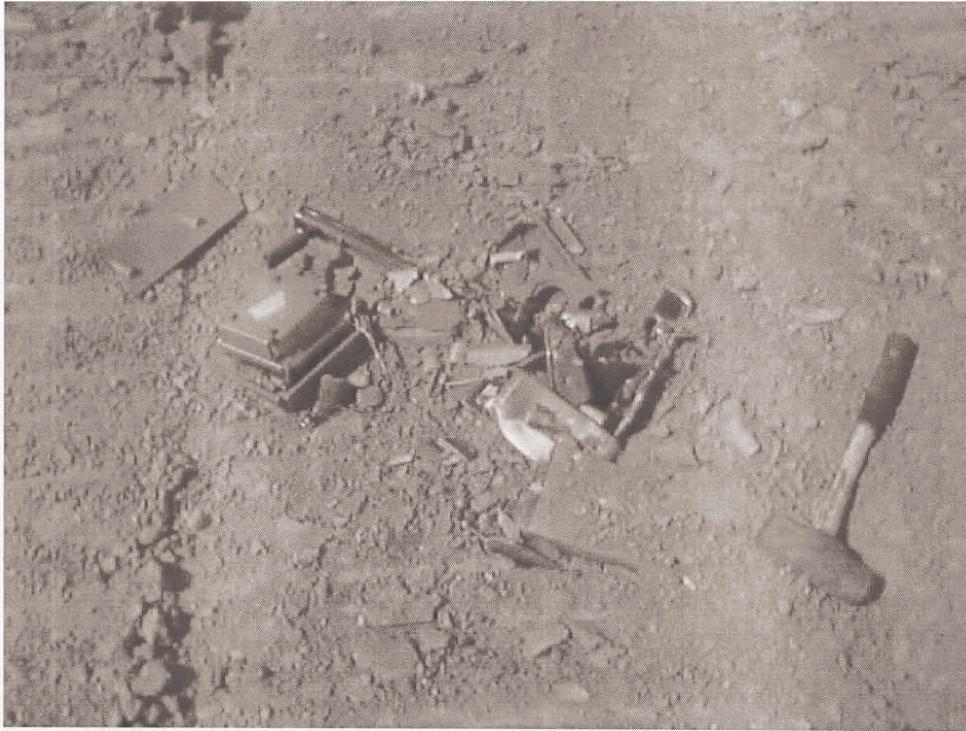
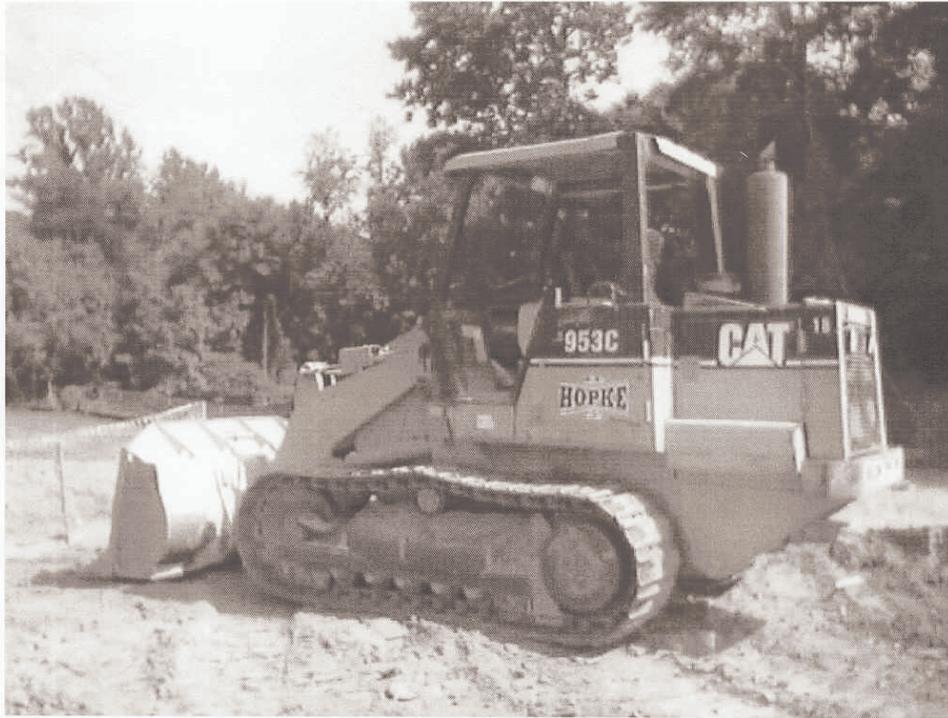
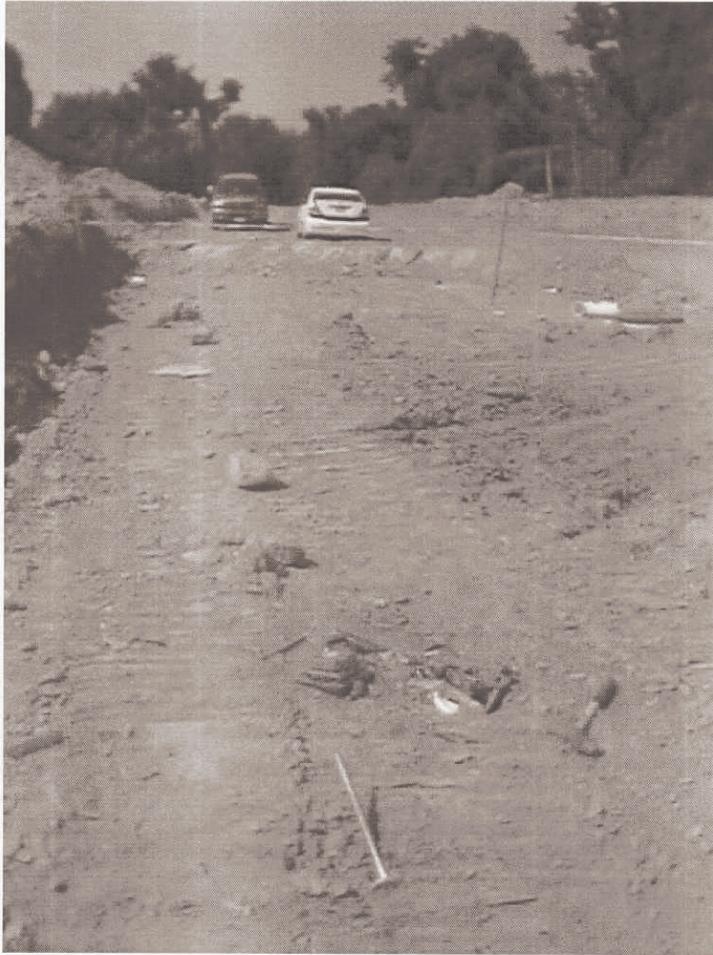
The RSO provided the inspector with the licensee's internal written report of the incident (Enclosure 1) which includes pictures of the destroyed gauge, the front end loader that ran over the gauge and a picture of the operator's car in relation to the destroyed gauge. The Corporate RSO stated that the gauge operator had a degree in civil engineering and was a certified gauge user and her hazmat training was current. He and the RSO interviewed the gauge operator upon her return to the office on the day of the incident and the operator was immediately terminated for violating the licensee's operating procedures and NRC regulations. The Corporate RSO stated that the operator had been audited in the field on November 3, 2004, and had been given a written warning for leaving the nuclear gauge unattended at the job site. She was also given re-training on controlling the gauge at all times.

The nuke got run over by a loader operated by Juan Pablo Diatoro and destroyed while it was under the control of our technician, Sonu Shukla.

Contrary to the initial Nuke Safety Training, the gauge was sitting on the field in the path of a loader with the technician was approximately 40 yards away from the gauge sitting in her car with her back turned to the gauge. This is a direct violation to the NRC rules and ECS' written policy as she had to be within 10' of the gauge. The same technician had received a written warning for leaving her gauge unattended at her jobsite on 11/03/04, and as a result the technician was terminated the same day.

The gauge was totally destroyed due to the impact but the source was in the shielded position. Several surveys have been made by using a survey meter (TroxaAlert calibrated 1/15/05) at one meter distance, and the readings were found to be around 0.4 mR/hr range.

All the pieces of the gauge were put in the box #49 and it was hauled back to the designated nuke storage in the Chantilly office around 5:00 PM. The remaining of the gauge will be returned to the manufacturer (CPN) for them to recycle the radioactive sources properly.

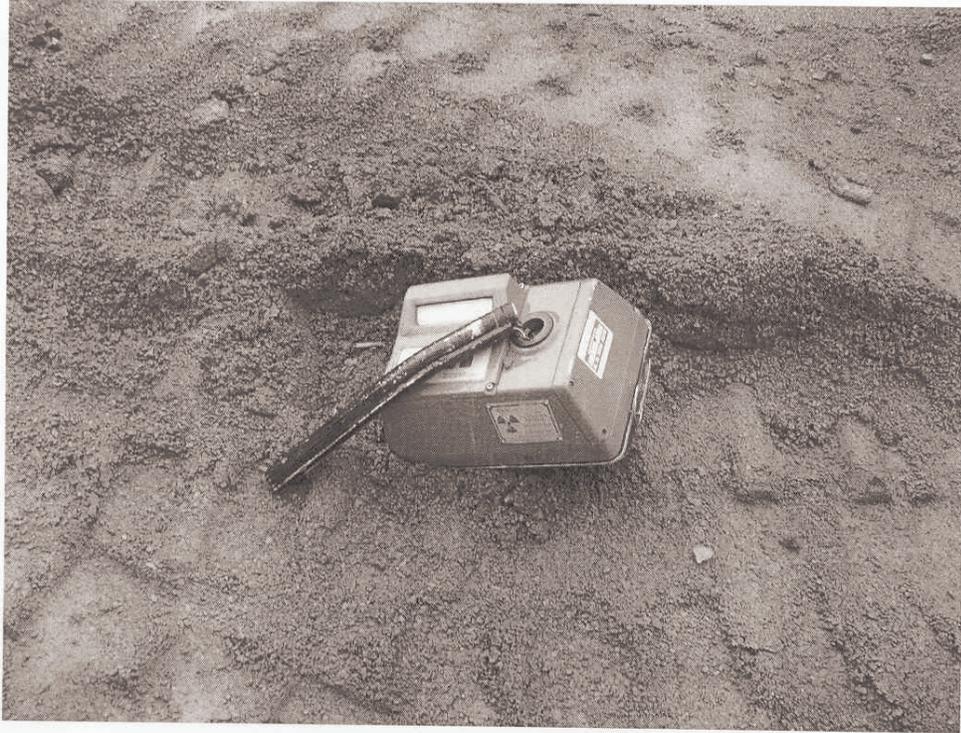
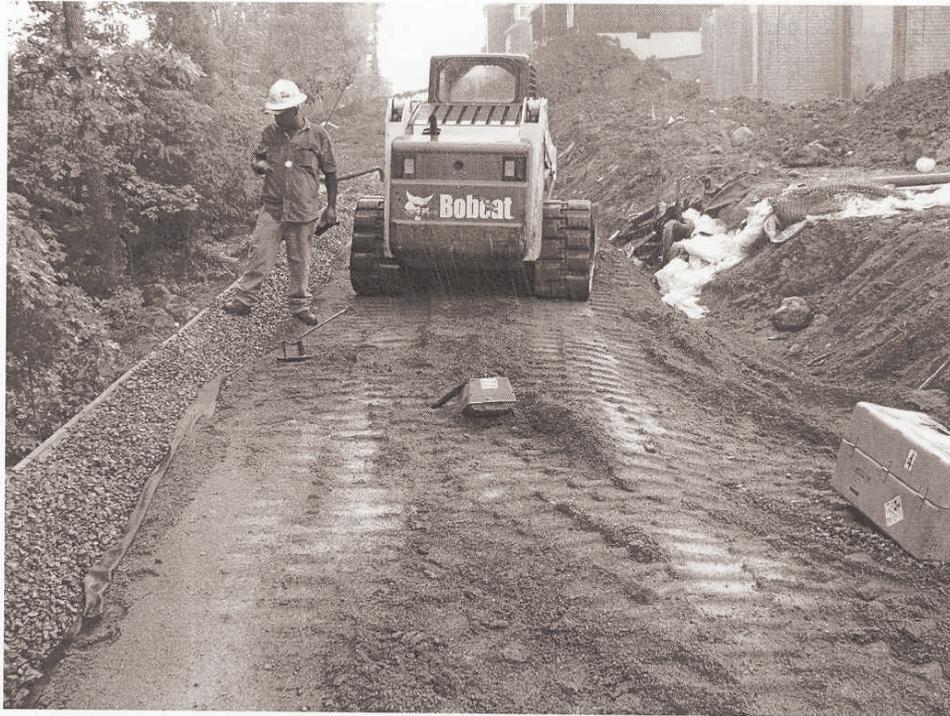
The RSO provided the inspector with the licensee's internal written report of the incident (Enclosure 2) which includes pictures of the damaged gauge and the Bobcat in relation to the damaged gauge with the operator taking radiation surveys. The RSO interviewed the gauge operator upon his return to the office on the day of the incident and determined that the operator was in control of the gauge (the operator was within 10 feet of the gauge), tried to get the Bobcat operator to stop backing up into his work area and had to jump out of the of way of the Bobcat to avoid injury to himself. No action was taken by the licensee against the operator as he had no previous violations of licensee operating procedures and NRC regulations. In this incident the licensee determine the gauge operator had constant surveillance and control of the gauge, tried to stop the bobcat from backing over the gauge by yelling at the operator to stop, but due to the danger of the bobcat operator's actions chose to save himself rather than the gauge.

The nuke got run over by a bobcat operated by Oliver Antonio Hernandez of KT Enterprises (703)526 0293 and destroyed while it was under the control of our technician, Edmund Attoh.

The technician had all his PPE equipment on (hardhat, safety glasses, reflective vest & steel toed boots), and was in control of the nuke the whole time and within 10 feet of the gauge. He tried to stop the bobcat by yelling at the bobcat's operator while it was backing up on the gauge but he couldn't stop it on time.

The gauge's guide tube & rod were broken due to the impact but the source was in the shielded position. Several surveys have been made by using a survey meter (Troxaalert calibrated 1/15/05) at one meter distance, and the readings were found to be around 0.4 mR/hr range.

All the pieces of the gauge were put in the box #40 and it was hauled back to the designated nuke storage in the Chantilly office around 5:15 PM. The remaining of the gauge will be returned to the manufacturer (CPN) for them to recycle the radioactive sources properly.
