Event # 42062

PART 21 REPORT INVOLVING A RADIOGRAPHIC SEALED SOURCE WITH A POTENTIAL SAFETY CONCERN

"Material: Model 702 Radiographic Source

Supplier Corrective Action Request

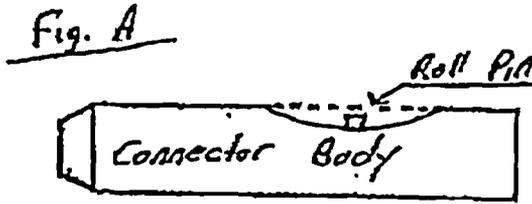
Connection Design

Roll Pin Flush or Below Flush With Connector Body

3. Corrective Action Taken: Per memo from Industrial Nuclear Company the roll pins were filed to a flush condition using a hand file. Sources were secured and locked within the exposure device during the operation.
