Subject: Licensee Event Report 2005-004-00  
Waterford 3 SES  
Docket No. 50-382  
License No. NPF-38

1. FACILITY NAME Waterford Steam Electric Station, Unit 3					2. DOCKET NUMBER 05000-382		3. PAGE 1 OF 6							
4. TITLE Loss of Offsite Power During Hurricane Katrina

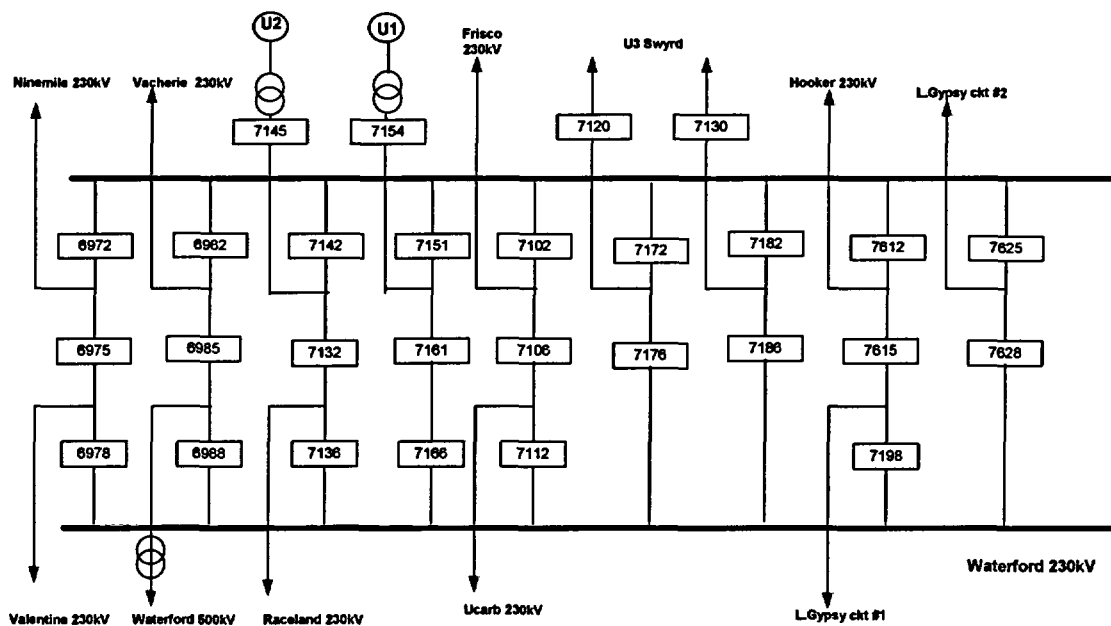
**FIGURE 1**  
Waterford 3 Switchyard Arrangement

The arrangement of the Waterford 3 switchyard [FK] is presented in Figure 1. The physical configuration of the Waterford 3 Switchyard (SWYD) and Switching Station (SWSTA) is designed to minimize degraded switchyard conditions. The Waterford 3 SWYD uses a breaker and half scheme with East and West busses. Waterford 3 is connected to the utility grid by two transmission lines [FK] to the Waterford 3 - 230 kV Switchyard via the Switching Station [FK]. Each line is designed to carry the full load required for safe shutdown of the plant. Each line can carry 100% output of the main generator. Transmission lines to the Waterford 3 SWSTA from the SWYD are each tied to the busses by one dedicated breaker (double bus double breaker scheme). These two 230 kV transmission lines, along with the 6.9 kV busses and bays connecting the Waterford 3 - 230 kV SWYD with the Waterford 3 SWSTA, are addressed in Waterford 3 TS 3.8.1.1 Limiting Condition for Operation (LCO) as the two physically independent circuits between the offsite transmission network and the onsite Class 1E distribution system that are required operable in Modes 1, 2, 3, and 4.

The Waterford 3 - 230 kV Switchyard also has several other 230 kV transmission lines connected to it. Three of these transmission lines connect Waterford Units 1 and 2 to the Switchyard. Three of the transmission lines cross the river on two separate river crossing towers to tie into the Little Gypsy 230 kV Switchyard. There is a 230kV tie to the adjacent 500kV Switchyard. There are other transmission lines which tie to other areas of the Entergy grid. The system is designed such that no transmission lines cross the 230kV lines connecting the Waterford 3 switching station to the Waterford 3 230kV Switchyard. A single failure such as spurious protective relay operation, breaker failure or transmission line failure associated with the offsite power source will be limited to one train of offsite power only.
