Subject: Licensee Event Report 2005-004-00  
Waterford 3 SES  
Docket No. 50-382  
License No. NPF-38

**LICENSEE EVENT REPORT (LER)**

**4. TITLE**  
Loss of Offsite Power During Hurricane Katrina

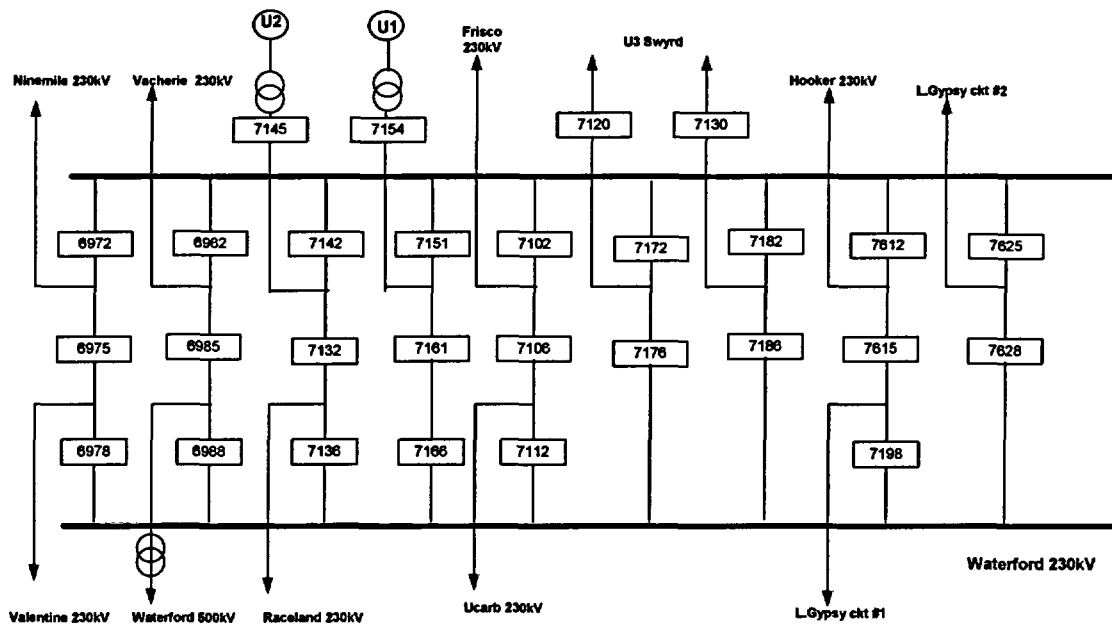
**FIGURE 1**  
Waterford 3 Switchyard Arrangement

The arrangement of the Waterford 3 switchyard [FK] is presented in Figure 1. The physical configuration of the Waterford 3 Switchyard (SWYD) and Switching Station (SWSTA) is designed to minimize degraded switchyard conditions. The Waterford 3 SWYD uses a breaker and half scheme with East and West busses. Waterford 3 is connected to the utility grid by two transmission lines [FK] to the Waterford 3 - 230 kV Switchyard via the Switching Station [FK]. Each line is designed to carry the full load required for safe shutdown of the plant. Each line can carry 100% output of the main generator. Transmission lines to the Waterford 3 SWSTA from the SWYD are each tied to the busses by one dedicated breaker (double bus double breaker scheme). These two 230 kV transmission lines, along with the 6.9 kV busses and bays connecting the Waterford 3 - 230 kV SWYD with the Waterford 3 SWSTA, are addressed in Waterford 3 TS 3.8.1.1 Limiting Condition for Operation (LCO) as the two physically independent circuits between the offsite transmission network and the onsite Class 1E distribution system that are required operable in Modes 1, 2, 3, and 4.

The Waterford 3 - 230 kV Switchyard also has several other 230 kV transmission lines connected to it. Three of these transmission lines connect Waterford Units 1 and 2 to the Switchyard. Three of the transmission lines cross the river on two separate river crossing towers to tie into the Little Gypsy 230 kV Switchyard. There is a 230kV tie to the adjacent 500kV Switchyard. There are other transmission lines which tie to other areas of the Entergy grid. The system is designed such that no transmission lines cross the 230kV lines connecting the Waterford 3 switching station to the Waterford 3 230kV Switchyard. A single failure such as spurious protective relay operation, breaker failure or transmission line failure associated with the offsite power source will be limited to one train of offsite power only.
