UNITED STATES NUCLEAR REGULATORY COMMISSION OFFICE OF INSPECTION AND ENFORCEMENT WASHINGTON, D.C. 20555

December 29, 1986

IE INFORMATION NOTICE NO. 86-108:

DEGRADATION OF REACTOR COOLANT SYSTEM PRESSURE BOUNDARY RESULTING FROM BORIC ACID CORROSION

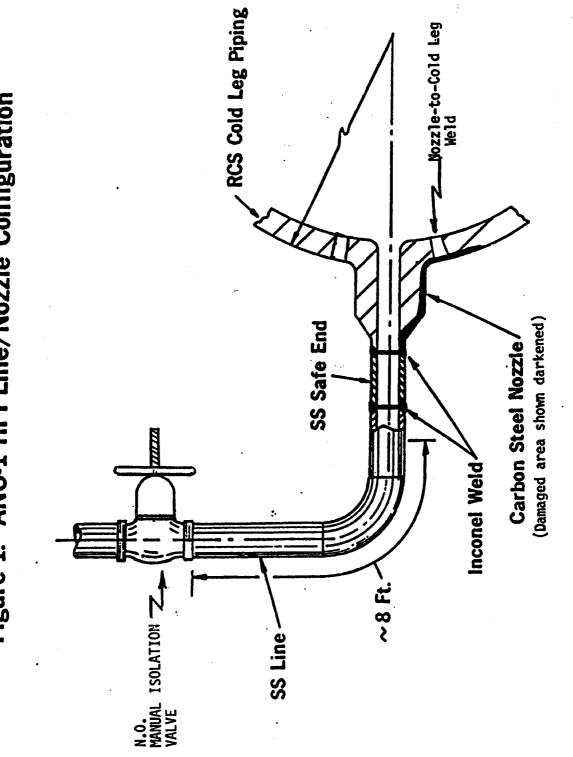
Figure 1: ANO-1 HPI Line/Nozzle Configuration

In October 1986, the Arkansas Nuclear One, Unit 1 (ANO-1) Plant was in cold shutdown and was performing nondestructive testing of the high pressure injection (HPI) nozzle thermal sleeves. An HPI nozzle is attached directly on the side of each of the four RCS cold legs. The metallic insulation was removed from the "A" HPI nozzle to allow radiographic examination. Removal of this insulation revealed severe corrosion wastage on the exterior of the HPI nozzle and some wastage on the RCS cold leg pipe. The corrosion apparently was caused by reactor coolant leakage from an HPI isolation valve located about 8 feet above the nozzle as shown in the attached Figure 1.

The wastage began adjacent to where the 3-1/2 inch OD stainless steel safe-end is welded to the carbon steel HPI nozzle. The safe-end is located between the stainless steel HPI line and the carbon steel HPI nozzle. The wastage was approximately 1/2 inch at its deepest location (adjacent to the stainless-tocarbon steel weld). The HPI nozzle (including cladding) is approximately 3/4inch thick at this point. At the transition weld between the safe-end and the carbon steel nozzle, the wastage extended approximately 20 percent around the circumference of the nozzle in the form of several trenches. From this point, the wastage narrowed to two separate trenches that became shallower as they progressed more than 10 inches along the bottom of the HPI nozzle towards the RCS cold leg. The two trenches then continued down the cold leg for approximately 6 inches. The depth of the trenches on the cold leg were less than 1/4 inch.

Boric acid corrosion has been found to be most active where the metal surface is cool enough so that it is wetted. If the metal is sufficiently hot, then the surface will stay dry and this loss of electrolyte will slow the corrosion rate. At ANO-1, borated water leaked from the HPI isolation valve in the form of a liquid and then ran down the HPI piping on the inside of the insulation to the HPI nozzle. As the leakage approached the cold leg, the increased piping temperatures caused evaporation of the water, thus increasing the boric acid concentration and lowering the PH of the solution. It is believed that the close tolerance between the HPI nozzle and the insulation, aided by boric acid crystallization, caused pooling of the solution at the nozzle. This pool of highly acidic solution wetted the nozzle and resulted in accelerated corrosive

The damaged HPI nozzle has been repaired by grinding out all indications of corrosion and rebuilding by welding in those areas with less than the minimum required wall thickness. Repair to the cold leg required only grinding out the corrosion. All repairs were in accordance with ASME codes. The other HPI nozzles were inspected and no evidence of corrosion wastage was found. The licensee continues to evaluate methods and procedures to minimize recurrence of this type of event. The primary defense is to minimize leaks, detect and stop leaks soon after they start, and promptly clean up any boric acid residue. Detection of leaks will be enhanced by an evaluation of any iron oxide stains on insulation.
