Exelon Nuclear
Peach Bottom Atomic Power Station
1848 Lay Road
Delta, PA 17314-9032

Peach Bottom Atomic Power Station (PBAPS) Unit 3
Facility Operating License No. DPR-56
NRC Docket No. 50-278

Subject: Licensee Event Report (LER) 3-05-03

4. TITLE
Residual Heat Removal System Small Bore Piping Leak due to Weld Deficiency

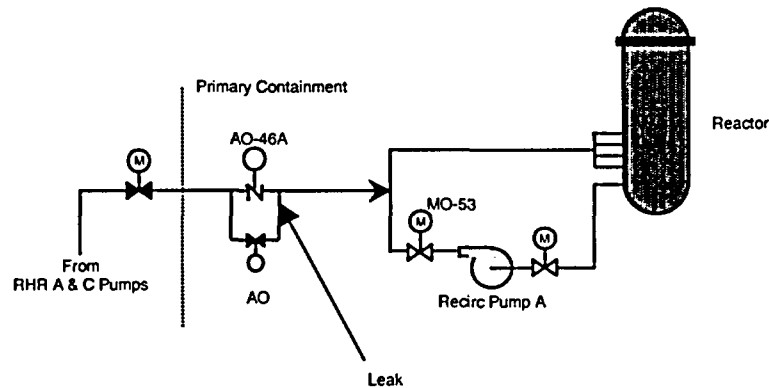
Simplified Diagram of 'A' RHR Loop

The RCS pressure boundary leakage (see below diagram) was determined to exist on a one-inch equalizing line for the 'A' Residual Heat Removal (RHR)(EIIS:BO) Loop testable air-operated check valve (AO-46A) (EIIS: V). The AO-46A valve is located on the 'A' RHR loop injection line. This line is located within the normally inaccessible Primary Containment and injects into the 'A' Recirculation (Recirc) line on the downstream side of the A Recirc line discharge motor-operated valve (MO-53A). The leak was located on a pipe coupling (EIIS: PSF) socket weld. This portion of the equalizing line is connected to the AO-46A check valve body on the downstream (Reactor) side of the check valve. The leaking pipe coupling is ASME Class 1 piping and therefore, is part of the RCS pressure boundary.

The RCS leakage was due to a socket weld crack in the one-inch pipe coupling associated with the 'A' RHR loop testable check valve equalizing line. The crack extended approximately 160 degrees around the circumference of the weld. The cause of the weld failure was due to lack of fusion (i.e. a weld flaw) associated with the root weld. The lack of fusion was the crack initiator. The lack of fusion extended approximately 120 degrees around the weld. Laboratory analysis indicated that the crack originated from the weld interior at the weld root. The lack of fusion at the root of this weld reduced the strength of the weld. This weld was completed as part of a Recirc / RHR pipe replacement project performed on Unit 3 in the 1987-1989 time period.

The welded joint was replaced and appropriately inspected and tested successfully during the Unit 3 Refueling Outage. The inspections included Non-Destructive Examinations (NDE).
