# CROW BUTTE RESOURCES, INC.

Subject: 2005 Annual Pond Inspection Report  
Source Materials License SUA-1534  
Docket Number 40-8943

**CROW BUTTE MINE  
DAWES COUNTY, NEBRASKA**

**2005 POND INSPECTION REPORT**

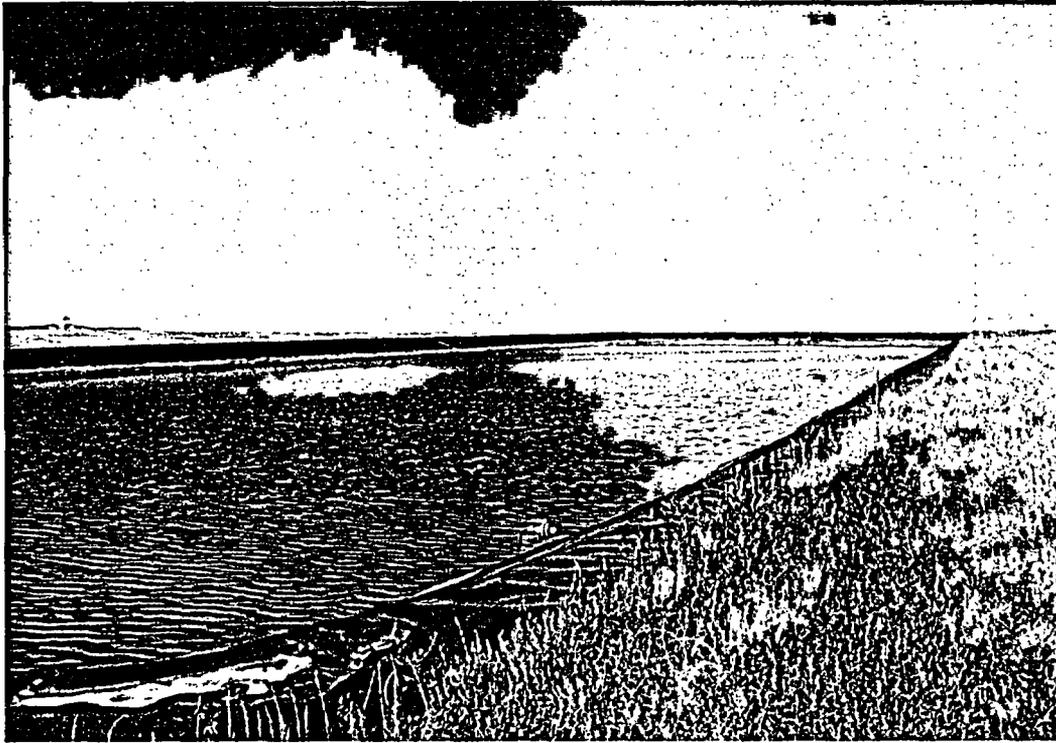
**Northwest view of evaporation pond #1, date: 10/24/05**

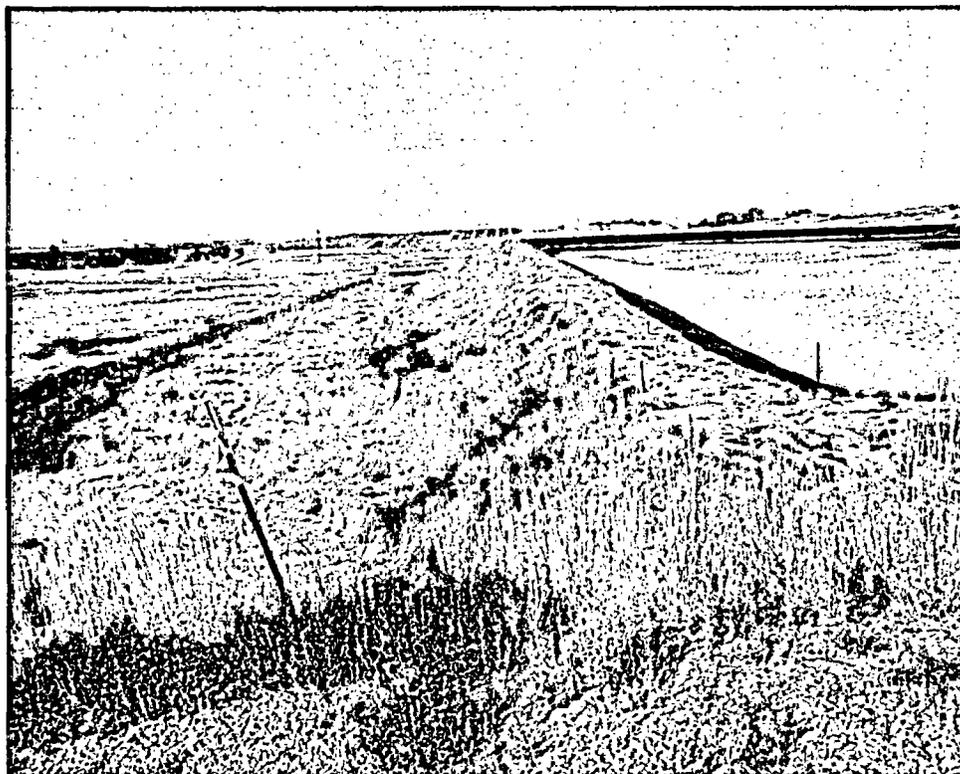
Pond #3 had excellent vegetative cover on the west and north slopes. The water level depth was about 11'.

**North view of west embankment of pond #3. Date: 10/24/05**

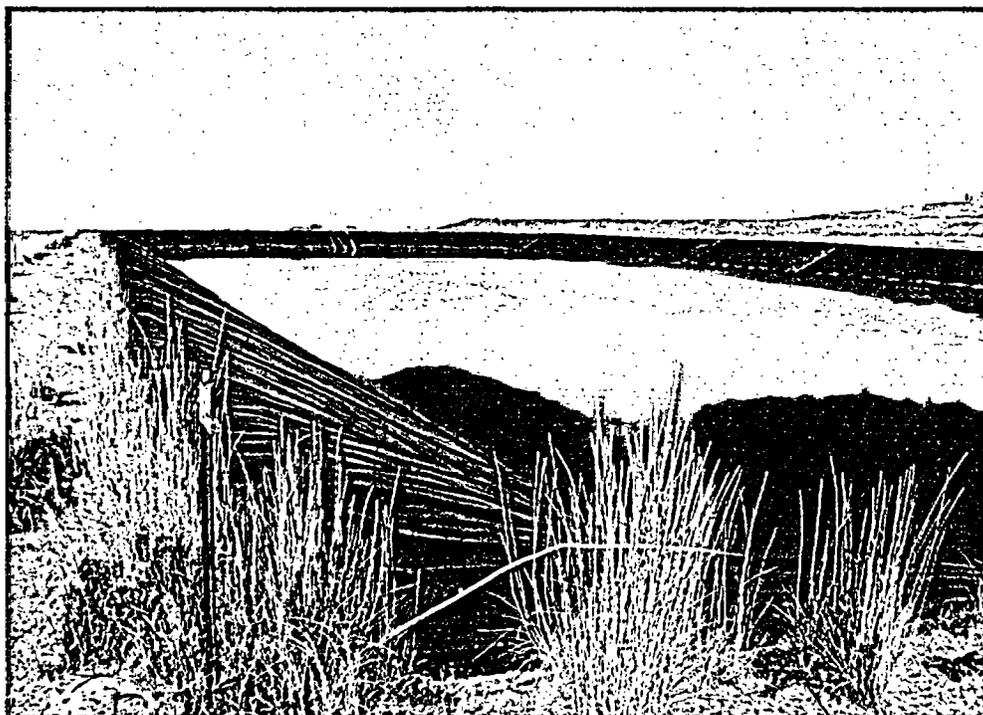
There were weekly conductivity readings of the commercial ponds. Most of the conductivity readings for ponds #3 & #4 were low enough not to warrant remedial actions. There were no pond leaks discovered during the 2005 season. Pond #4 had numerous repairs on the exterior liner. During this inspection there was transfer taking place from pond #1 to pond #4.

**Northeast view of pond #4. Date: 10/24/05**

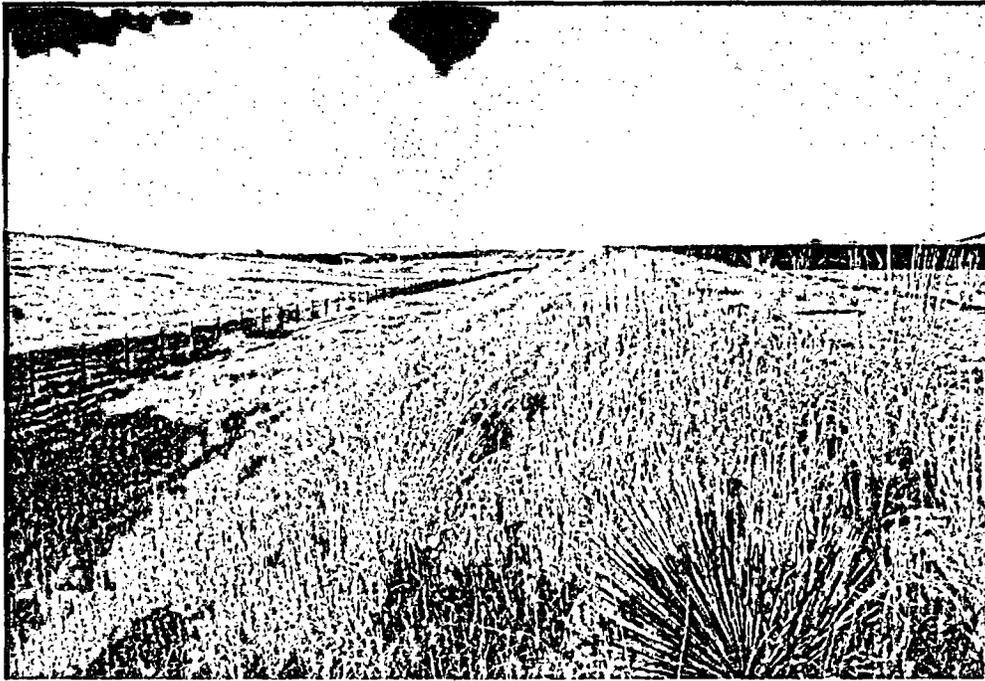
**West embankment of Pond #4, dated: 10/24/05**

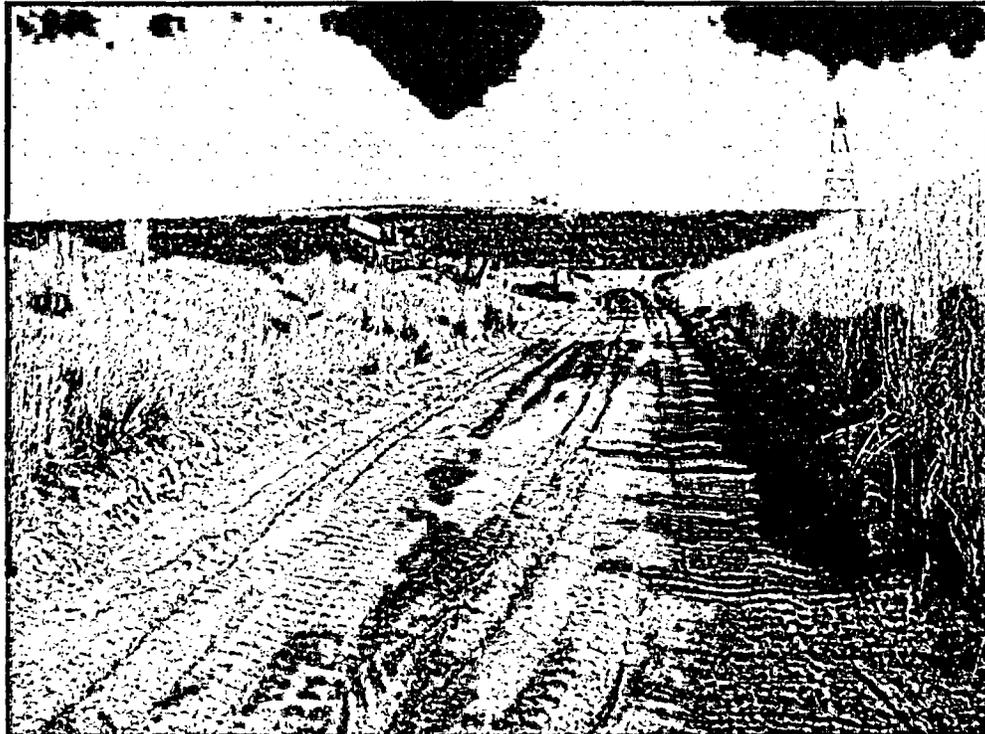
Crow Buttes Resources did considerable work on the drainage channel between ponds 3 & 4 this summer. The bottom of the channel was flattened out and the grade was reconstructed to eliminate low spots where water could accumulate. This inspection did not result in any wet areas between ponds 3 & 4. Traffic control measures were implemented along the drainage channel. Top soil was spread on the top surface of the drainage channel. The top soil will enhance the vegetative cover.

**Channel improvement between ponds #3 & #4. No damp or wet areas noticed this year.  
Date: 10/24/05**

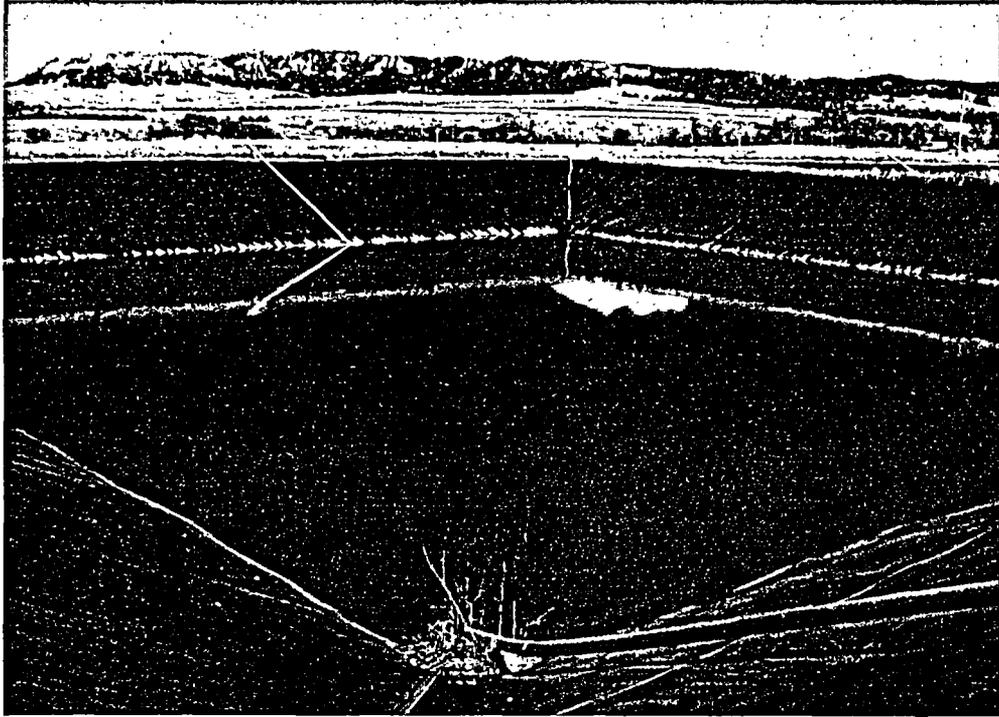
**Southeast view of Cell #1 (west) of R & D Ponds. 10/24/05**

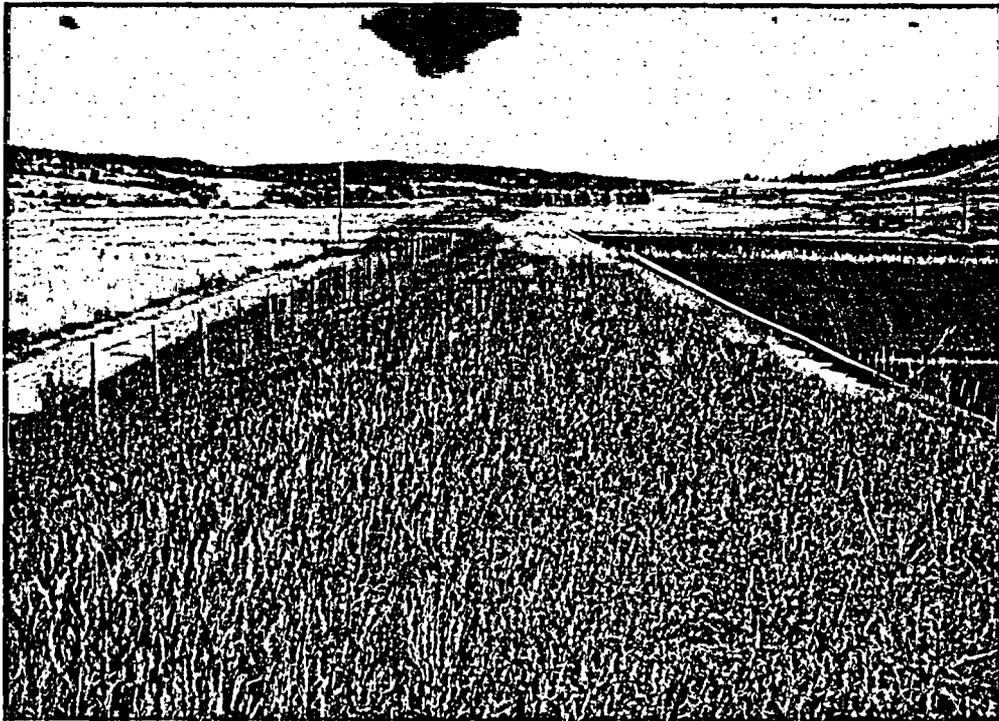
**East view of north embankment of R&D ponds. Excellent vegetative cover.  
Date: 10/24/05**

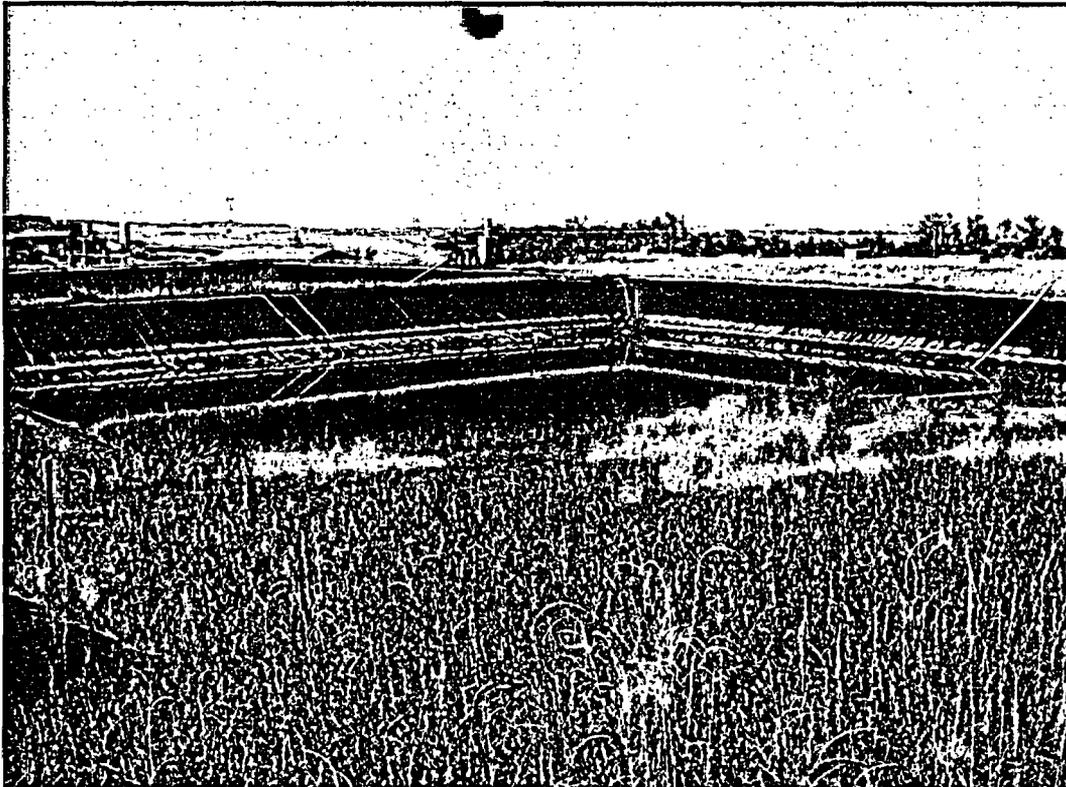
**Northwest view of Cell #2 (East): Date: 10/24/05**
