Re: St. Lucie Unit 1
Docket No. 50-335
Revised Steam Generator Tube Inservice Inspection
Special Report for Refueling Outage SL1-19 & RAI Response

**Replacement St. Lucie Unit 1
Spring 2004 Refueling Outage SL1-19
Steam Generator Tube Inservice Inspection
Special Report**

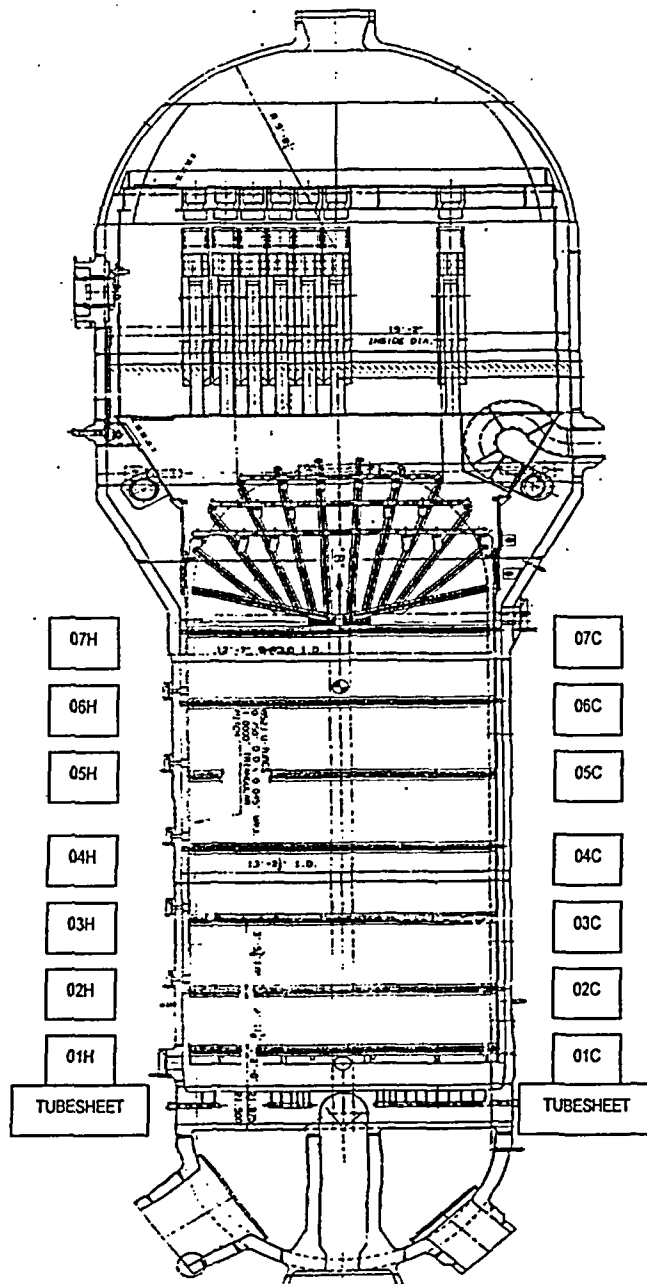
FIGURE 1
PSL-1 Replacement Steam Generator Support Identification

(e) tube pitch and pattern (e.g., 0.95 inches triangular)	1.0 inch triangular
(f) tubesheet thickness (with/without clad)	21.875 inches / 21.50 inches
(g) a sketch depicting the tube support structure naming	See Figure 1

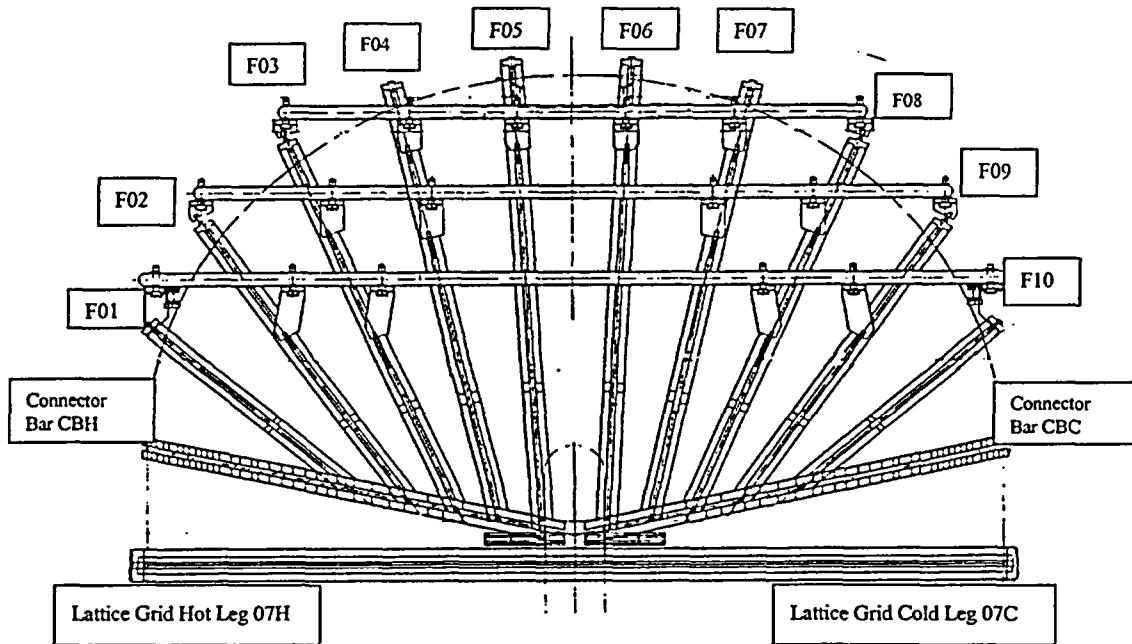
FIGURE 2
PSL-1 Replacement Steam Generator U-Bend Structure Identification

(h) anti-vibration bar (fan bar) design,	See Figure 2
(i) tube support material (e.g., 410 Stainless Steel)	410 Stainless Steel
(j) a sketch of a tubesheet map which depicts the rows and columns of the tubes in the steam generators	See Figure 3
