Hairline Crack in IPEC Unit 2 Spent Fuel Pool South Wall

9/8/05

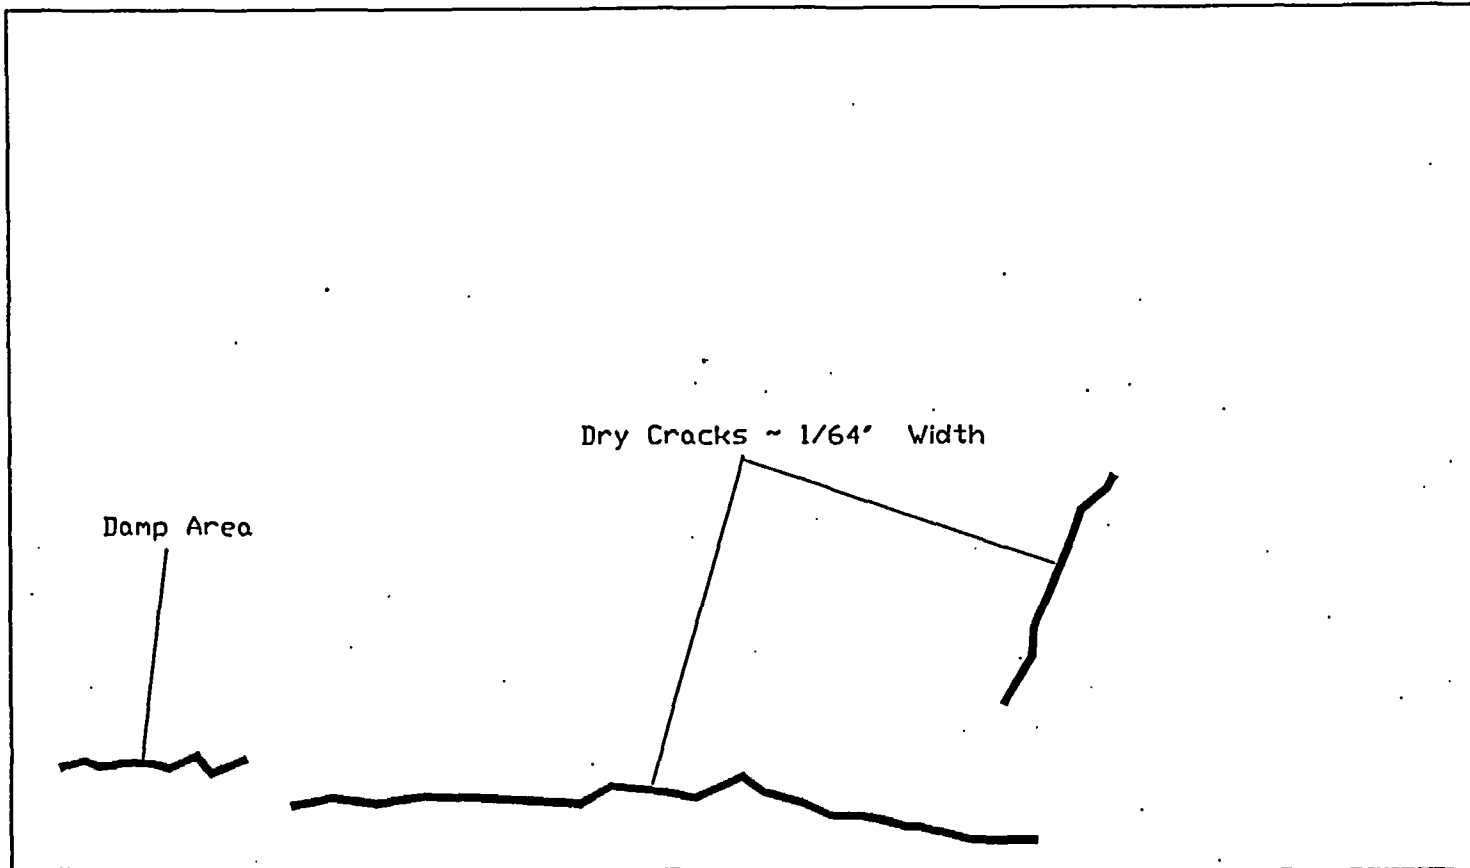
Crack Map of South Wall Spent Fuel Pit  
Looking North

and replaced with a significantly more substantial structure. The original floor has been removed, and excavation of soil and rock in the loading bay is in progress. During removal of loose soil and rocks in the north area of the loading bay (along the SFP south wall), approximately horizontal cracks were exposed at an elevation of approximately 65 feet, and an approximately vertical crack above. The cracks are very narrow (less than 1/64-inch wide). One of the cracks, on the west side of the south SFP wall, has moisture in and near it.

\*) The cracks have been visually inspected by an IPEC civil/structural engineer, and the IPEC Supervisor of Civil/Mechanical Engineering. The condition is typical of cracking due to shrinkage during post-construction concrete curing. The moisture in and around one of the cracks is very slight, essentially a film which is not dripping or beading. The moisture has been analyzed and found to contain trace amounts of Cesium 134 and 137, Cobalt-60, and Boron. The Boron concentration is about six times less than the concentration in the SFP, and the ratios of Cesium-134 and 137 indicate the activity is about six years old. The crack has calcium stains emanating from it, as is expected when moisture leaches through concrete, and no visual evidence of steel corrosion products (rust). Due to the thickness of the SFP wall, amount of steel reinforcement, and lack of evidence that the small amounts of moisture and boron have caused corrosion of the reinforcing rods, there is reasonable assurance that the SFP wall is structurally sound and capable of performing it's intended function.

West Side

Damp Area

Dry Cracks ~ 1/64" Width

East Side
