Hairline Crack in IPEC Unit 2 Spent Fuel Pool South Wall

9/8/05

FOIA-2005-0369

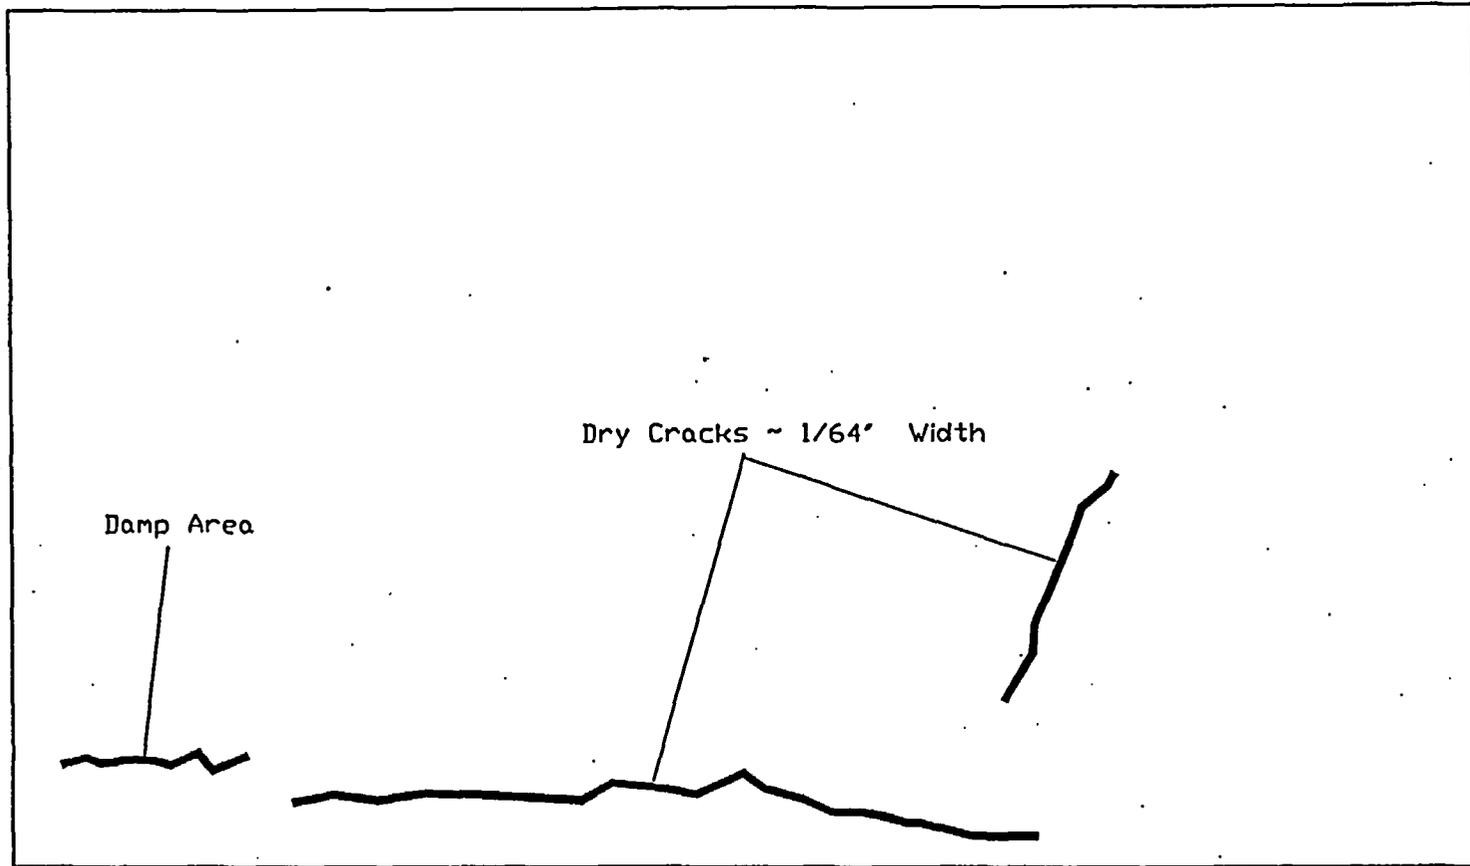
Crack Map of South Wall Spent Fuel Pit
Looking North

and replaced with a significantly more substantial structure. The original floor has been removed, and excavation of soil and rock in the loading bay is in progress. During removal of loose soil and rocks in the north area of the loading bay (along the SFP south wall), approximately horizontal cracks were exposed at an elevation of approximately 65 feet, and an approximately vertical crack above. The cracks are very narrow (less than 1/64-inch wide). One of the cracks, on the west side of the south SFP wall, has moisture in and near it.

*) The cracks have been visually inspected by an IPEC civil/structural engineer, and the IPEC Supervisor of Civil/Mechanical Engineering. The condition is typical of cracking due to shrinkage during post-construction concrete curing. The moisture in and around one of the cracks is very slight, essentially a film which is not dripping or beading. The moisture has been analyzed and found to contain trace amounts of Cesium 134 and 137, Cobalt-60, and Boron. The Boron concentration is about six times less than the concentration in the SFP, and the ratios of Cesium-134 and 137 indicate the activity is about six years old. The crack has calcium stains emanating from it, as is expected when moisture leaches through concrete, and no visual evidence of steel corrosion products (rust). Due to the thickness of the SFP wall, amount of steel reinforcement, and lack of evidence that the small amounts of moisture and boron have caused corrosion of the reinforcing rods, there is reasonable assurance that the SFP wall is structurally sound and capable of performing it's intended function.
