Hairline Crack in IPEC Unit 2 Spent Fuel Pool South Wall  
Revision 1, 9/9/05

Background

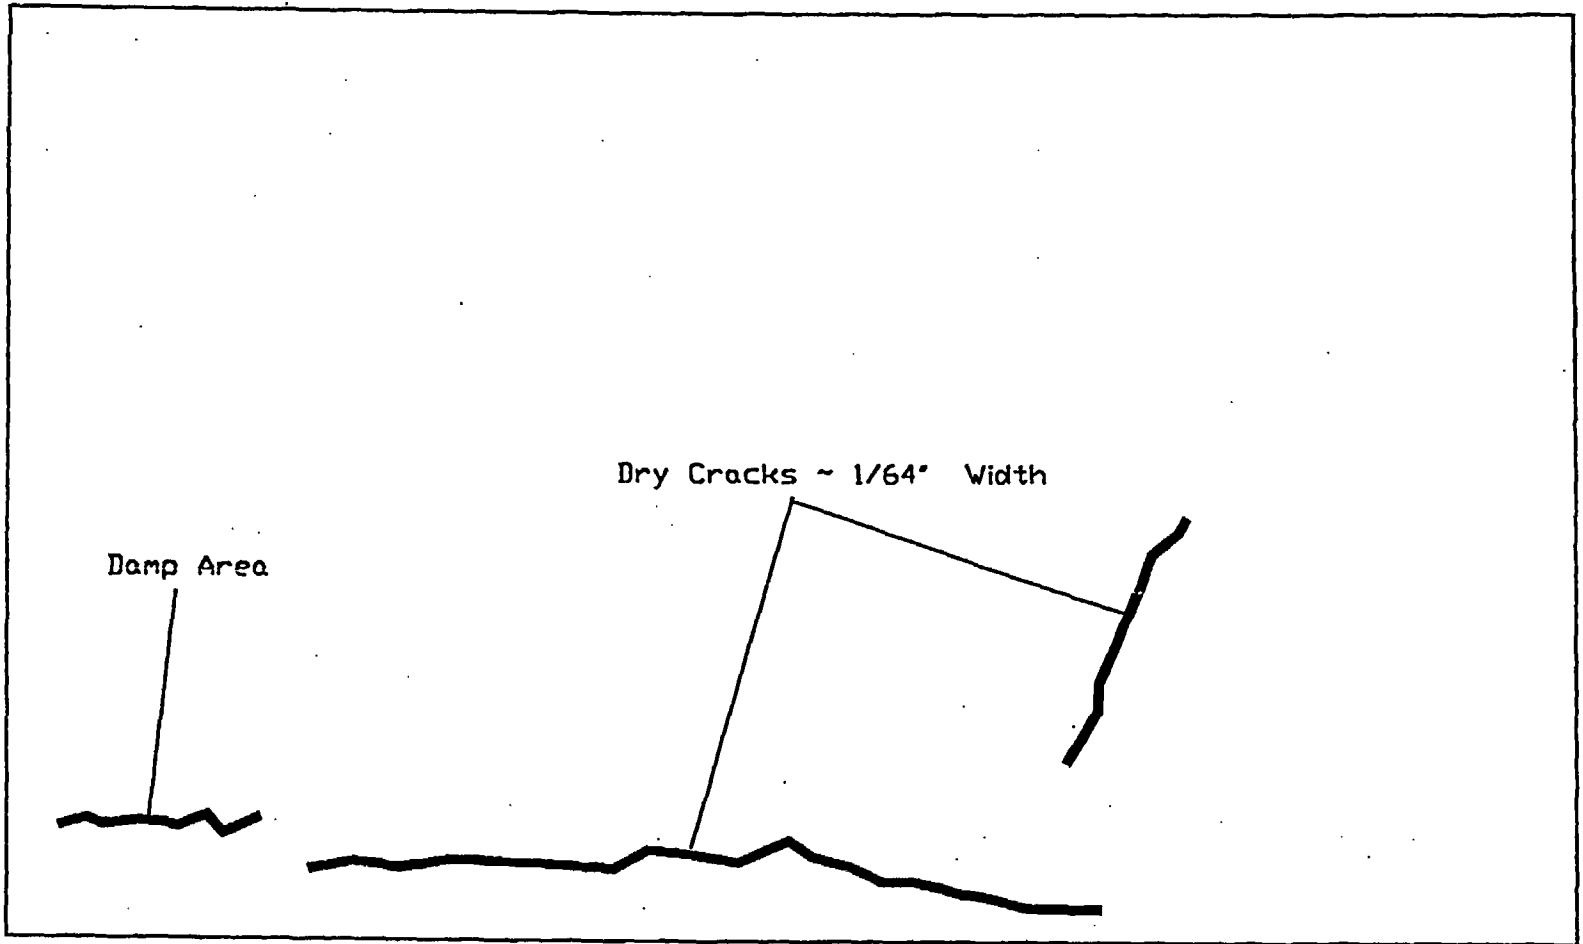
Crack Map of South Wall Spent Fuel Pit  
Looking North

and replaced with a significantly more substantial structure. The original floor has been removed, and excavation of soil and rock in the loading bay is in progress. During removal of loose soil and rocks in the north area of the loading bay (along the SFP south wall), approximately horizontal cracks were exposed at an elevation of approximately 65 feet, and an approximately vertical crack above. The cracks are very narrow (less than 1/64-inch wide). One of the cracks, on the west side of the south SFP wall, has moisture in and near it.

The cracks have been visually inspected by an IPEC civil/structural engineer, and the IPEC Supervisor of Civil/Mechanical Engineering. The condition is typical of cracking due to shrinkage during post-construction concrete curing. The moisture in and around one of the cracks is very slight, essentially a film which is not dripping or beading. The moisture has been analyzed and found to contain trace amounts of Cesium 134 and 137, Cobalt-60, and Boron. The Boron concentration is about 6 to 15 times less than the concentration in the SFP, and the ratio of Cesium-134 to 137 indicate the activity is about 6 to 10 years old. The crack has calcium stains emanating from it, as is expected when moisture leaches through concrete, and no visual evidence of steel corrosion products (rust). Due to the thickness of the SFP wall, amount of steel reinforcement, and lack of evidence that the small amounts of moisture and boron have caused corrosion of the reinforcing rods, there is reasonable assurance that the SFP wall is structurally sound and capable of performing it's intended function.
