Hairline Crack in IPEC Unit 2 Spent Fuel Pool South Wall

Revision 1, 9/9/05

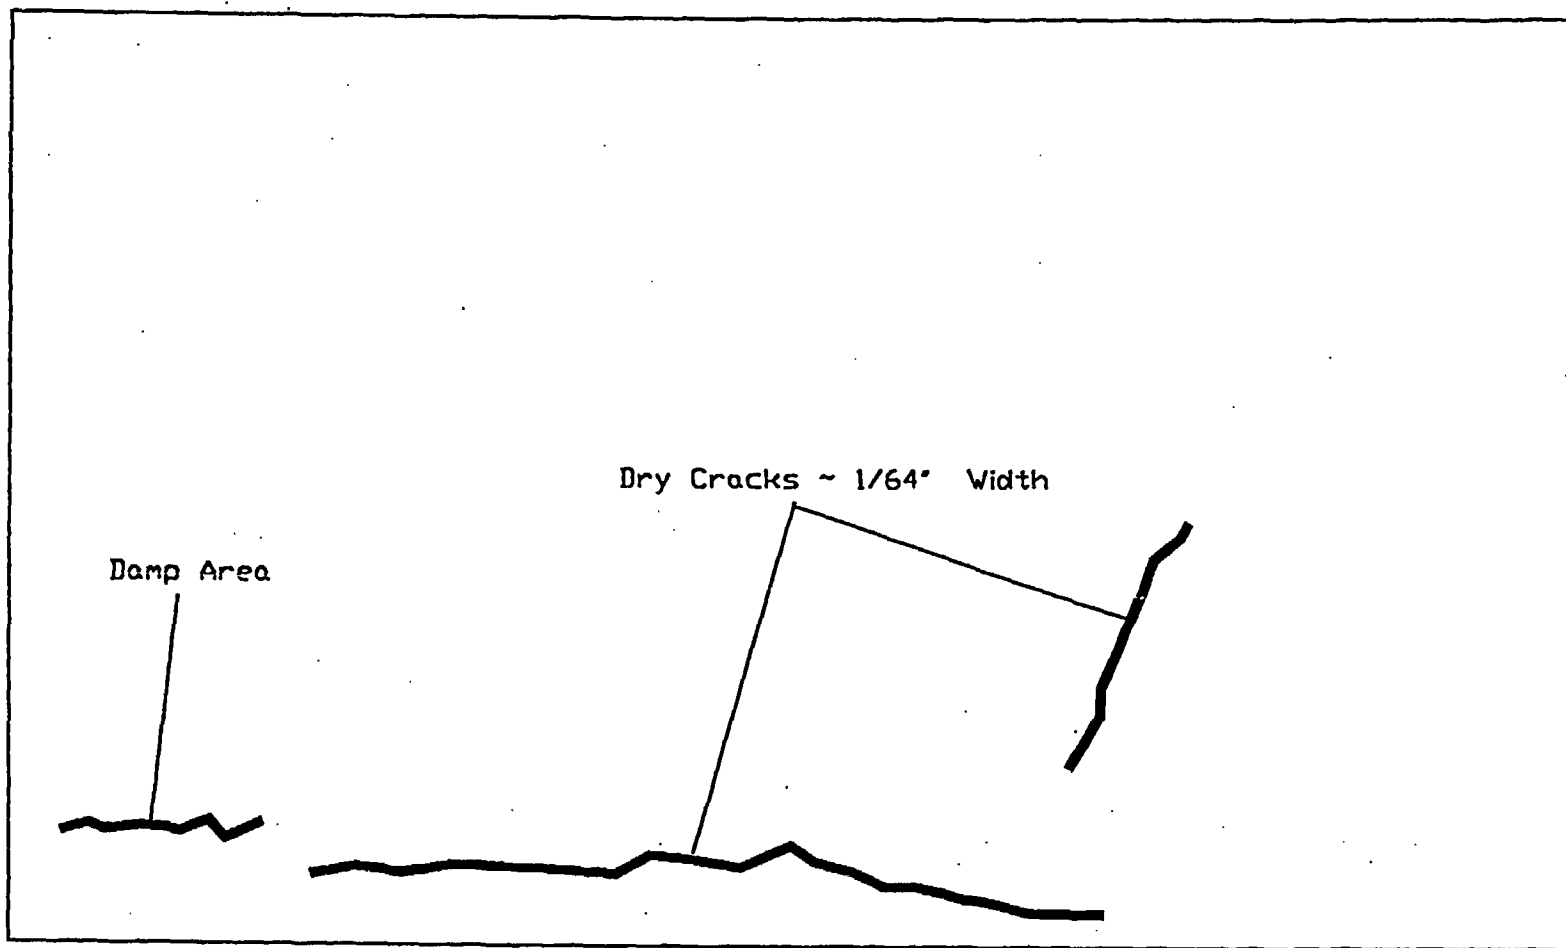
Crack Map of South Wall Spent Fuel Pit
Looking North

and replaced with a significantly more substantial structure. The original floor has been removed, and excavation of soil and rock in the loading bay is in progress. During removal of loose soil and rocks in the north area of the loading bay (along the SFP south wall), approximately horizontal cracks were exposed at an elevation of approximately 65 feet, and an approximately vertical crack above. The cracks are very narrow (less than 1/64-inch wide). One of the cracks, on the west side of the south SFP wall, has moisture in and near it.

The cracks have been visually inspected by an IPEC civil/structural engineer, and the IPEC Supervisor of Civil/Mechanical Engineering. The condition is typical of cracking due to shrinkage during post-construction concrete curing. The moisture in and around one of the cracks is very slight, essentially a film which is not dripping or beading. The moisture has been analyzed and found to contain trace amounts of Cesium 134 and 137, Cobalt-60, and Boron. The Boron concentration is about 6 to 15 times less than the concentration in the SFP, and the ratio of Cesium-134 to 137 indicate the activity is about 6 to 10 years old. The crack has calcium stains emanating from it, as is expected when moisture leaches through concrete, and no visual evidence of steel corrosion products (rust). Due to the thickness of the SFP wall, amount of steel reinforcement, and lack of evidence that the small amounts of moisture and boron have caused corrosion of the reinforcing rods, there is reasonable assurance that the SFP wall is structurally sound and capable of performing it's intended function.

Due to the thickness of the SFP wall, amount of steel reinforcement, and lack of evidence that the small amounts of moisture and boron have caused corrosion of the reinforcing rods, there is reasonable assurance that the SFP wall is structurally sound and capable of performing it's intended function.
