From: Schwartz, Geoffrey
Sent: Tuesday, September 13, 2005 7:02 PM
To: Dacimo, Fred; Rubin, Paul; Limpas, Oscar; Ventosa, John; Comiotes, Jim; Mayer, Don; Cox, Mark; Hipschman, Thomas; Axelson, William L; Lavera, Ron; Skonieczny, John; Hinrichs, Gary; Sandike, Steven; Bruck, Paul; Verrochi, Steven; Blizard, Andrea
Cc: Schwartz, Geoffrey
Subject: U2 south pool wall update

Hairline Crack in IPEC Unit 2 Spent Fuel Pool South Wall
Revision 3, 9/13/05

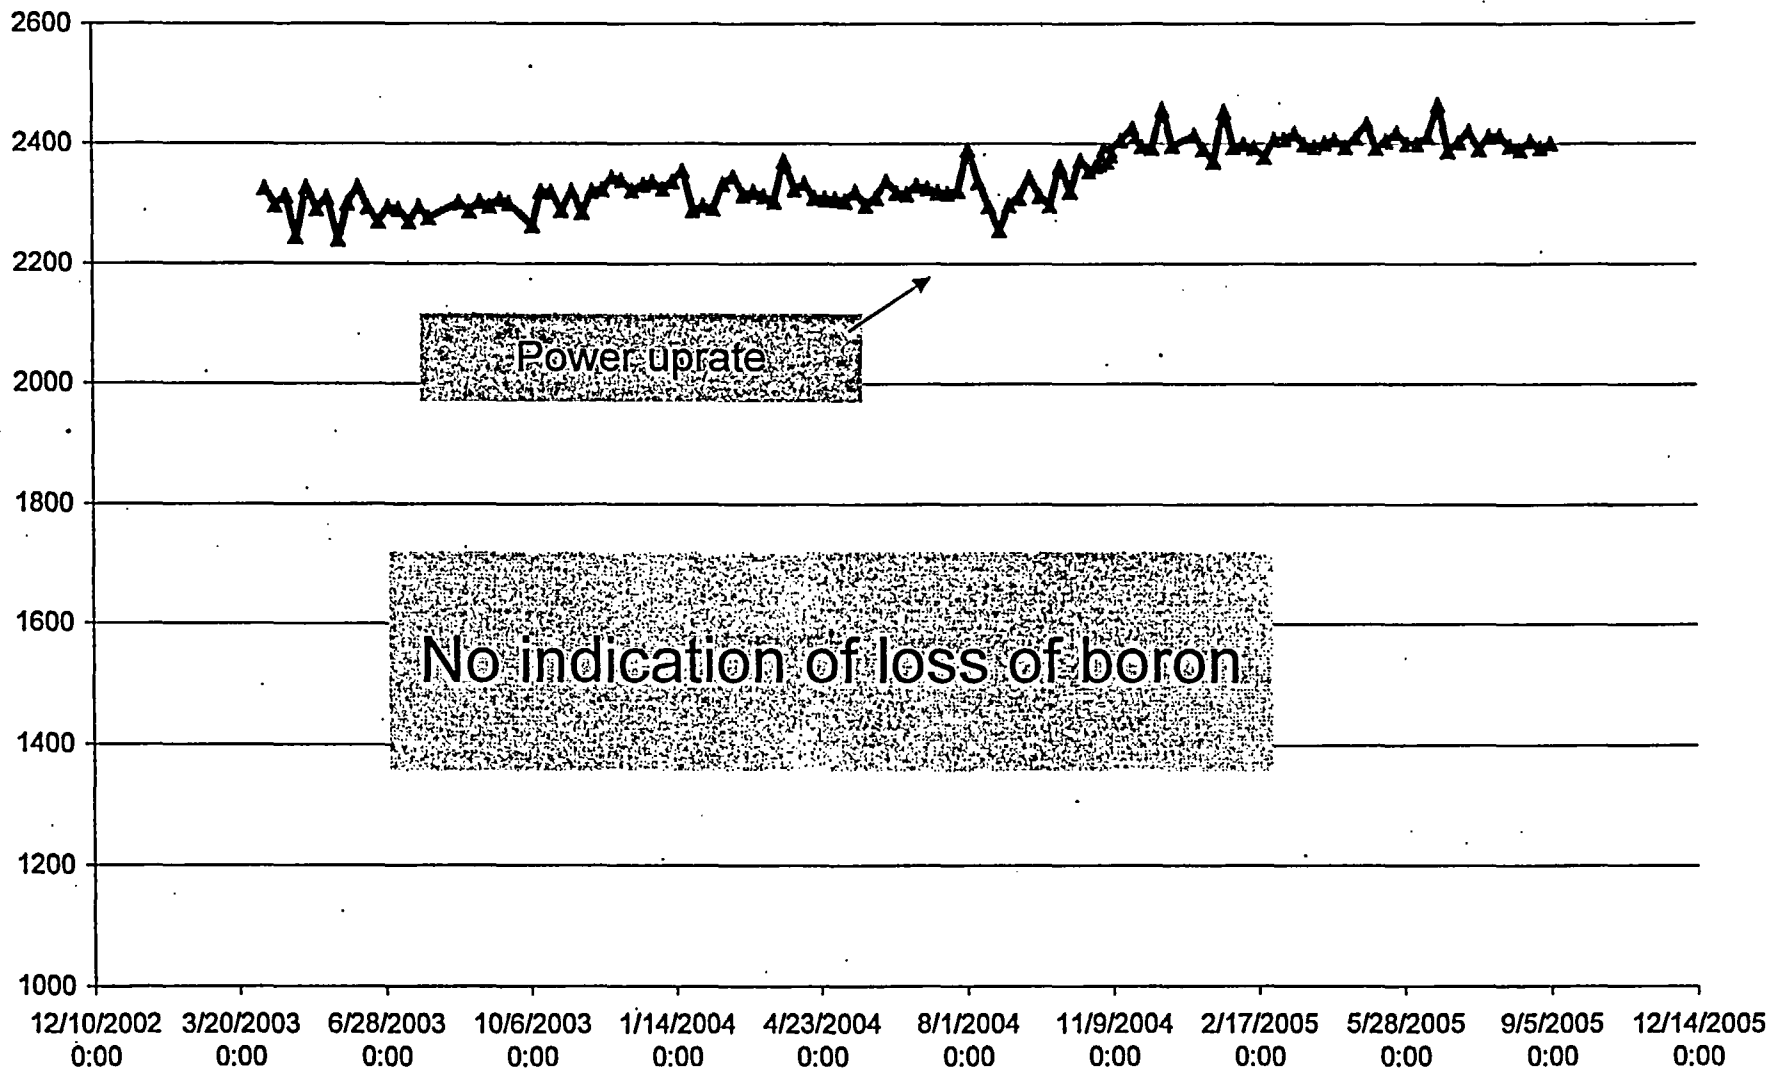
U2 SFP

For Communications Department: We have found hairline cracks, typical of those which form during concrete curing, in the Unit 2 spent fuel pool south wall. Several have evidence of a slight amount of moisture. The wall has been evaluated by structural engineers and is sound. The source of the moisture is under investigation by a full time multi-discipline team, following a detailed action plan.

The lower moist crack that we found yesterday (at about 61.5 foot elevation, 3 feet below the first moist crack) was covered with plastic for 24 hours, allowing us to capture about 12 mL of water. Initial analysis indicated the presence of low level Cs-137 and a boron concentration of approximately 1200 ppm. The upper crack (the first one) visually now appears almost dry. Full test results (including Tritium) of soil and the 12 mL sample are expected to be available tomorrow. All visually accessible areas of the pool wall have been inspected (south wall in the FSB loading bay, east wall outside and adjacent to the MOB, west wall in the Pipe Pen, and west wall between the VC, FSB and PAB). In the Pipe Pen where the west wall is visible we found dry hairline cracks at about the same elevation as the south wall (64.5 foot) with white streaks. The white material is being analyzed. After all radiochemistry analysis is complete we will develop initial conclusions and further recommendations for discussion with Senior Management.
