Oconee Nuclear Station High Energy Line Break Outside Containment

***Summary of East
Penetration Room
Activities
NRC Update***

November 14, 2005

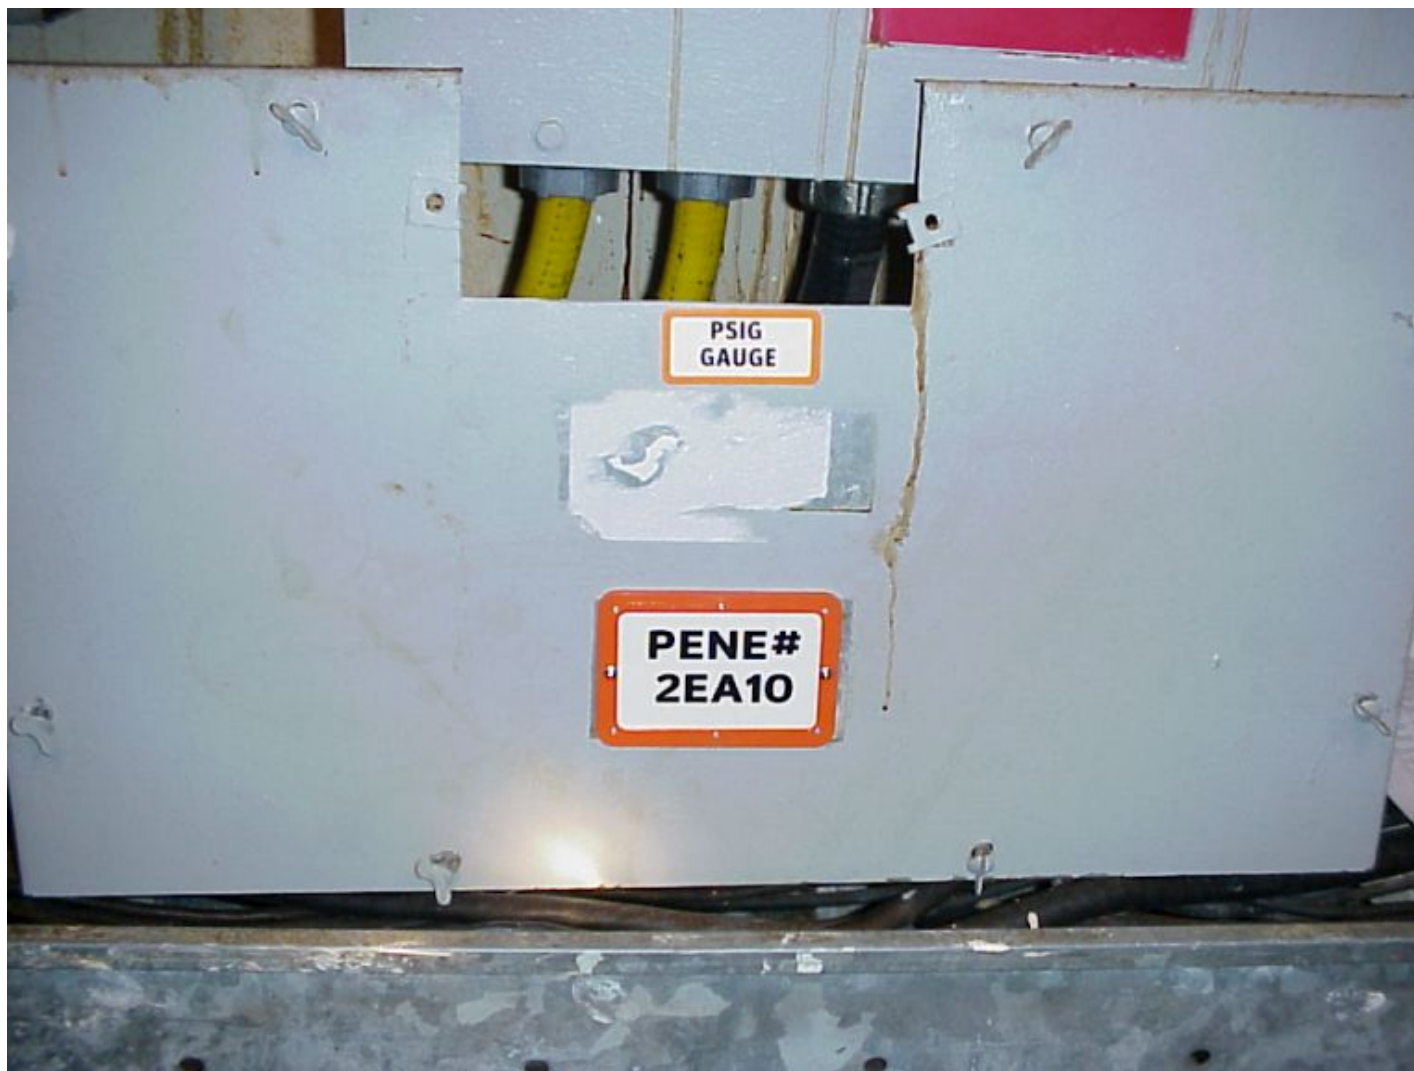
Electrical Penetrations / cont.

- **Configuration of electrical penetration enclosures has not been maintained.**
- **Initiated inspection and repair program to restore the enclosures to correct configuration.**
- **Inspections performed on selected Unit 2 EPR electrical penetrations consisting of all HELB mitigation related (4) and 6 other penetrations with missing covers.**
- **No degradation of terminal boards or connections was noted. Some minor rusting of enclosure interior bottom and minor debris was found.**
- **Inspection and restoration of other units penetrations are planned for the upcoming Unit 3 (Spring 2006) and the Unit 1 (Fall 2006) outages.**
