Subject: **Vermont Yankee Nuclear Power Station**
Technical Specification Proposed Change No. 263 – Supplement No. 42
Extended Power Uprate – Steam Dryer Inspection Results

Steam Dryer Inspection Results

During the fall 2005 refueling outage (RFO-25), an inspection of the steam dryer was conducted using enhanced visual techniques, revealing 46 additional surface indications. The following provides an evaluation of the indications for operation at EPU conditions.

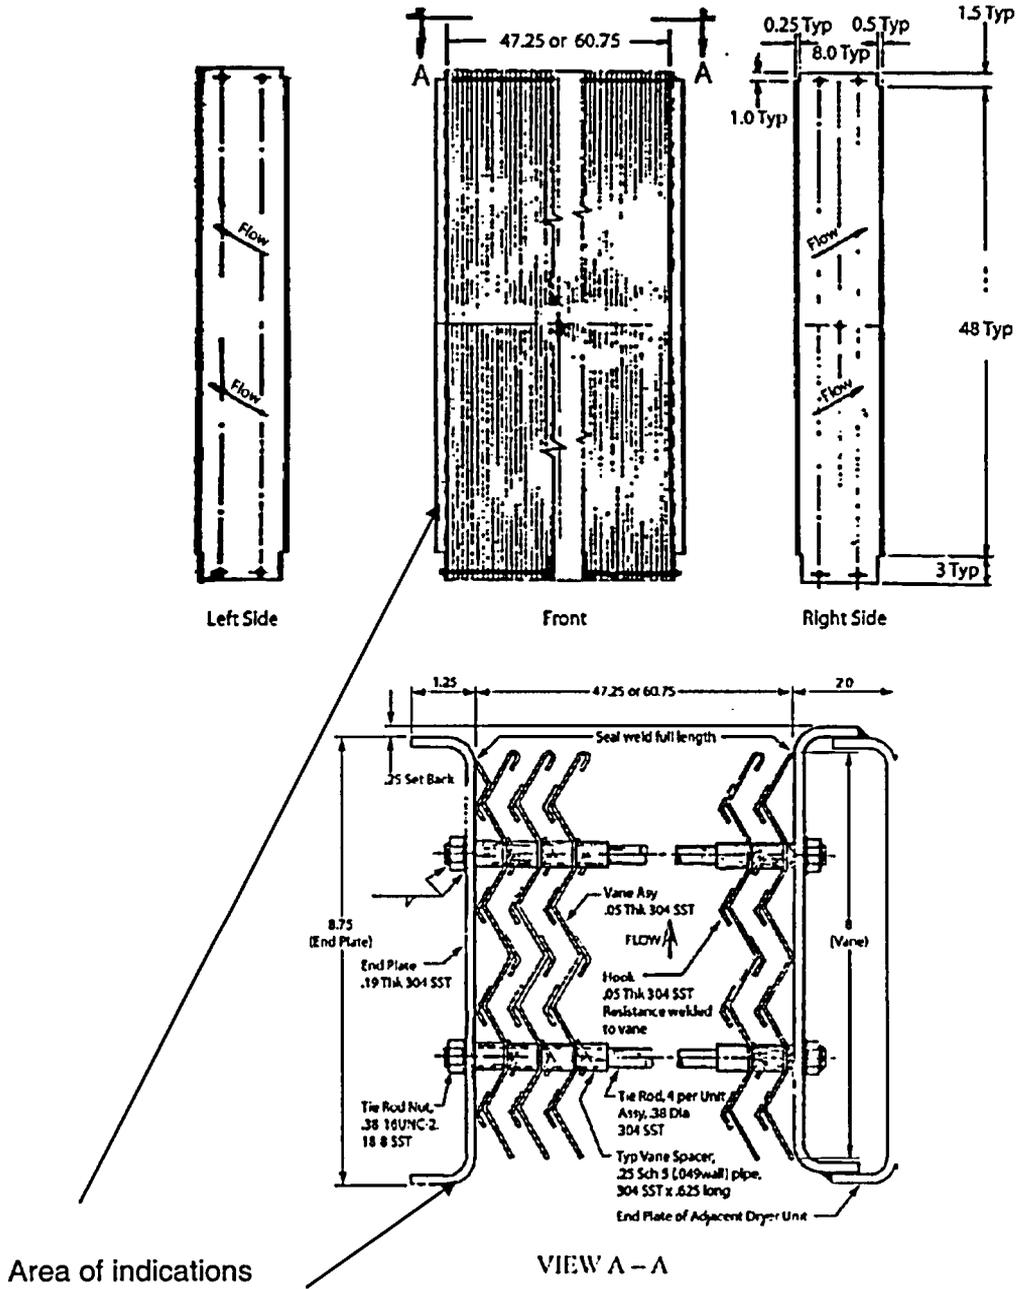
Figure 1
Steam Dryer Vane Bank Assembly

During the RFO-25 inspections, additional indications on the steam dryer vane bank end plates and the vane end plate to trough welds were identified. It is believed that these additional indications were identified due to enhanced visual inspection techniques utilized in the RFO-25 inspections and by positioning the camera closer to the inspection surface. The inspection techniques used for the RFO-24 inspections fully met VT-1 (visual testing, level 1) requirements, while the inspection techniques in RFO-25 more closely met an EVT-1 (enhanced visual testing, level 1) resolution, although a VT-1 inspection method with a 1/32-inch calibration standard was specified. The additional indications identified on the vane bank end plates and vane end plates to vane trough welds are similar to those documented during the RFO-24 refueling outage inspections. The newly identified indications on the dryer vane bank end plates and vane end plate to vane trough welds have been evaluated and are considered acceptable for operation at EPU conditions. Figure 1 shows various views of the type of steam dryer vane bank assembly installed at VYNPS.

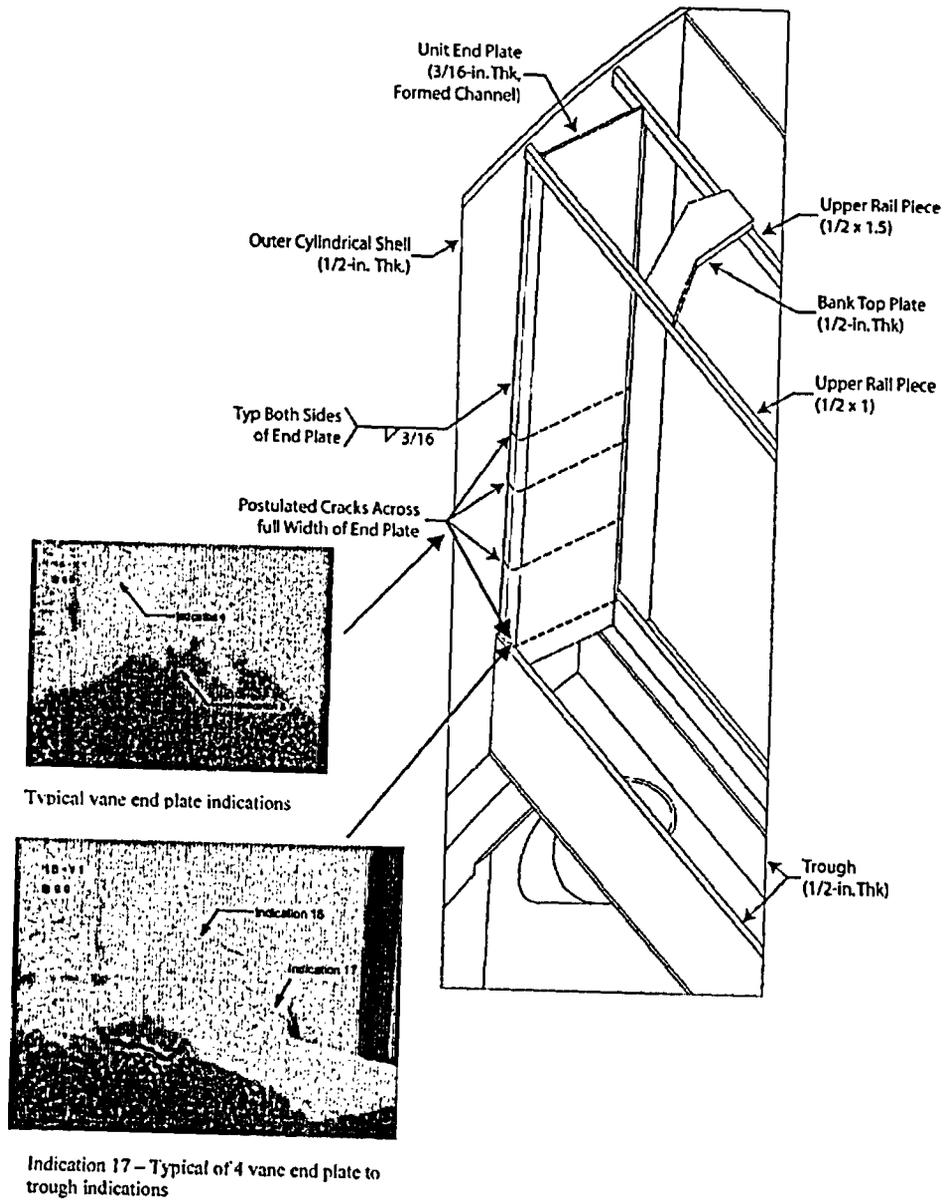
Figure 3
Cut-away of Bank Showing Unit End Plate

The dryer unit end plates, with indications, are securely attached and captured within the structure of the steam dryer bank assembly. The vertical edges of these end plates are attached to the dryer assembly with 3/16-inch fillet welds (each weld approximately 48-inches long). There were no relevant indications reported in these vertical welds. The geometric configuration of unit end plates is such that the upper and lower edges are mechanically captured by the steam dryer assembly as shown in Figures 2 and 3. The reported horizontal indications were seen in the 1.25-inch inlet side end plate flange. The vanes prevent inspection of the central end plate surface, but inspection of the outlet side end plate flanges found no indications. If it is conservatively postulated that the end plate horizontal indications propagate across the entire 8.75-inch unit end plate width including both the inlet and outlet side flange, as shown in Figure 3, such full-width, through-thickness indications would have no impact due to structural redundancy, nor is there any concern for generating loose parts. The postulated separated end plate sections, as shown in Figure 3, are still attached and will continue to function. Therefore, operation at EPU conditions with these non-structural indications is also acceptable.
