Subject: **Vermont Yankee Nuclear Power Station**  
**Technical Specification Proposed Change No. 263 – Supplement No. 42**  
**Extended Power Uprate – Steam Dryer Inspection Results**

Vermont Yankee Nuclear Power Station

Steam Dryer Inspection Results

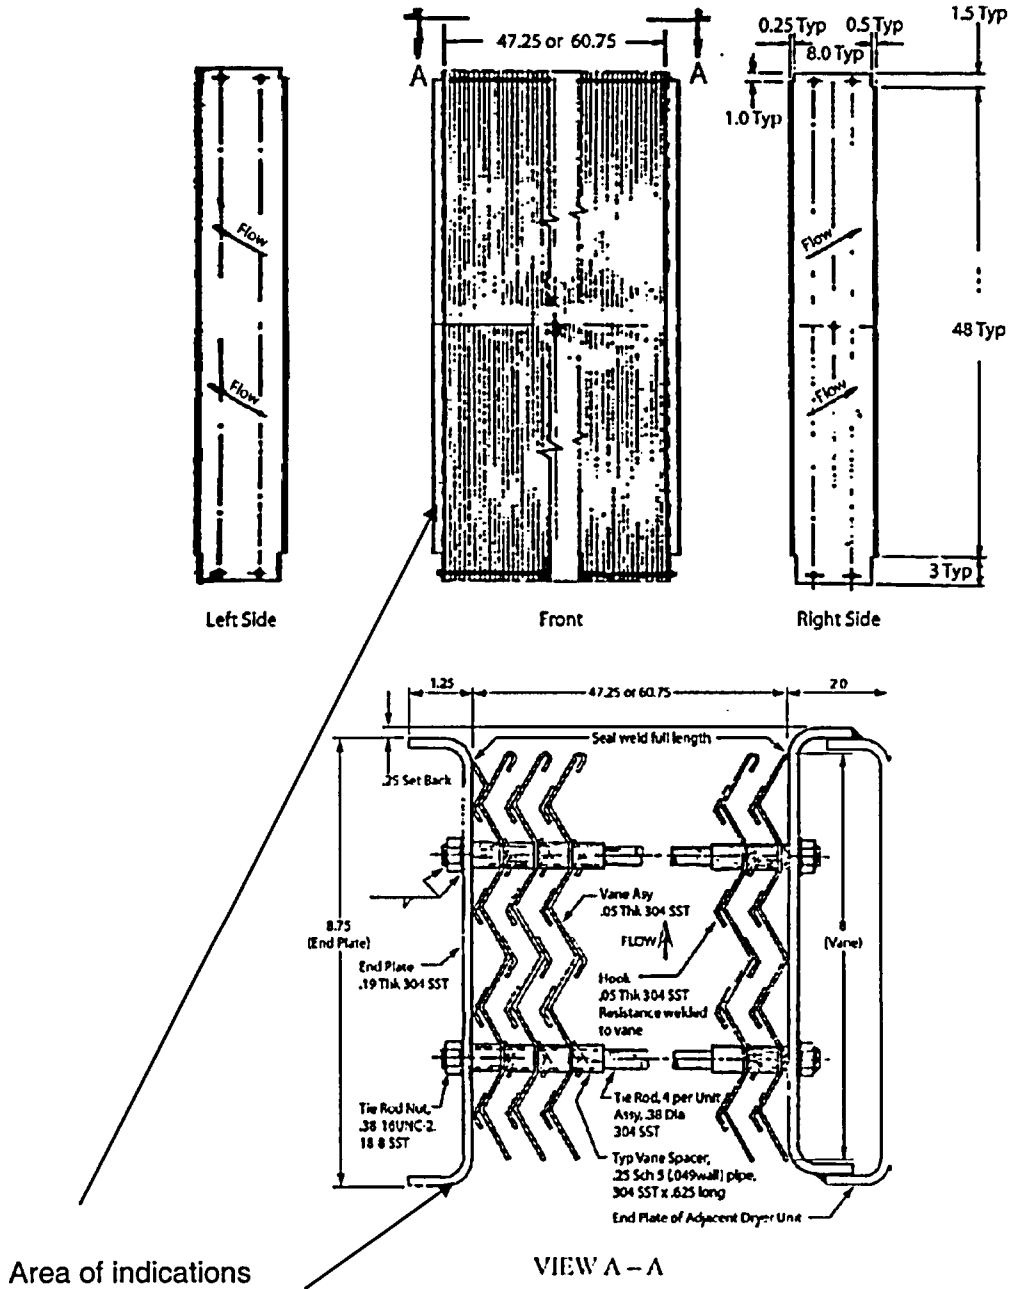
**Figure 1**  
**Steam Dryer Vane Bank Assembly**

During the RFO-25 inspections, additional indications on the steam dryer vane bank end plates and the vane end plate to trough welds were identified. It is believed that these additional indications were identified due to enhanced visual inspection techniques utilized in the RFO-25 inspections and by positioning the camera closer to the inspection surface. The inspection techniques used for the RFO-24 inspections fully met VT-1 (visual testing, level 1) requirements, while the inspection techniques in RFO-25 more closely met an EVT-1 (enhanced visual testing, level 1) resolution, although a VT-1 inspection method with a 1/32-inch calibration standard was specified. The additional indications identified on the vane bank end plates and vane end plates to vane trough welds are similar to those documented during the RFO-24 refueling outage inspections. The newly identified indications on the dryer vane bank end plates and vane end plate to vane trough welds have been evaluated and are considered acceptable for operation at EPU conditions. Figure 1 shows various views of the type of steam dryer vane bank assembly installed at VYNPS.

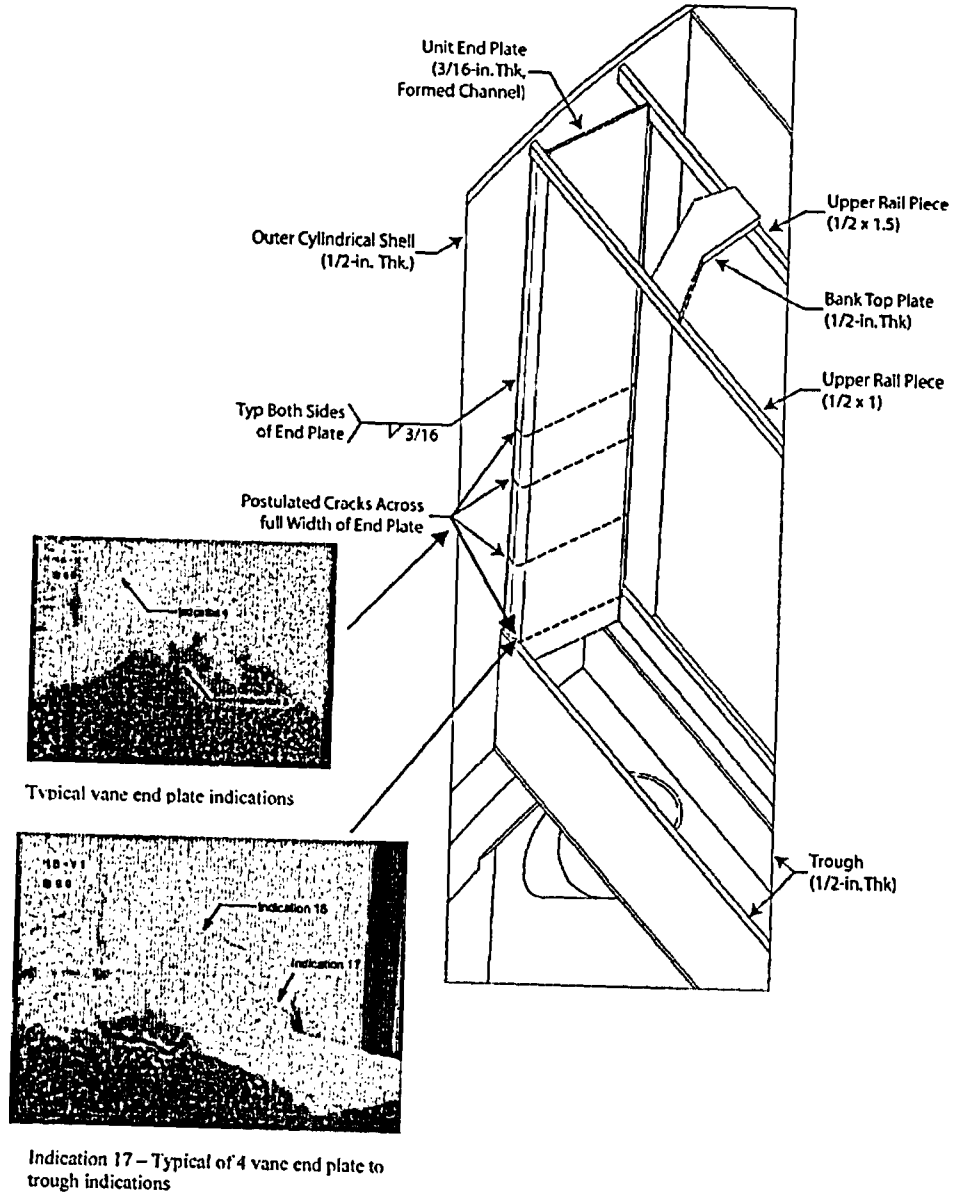
**Figure 3**  
**Cut-away of Bank Showing Unit End Plate**

The dryer unit end plates, with indications, are securely attached and captured within the structure of the steam dryer bank assembly. The vertical edges of these end plates are attached to the dryer assembly with 3/16-inch fillet welds (each weld approximately 48-inches long). There were no relevant indications reported in these vertical welds. The geometric configuration of unit end plates is such that the upper and lower edges are mechanically captured by the steam dryer assembly as shown in Figures 2 and 3. The reported horizontal indications were seen in the 1.25-inch inlet side end plate flange. The vanes prevent inspection of the central end plate surface, but inspection of the outlet side end plate flanges found no indications. If it is conservatively postulated that the end plate horizontal indications propagate across the entire 8.75-inch unit end plate width including both the inlet and outlet side flange, as shown in Figure 3, such full-width, through-thickness indications would have no impact due to structural redundancy, nor is there any concern for generating loose parts. The postulated separated end plate sections, as shown in Figure 3, are still attached and will continue to function. Therefore, operation at EPU conditions with these non-structural indications is also acceptable.
