Subject: **Vermont Yankee Nuclear Power Station
Technical Specification Proposed Change No. 263 – Supplement No. 42
Extended Power Uprate – Steam Dryer Inspection Results**

Proposed Technical Specification Change No. 263 – Supplement No. 42

Steam Dryer Inspection Results

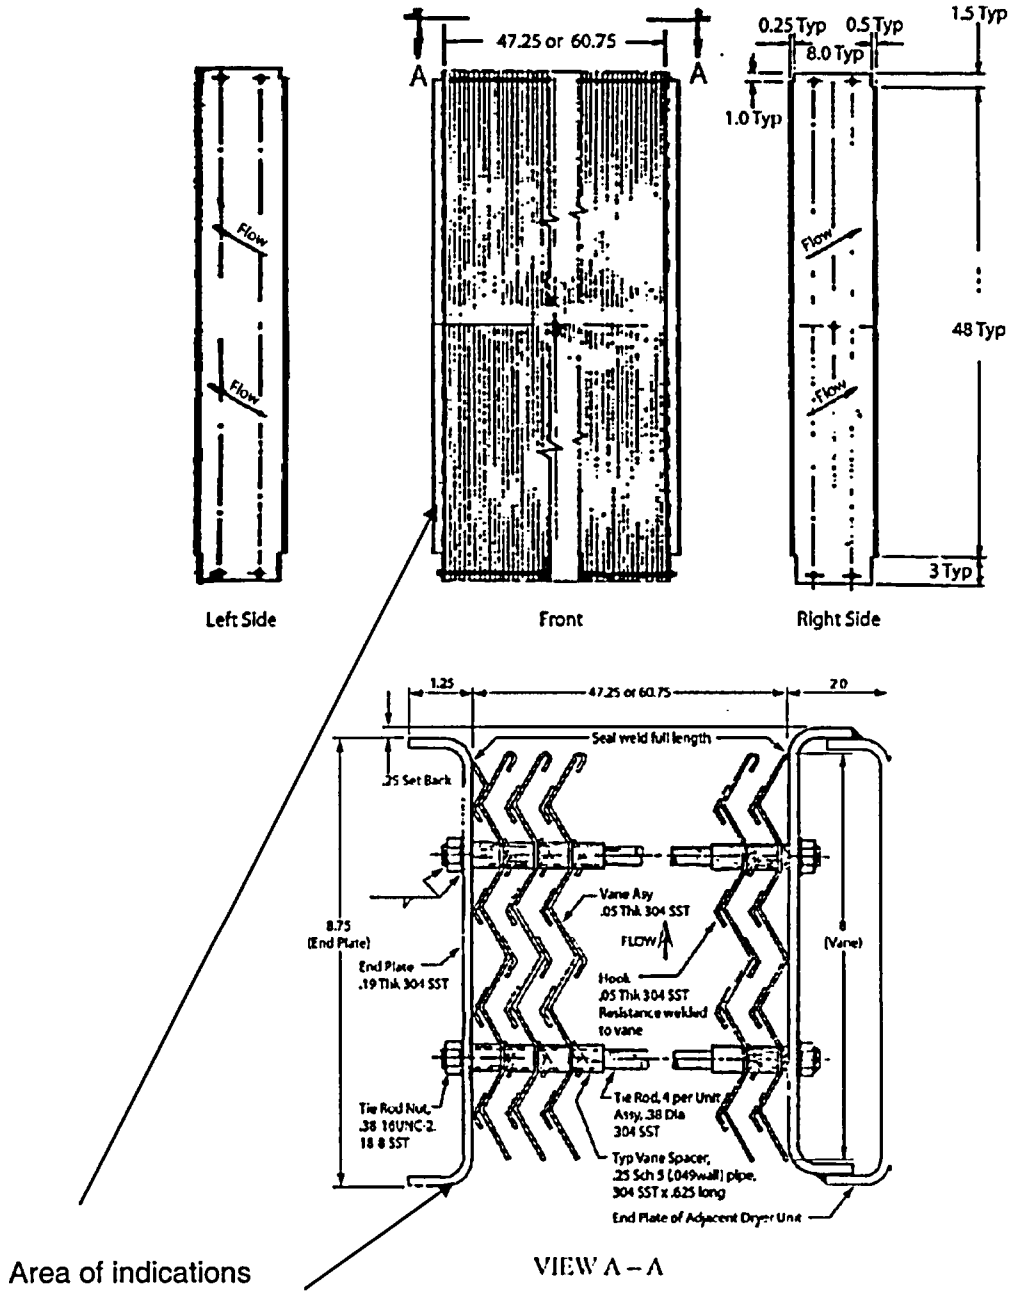
Figure 1
Steam Dryer Vane Bank Assembly

During the RFO-25 inspections, additional indications on the steam dryer vane bank end plates and the vane end plate to trough welds were identified. It is believed that these additional indications were identified due to enhanced visual inspection techniques utilized in the RFO-25 inspections and by positioning the camera closer to the inspection surface. The inspection techniques used for the RFO-24 inspections fully met VT-1 (visual testing, level 1) requirements, while the inspection techniques in RFO-25 more closely met an EVT-1 (enhanced visual testing, level 1) resolution, although a VT-1 inspection method with a 1/32-inch calibration standard was specified. The additional indications identified on the vane bank end plates and vane end plates to vane trough welds are similar to those documented during the RFO-24 refueling outage inspections. The newly identified indications on the dryer vane bank end plates and vane end plate to vane trough welds have been evaluated and are considered acceptable for operation at EPU conditions. Figure 1 shows various views of the type of steam dryer vane bank assembly installed at VYNPS.

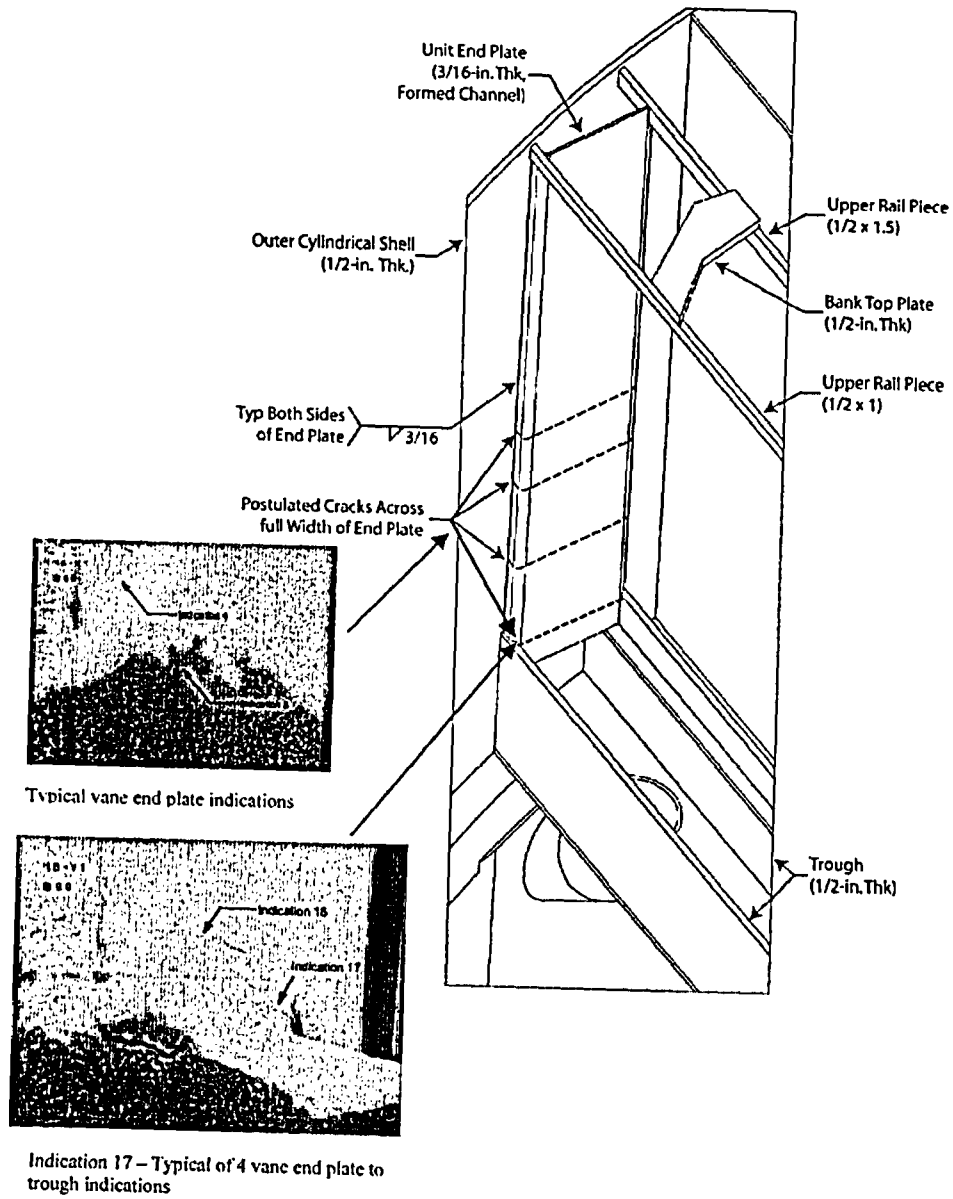
Figure 3
Cut-away of Bank Showing Unit End Plate

The dryer unit end plates, with indications, are securely attached and captured within the structure of the steam dryer bank assembly. The vertical edges of these end plates are attached to the dryer assembly with 3/16-inch fillet welds (each weld approximately 48-inches long). There were no relevant indications reported in these vertical welds. The geometric configuration of unit end plates is such that the upper and lower edges are mechanically captured by the steam dryer assembly as shown in Figures 2 and 3. The reported horizontal indications were seen in the 1.25-inch inlet side end plate flange. The vanes prevent inspection of the central end plate surface, but inspection of the outlet side end plate flanges found no indications. If it is conservatively postulated that the end plate horizontal indications propagate across the entire 8.75-inch unit end plate width including both the inlet and outlet side flange, as shown in Figure 3, such full-width, through-thickness indications would have no impact due to structural redundancy, nor is there any concern for generating loose parts. The postulated separated end plate sections, as shown in Figure 3, are still attached and will continue to function. Therefore, operation at EPU conditions with these non-structural indications is also acceptable.
