RDM-05-020

Subject: **10 CFR 71.95 Report of Non-Compliance with Certificate of Compliance  
USA/9309/B(U)F-96, Revision 1, for the Model No. RAJ-II Package**

### Outer Container Boss Welding Details and Summary of FANP Inspections/Findings by RAJ-II Package Identification Number

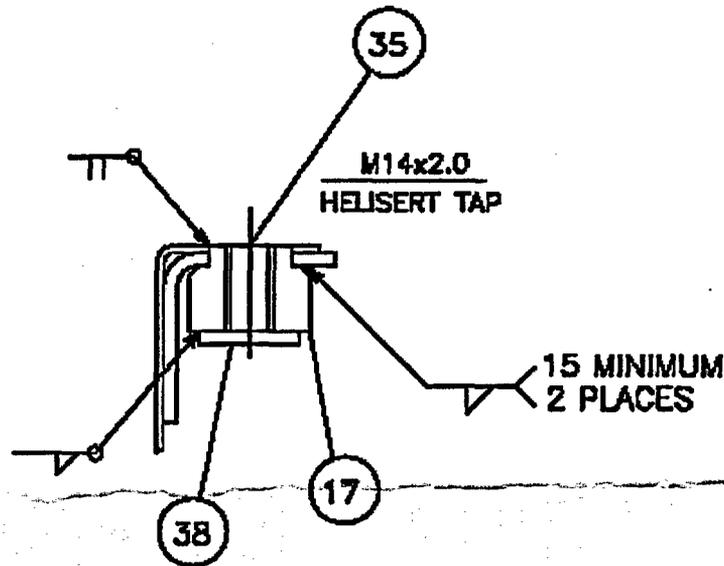
Figure 1 – Cover Mounting Boss, Item #17, Weld Details. License Drawing Requirement in effect at time of shipment, not to size

The missing or under-length fillet welds and missing seal welds on the cover mounting boss (Item #17 of Drawing 105E3738, Revision 4, Sheet 1) are shown on Drawing 105E3738, Revision 4, Sheet 2, Detail C-C. The upper left weld detail represents the seal weld and the right weld detail represents the fillet weld. This first weld seals the boss to the outer shell. The seal weld is not a structural weld but is intended to prevent the ingress of debris (moisture, dirt, etc.) to the interior of the outer container. The fillet weld holds the boss in place to allow bolt insertion and tightening. When the package is assembled and in service, the boss is in compression against the support angle and the outer skin. It is also inserted into the holes in the angle and skin allowing any shear loads to be further transmitted to the angle even in the absence of the seal or fillet weld. Therefore, the missing or under-length welds are non-safety issues. Attachment I, Figure 1, identifies the locations of the missing and under-length welds. Attachment I, Table 1, lists the packages identified with missing or under-length welds and the extent of the deficiencies.

Finding Date	Container Number	Description of Deficiency
12-Sep-2005	RA-042	Missing fillet weld on cover mounting boss
20-Sep-2005	RA-031	Missing fillet weld on cover mounting boss
21-Sep-2005	RA-010	Missing fillet weld on cover mounting boss
24-Sep-2005	RA-058	Missing seal weld on cover mounting boss
3-Oct-2005	RA-003, 041, 049, and 064	Missing or under-length fillet weld on cover mounting boss

FANP has taken immediate action to discontinue use of RAJ-II packages that were not in full compliance with the license drawings. Unfortunately, RAJ-II packagings RA-001 through RA-072 were used to ship fuel assemblies to Browns Ferry in December 2004 and January 2005. Condition 5(a)(3) of the Certificate of Compliance (CoC) [USA/9309/B(U)F-96, Revision 1], in effect at the time of the shipment, requires that the construction of the outer container must be in accordance with Global Nuclear Fuels (GNF) Drawing 105E3738, Revision 4, Sheet 2. The existing license drawing 105E3738, Revision 6, Sheet 2 as indicated in the current Certificate of Compliance (CoC) [Revision 4] does not alter the boss welding details. The package license holder, Global Nuclear Fuel-Americas, LLC (GNF-A), was initially notified of the missing or under-length fillet welds and missing seal welds on the cover mounting boss on October 4, 2005.

The fillet and seal welds are identified as non-safety related in the safety analysis report for the package. As a result, the welds did not receive sufficient QA oversight by the package fabricator, CHT to ensure satisfactory completion of these welds in conformance with the licensing drawings. Additional weld inspections performed by FANP have not shown any further discrepancies. A meeting was held with the package fabricator, CHT on October 27, 2005 to discuss the weld deficiencies. Based on discussions at the meeting and a follow-up inspection of the facility, CHT has upgraded their staffing and inspection protocols to address these issues.
