SUBJECT: PALO VERDE NUCLEAR GENERATING STATION, UNIT 1 - REVIEW OF
STEAM GENERATOR TUBE INSPECTION SUMMARY REPORT
(TAC NO. MC7368)

REVIEW OF THE 2002 AND 2004 STEAM GENERATOR TUBE INSPECTION REPORTS

PALO VERDE NUCLEAR GENERATING STATION, UNIT 1

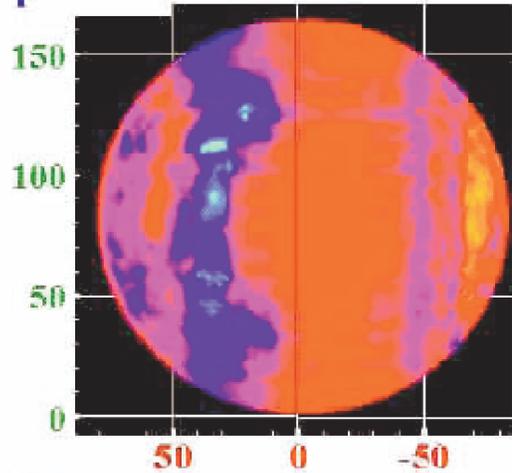
Unit 1 - Palo Verde S/G 12 2001 Inspection

Note:
X and Y axes are displayed in inches.
Conversion:

- Row = Inches * 2.0
- Negative Row = Cold Leg Side
- Column = Inches * 1.1

9H + 9C Level

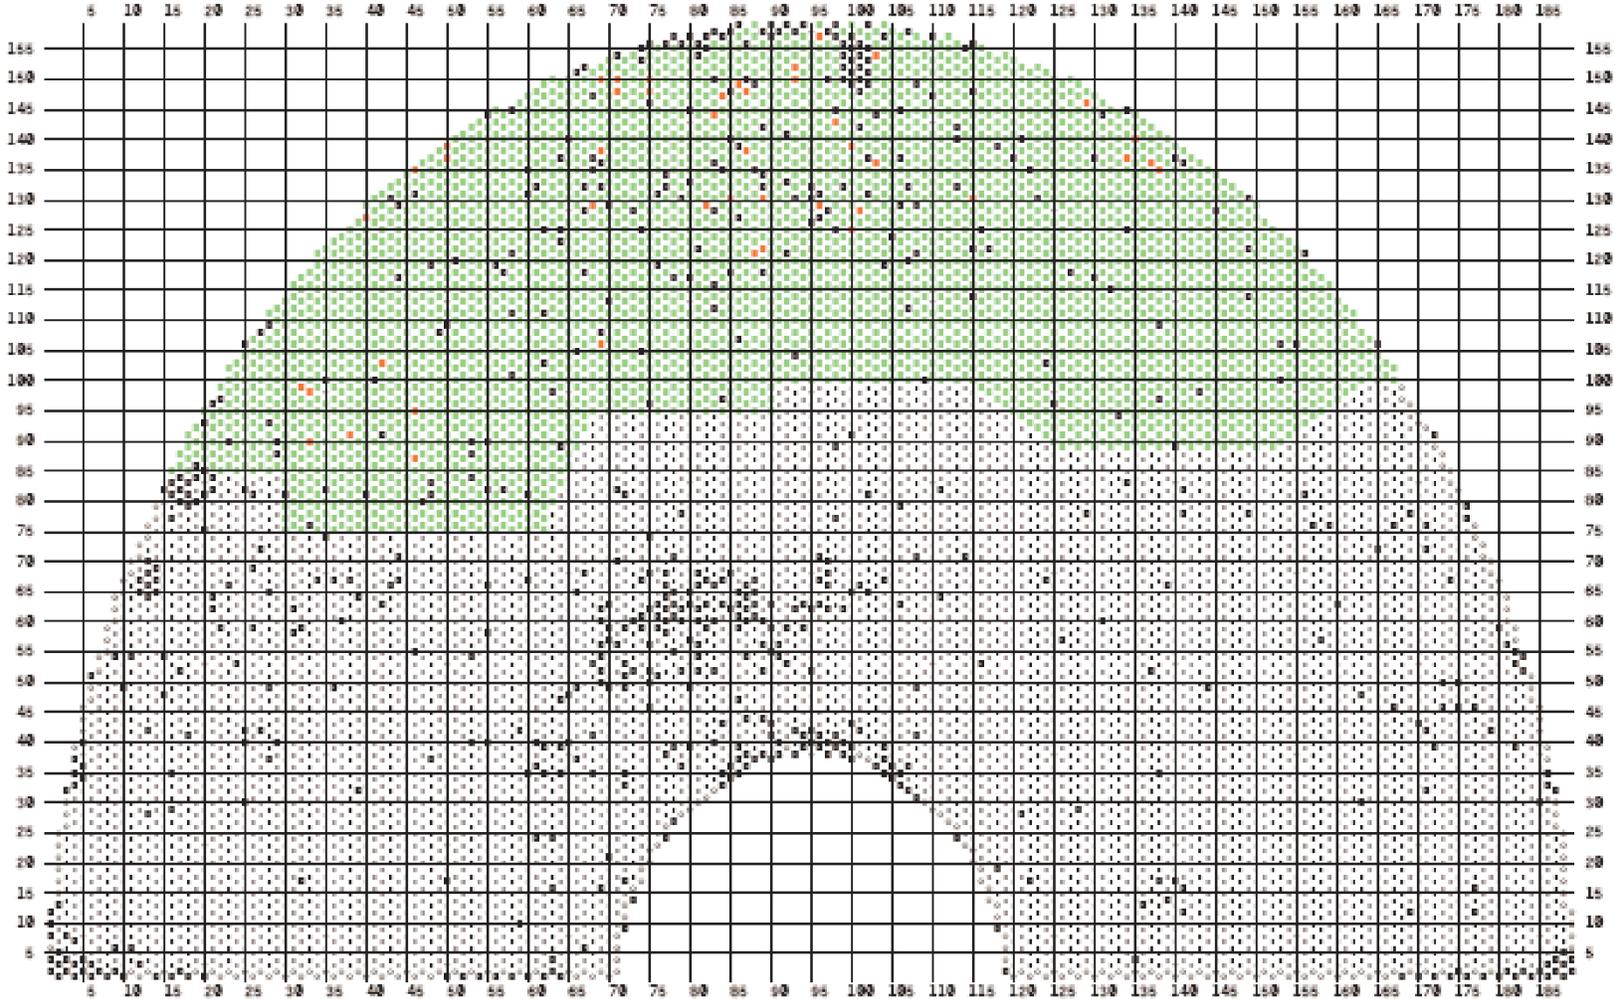
SG - 11 ARC REGION WITH AXIAL INDICATIONS

Yes, all of the axial indications noted during cold-leg ARC examinations were at structures. Axial outer-diameter stress corrosion cracking (ODSCC) was first observed via bobbin coil inspection in the cold leg upper bundle region in U1R10. Unit 1 has been the only Palo Verde unit to observe such findings. In U1R10, the rotating probe examination was expanded to include an additional 464 inspections. There were no freespan ODSCC indications found during that inspection. Based on the U1R10 results, APS performed a degradation assessment and found that the bobbin detected support indications were within a region on the cold leg coincident with moderate scale deposition. This conclusion was reached based on scale profiling results performed prior to chemical cleaning (See Figure). Based on the assessment, APS planned a 25% RPC (~600 tubes per steam generator) inspection from 07C-VS5 during U1R11. Additionally, approximately 100 cold leg bends per steam generator were also inspected as part of Palo Verde’s wear confirmation program. No freespan indications were identified. Therefore, greater than 1800 inspections have been performed over two inspection campaigns with no freespan indications found. The only flaws found by RPC and not called by bobbin coil were at support locations. The maximum depth of these indications were consistent with bobbin coil probability of detection. No structurally significant indications were missed by the bobbin coil. In steam generator 11, 5 of the 11 were detected with bobbin. The maximum depth of indications in each tube not detected by bobbin were sized at: 39, 43, 38, 43, 38, and 33%. In steam generator 12, 3 of the 14 were detected with bobbin. The maximum depth of indications in each tube not detected were sized at: 30, 39, 11, 31, 35, 35, 30, 32, 39, 33, and 33%. In the Cycle 12 Operational Assessment, APS concluded that the bobbin coil provided sufficient POD in this region and no structural or leakage integrity issues were identified.

- 3587 ARC 07H - V33
- 45 SAI, MAI
- * 53 Stay Rod
- 652 Plugged Tube

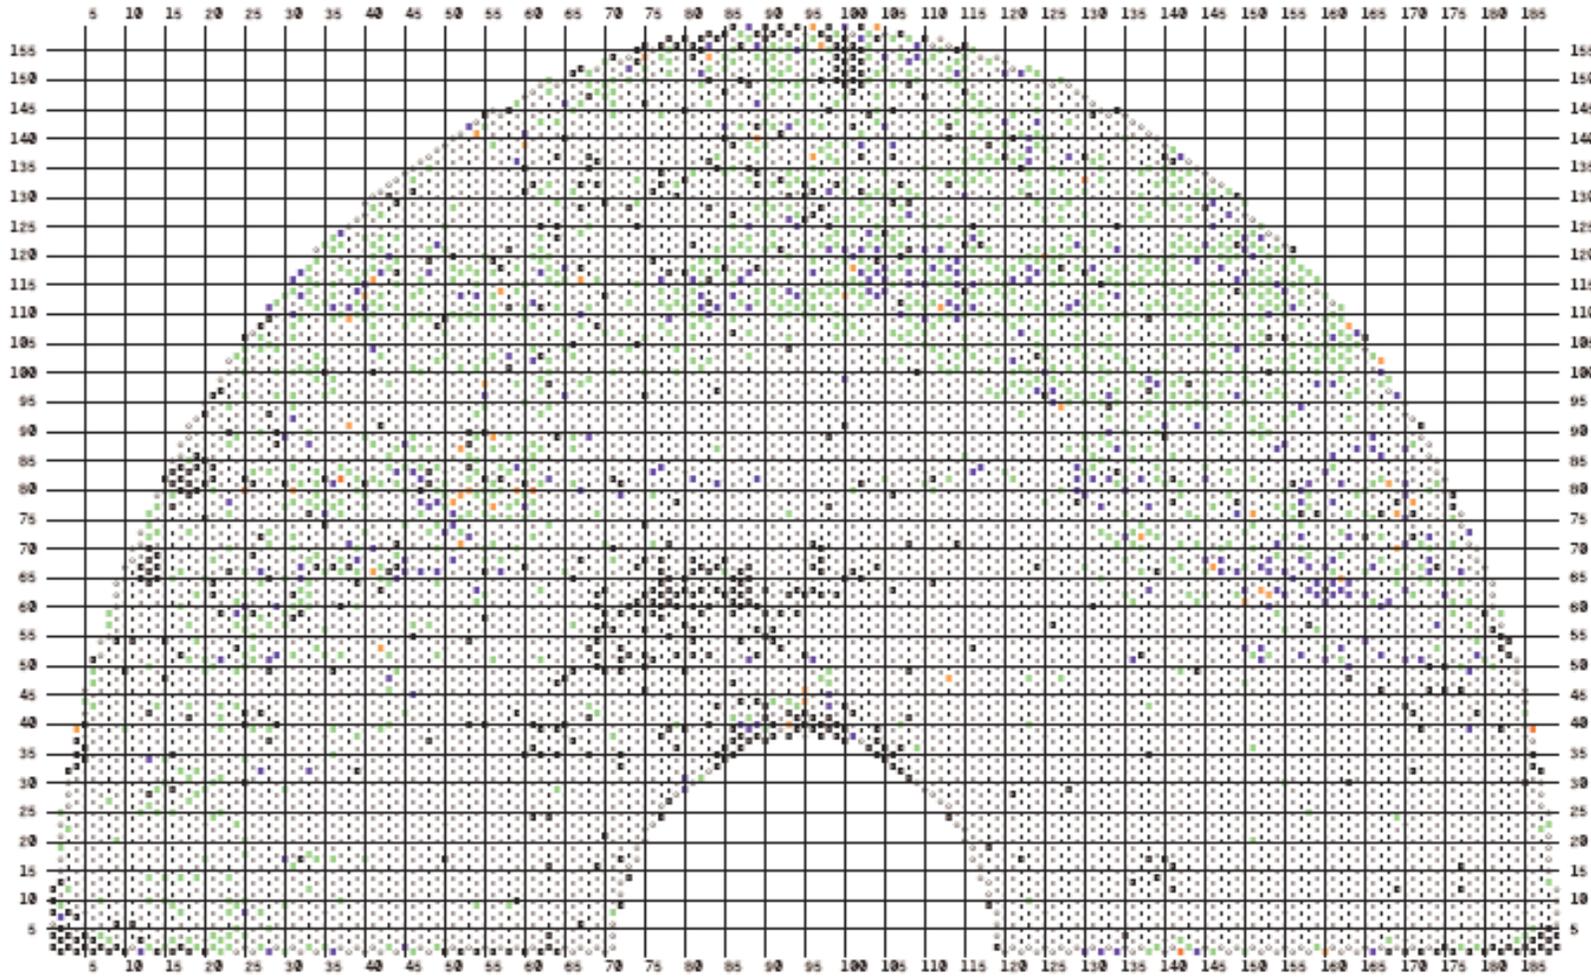
SG - 11 PERCENT INDICATION MAP BOBBIN AND MRPC

- 1277 0% TO 19%
- 324 20% TO 29%
- 51 30% TO 39%
- 6 40% TO 100%
- ★ 53 Stay Rod
