UNITED STATES
NUCLEAR REGULATORY COMMISSION
REGION III
799 ROOSEVELT ROAD
GLEN ELLYN, ILLINOIS 60137

SUBJECT: INVESTIGATION OF DEFECTIVE URANIUM HEXAFLUORIDE (UF₆)
CYLINDER VALVE INCIDENT AT COMBUSTION ENGINEERING, INC. (CE)
(HEMATITE) FACILITY

Inspection Report No. 70-0036/9002 (CE-Hematite facility) Conducted
on April 23-27, 1990

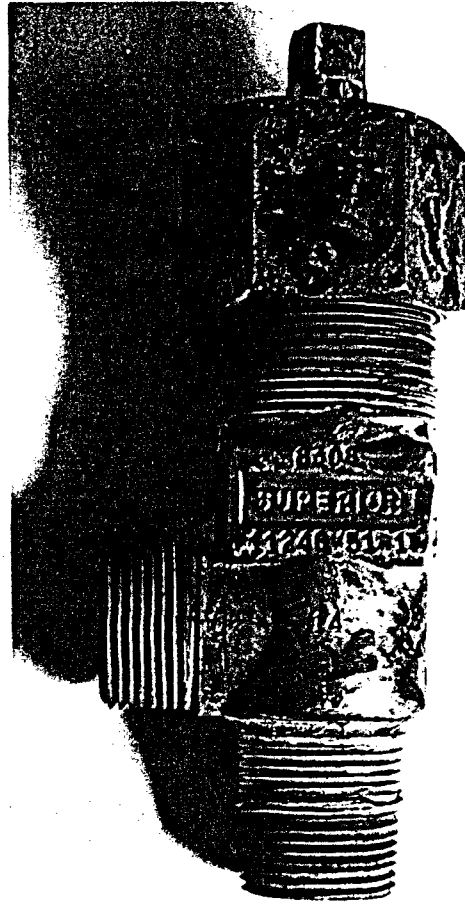
Figure 1

- a. Excessive stresses placed on the nut by cold flow and thermal expansion of the teflon packaging rings, resulting from retightening of the nut and repeated heating of the valve;
- b. Mechanical and structural characteristics of the packing nut material are incompatible with these stresses; and
- c. The presence of uranium hexafluoride, hydrofluoric acid, and nascent hydrogen facilitates cracking.

Photographs taken of the failed valve at CE-Hematite were examined at NRC Headquarters and the type of failure was found to be the same as addressed in Information Notice No. 89-78.

2. Reviewed the failure mechanism of the packing nut with the licensee. Further investigation of their specific failed valve was not warranted, due to similarity to other failed valves.

Crack 270°, 1/8"
Wide Along Edge of
Packing Nut

Cracked Packing Nut
CE-Hematite Facility

1. Reviewed Information Notice No. 89-78 with engineering personnel to be sure they understood the proper methods for torquing the packing nut. The licensee had not seen, nor were they aware of this Information Notice.

5. Reviewed ORO-651, Revision 5 document, "Uranium Hexafluoride: Handling Procedures and Container Criteria" with licensee. The licensee's hook-up and leak checking procedures (OS-601.5) for UF₆ cylinders were not adequate for finding a leak prior to pressurization with UF₆ gas. More specific instructions (consistent with ORO-651) have been incorporated into their operating procedure.
