UNITED STATES
 NUCLEAR REGULATORY COMMISSION
 REGION I
 476 ALLENDALE ROAD
 KING OF PRUSSIA, PENNSYLVANIA 19406

Subject: Inspection Number 70-1100/90-07

Report No. 70-1100/90-07

Facility Name: Nuclear Fuel Manufacturing and Nuclear Laboratories

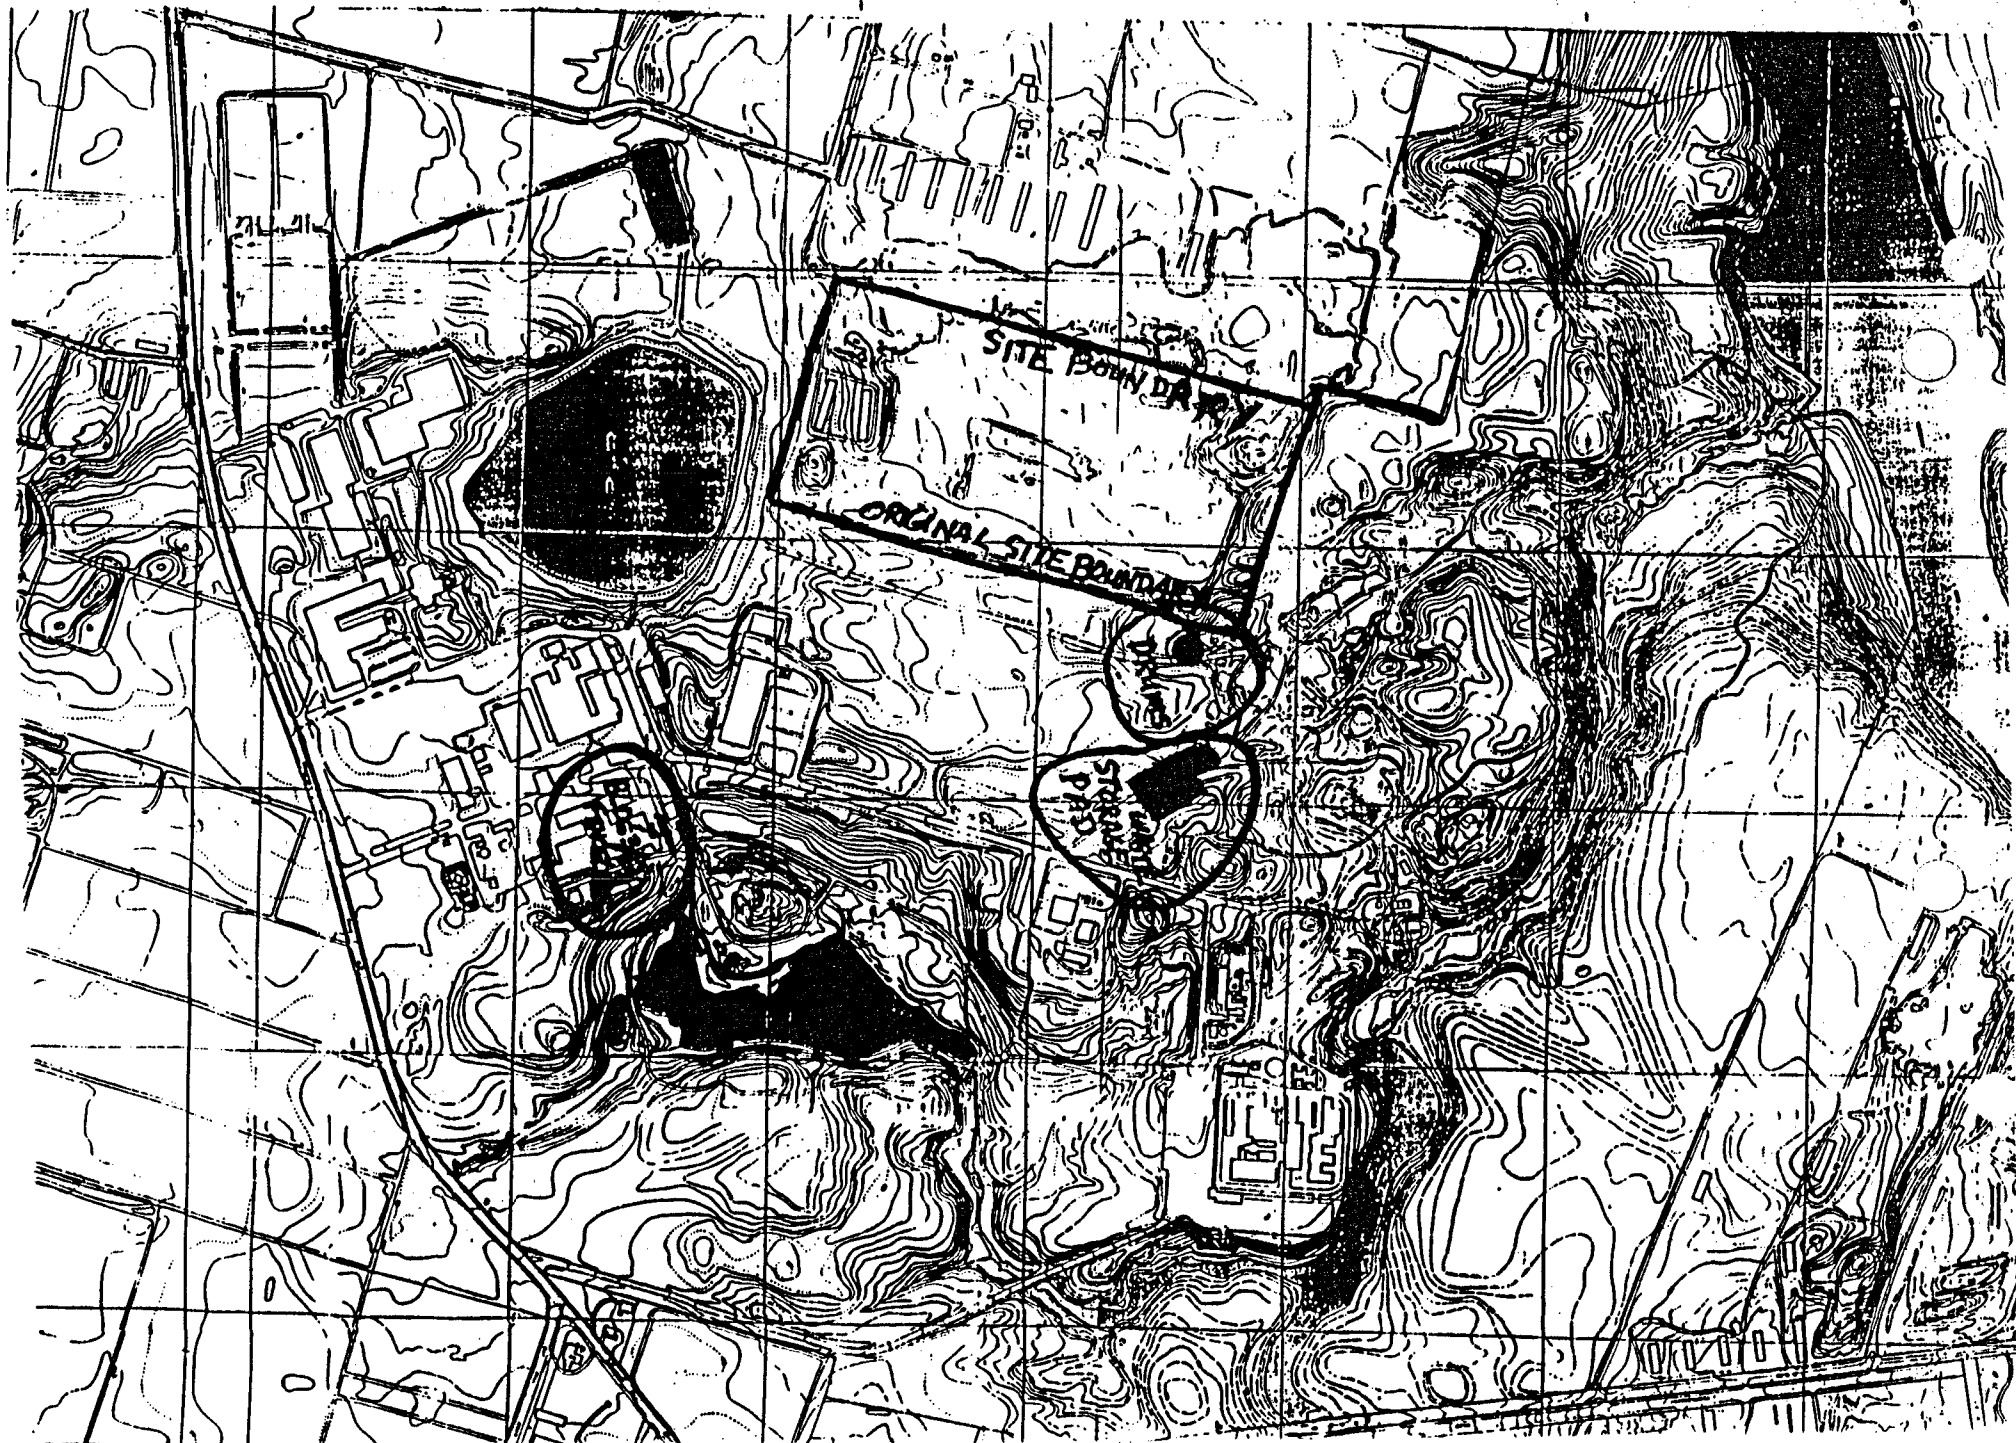
(Refer to Attachment 1 for the approximate location of each area.)

Through discussions with licensee representatives, the inspector determined that the licensee had essentially completed soil

sampling needed for characterization of this area and expected to develop decontamination plans and procedures over the winter.

Prior to this inspection, licensee representatives informed the inspector that an old drum storage area had been identified along the former west site boundary. In about mid-1985 the licensee purchased an additional piece of property which extended the west site boundary out about 900 feet further to the west. During this inspection the inspector examined the old drum storage area and noted that the storage area was a pit about 50 feet in diameter and appeared to be about three or four drums deep. Preliminary analytical results obtained by the licensee indicated that the total uranium contamination present in the soil in the pit ranged from 80 to 9000 picocuries per gram of soil and was enriched in excess of 50 percent uranium-235. After discovery of the drums, the licensee placed two groundwater wells to the north and northeast of the area. Preliminary analysis of groundwater samples indicated that neither uranium nor other USEPA regulated chemicals were present in the ground water in excess of established limits. Subsequent to this inspection, the inspector was informed, on November 19, 1990, that the licensee had initiated removal of some of the drums from the area. The drums were repackaged as appropriate and stored in a controlled area. About 26 drums were removed from the storage pit, down to a depth of about 10 to 12 feet. The opened drums were filled with contaminated trash, plastics, floor tiles, metal parts, fencing, etc. Mud present in one of the drums was found to contain uranium in excess of 40 picocuries total uranium per gram of soil. This uranium was also enriched in excess of 50% uranium-235. The licensee does not expect to perform additional remediation activities in this area between December 1, 1990 and the Spring of 1991 because of expected poor weather conditions.

As a result of environmental surveys conducted around Building 6, the site radioactive liquid waste storage facility, the licensee identified elevated contamination areas along the fenceline separating Building 6 from the adjacent Building 3. The fence is located on the north side of Building 3. Soil analysis had not been completed as of the end of this inspection. Further licensee actions in this area will be followed during subsequent inspections.
