SUBJECT: Calvert Cliffs Nuclear Power Plant
Unit No. 1; Docket No. 50-317
Class 1 Piping Operability Evaluation Submittal per Code Requirements

**CALVERT CLIFFS NUCLEAR POWER PLANT
OPERABILITY DETERMINATION NO. 05-004R1**

Title: Prediction of potential crack growth of weld indication.

Appendix 1: Structural Integrity Calculation No. CCNP-06Q-301, "Prediction of Potential Crack Growth Rate of Weld Indication found in the Unit 1 Shutdown Cooling Outlet Nozzle Safe-End-to-Pipe Weld," Rev. 0.

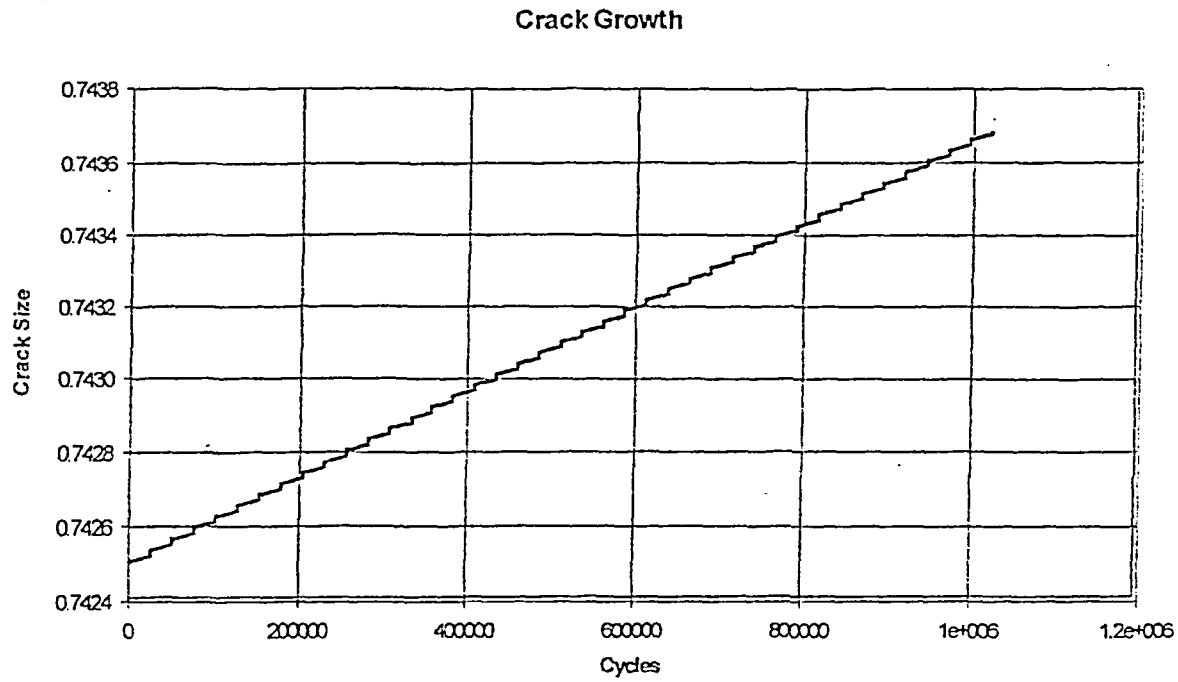
Figure 1: Fatigue Crack Growth

pc-CRACK software using ASME Code, Section XI elliptical surface crack in infinite plate model and the transient load cases described above as input calculated the fatigue crack growth for the next two operating cycles. Supporting calculations are contained in the project files.

The observed indication was 66% of the wall thickness at the time of the 1994 UT examination and the ASME Code allowable flaw depth is 75% of the wall thickness. The crack depth, including fatigue crack growth for the period from 1994 to 2005 is 0.7428 inches. The crack depth, including fatigue crack growth, for the next two operating cycles, through April 2010 is 0.7429 inches. This indicates that there is 9% of wall available to accommodate any potential future crack growth after two more operating cycles. The growth of the indication length is on the same order as the crack depth.

results, it is concluded that operation for at least the next two operating cycles is justified with the observed indication left as-is.
