Industry NDE of North Anna 2 RPV Head Penetrations 31 & 59

Review Meeting for NRC RES NA2
CRDM Program

18 January 2006

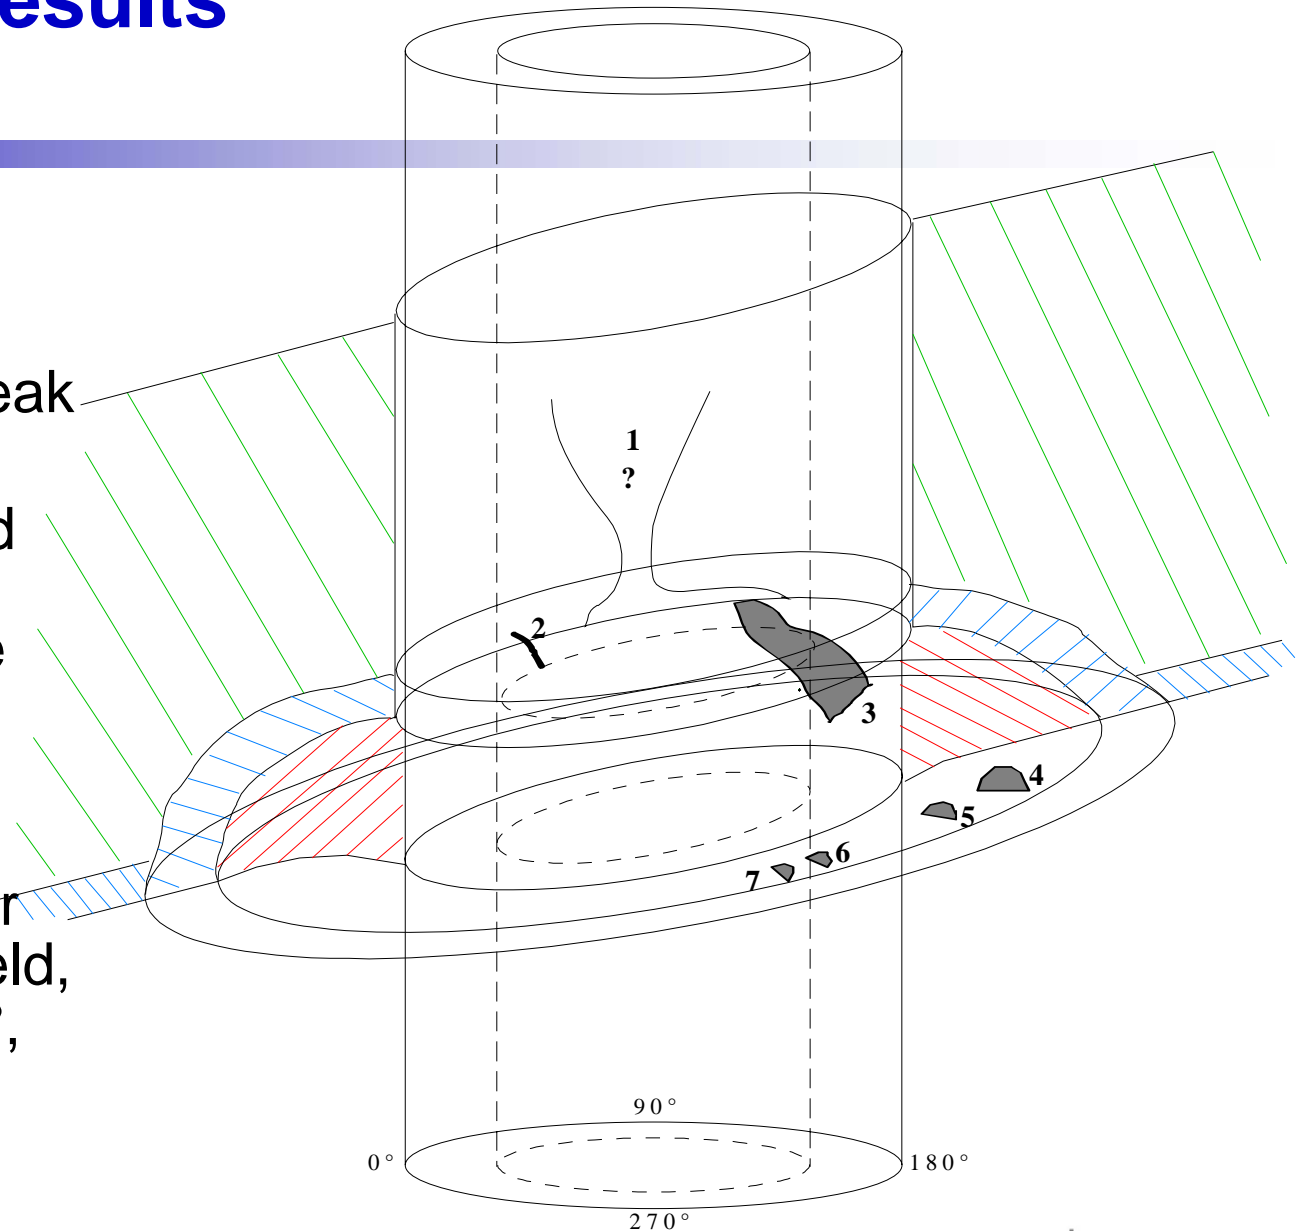
Field NDE Results

- **Penetration 31:**
- **Visual: leaking**
- **UT 1:** possible leak path, 80/120°
- **UT 2:** nozzle mid wall indication, 0.28", above the weld, 300/304°
- **ET 3 to 7:** weld surface axial indications, outer portion of the weld, 154°, 209°, 235°, 264°, 265°

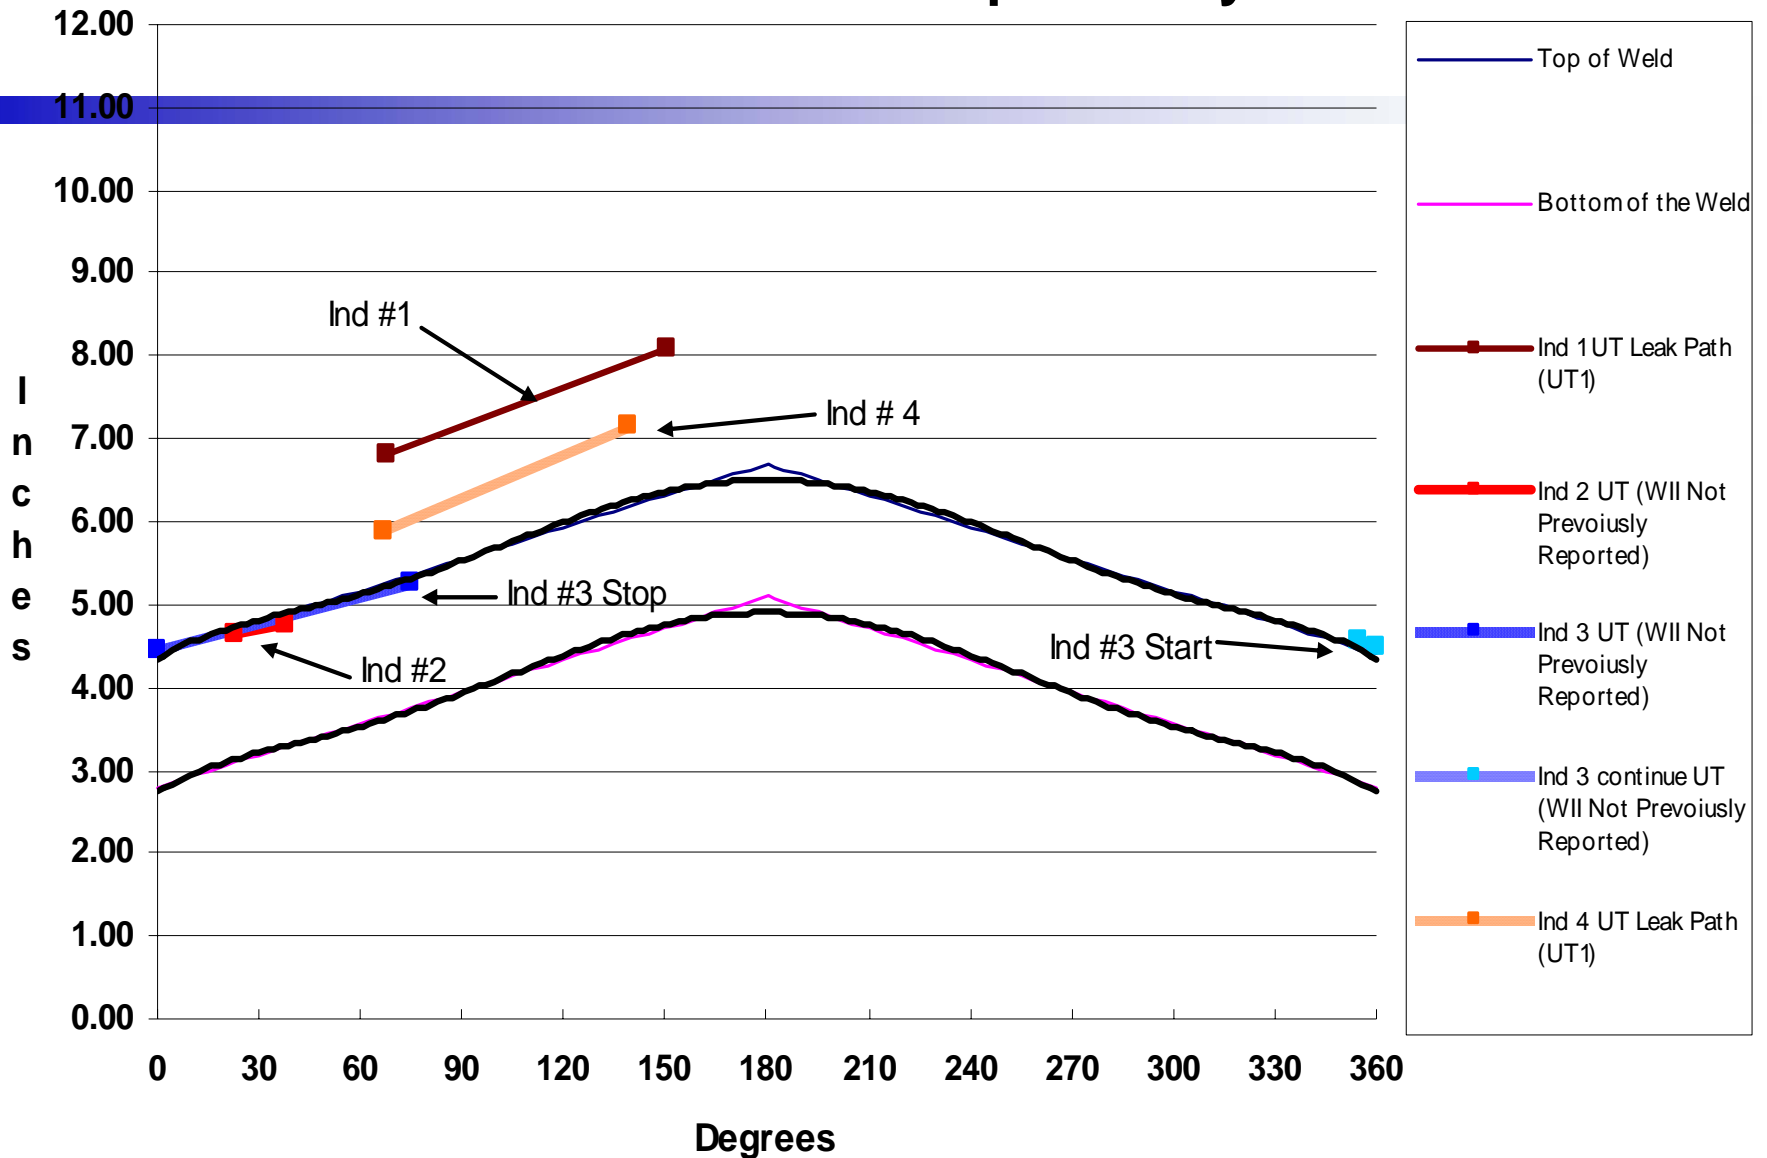
Nozzle 31 UT Indications Reported by Vendors

- Three vendors inspected the nozzle to various degrees
 - UT & ET tube ID and EMATS
 - EMATS data was inconclusive due to upper end adaptor signal interference
 - J-Groove weld wet surface not inspected
 - A new technology (ET) identified a possible leak path
 - UT reported intermittent Weld Interface Indications (WII) 360° around the interface of the J-Groove to tube

- Visual: Not Applicable
- **UT 1:** Two vendors reported possible leak path
- **UT 2:** Mid wall indication not reported
- **ET 3 to 7:** No vendor examined this region
- ***Newly reported UT LOF intermittent around weld, ET Permeability Variation (PV) indications above weld and ET (Low Freq) possible leak path***

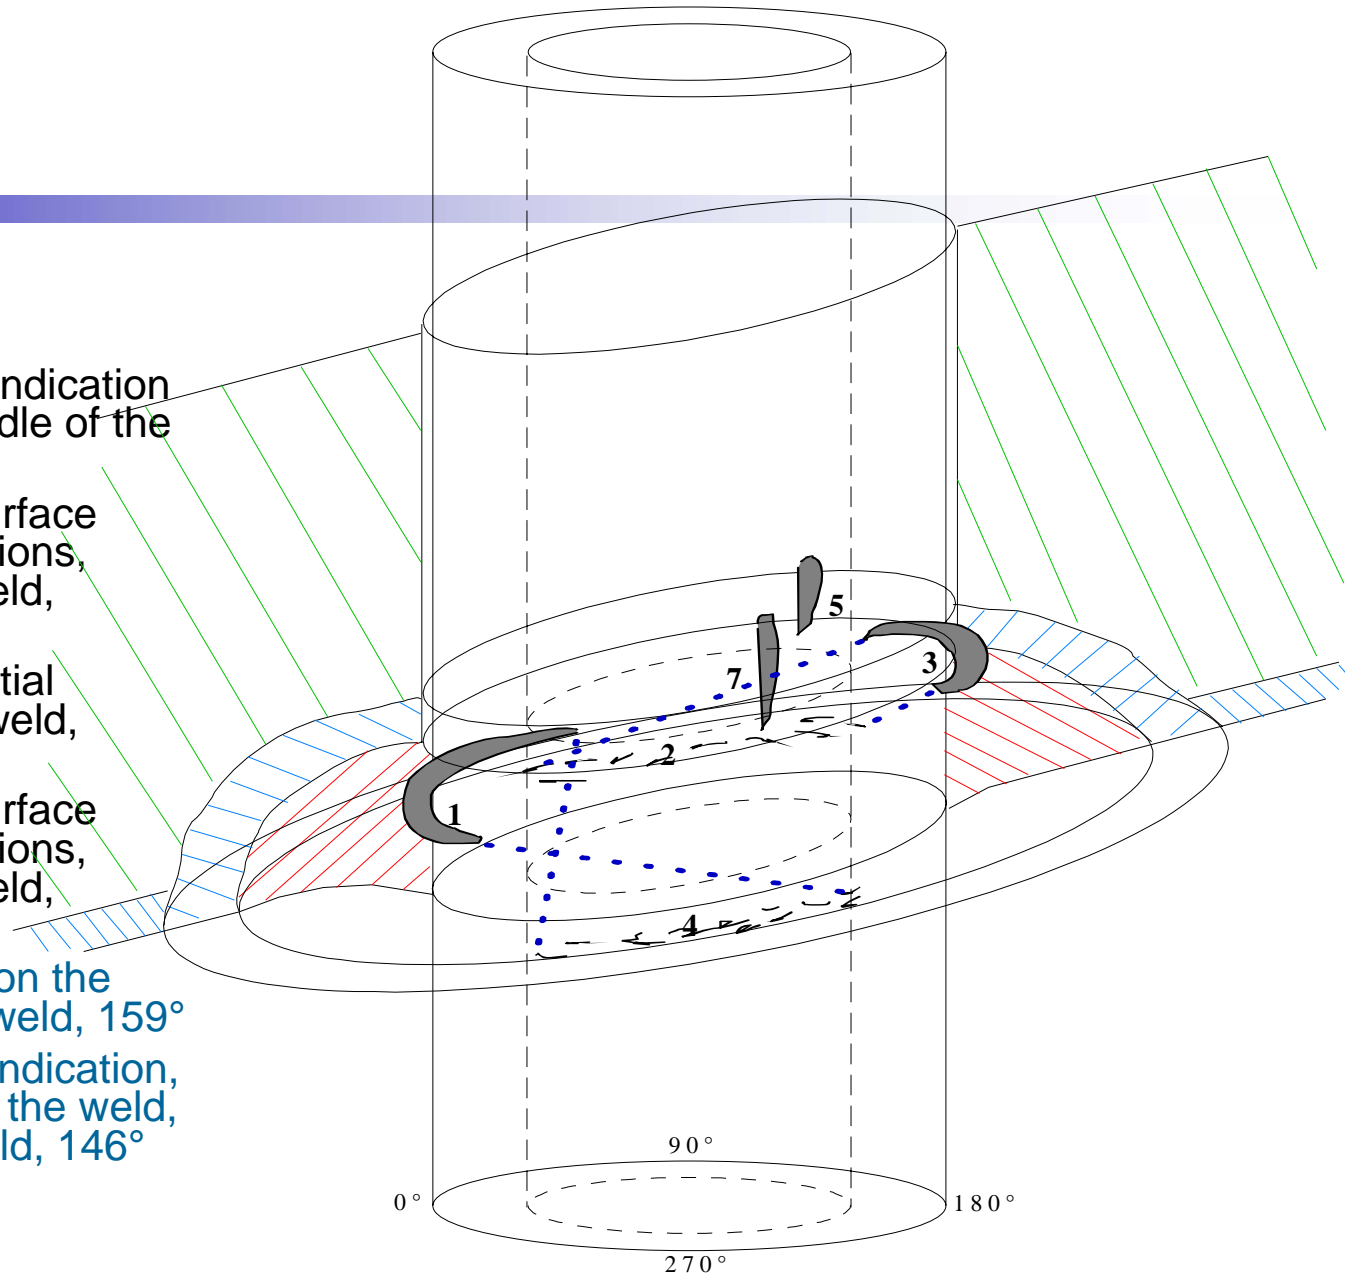
Field NDE Results

- **Penetration 59:**
- **Visual : masked**
- **UT 1:** circumferential indication at the nozzle OD, middle of the weld, 347/63°
- **ET 2:** multiple weld surface circumferential indications, outer portion of the weld, 49/136°
- **UT 3:** OD circumferential indication, top of the weld, 156/206°
- **ET 4:** multiple weld surface circumferential indications, outer portion of the weld, 256/306°
- **UT 5:** axial indication on the nozzle ID, above the weld, 159°
- **ET 7:** axial nozzle ID indication, opposite (?) middle of the weld, extends above the weld, 146°

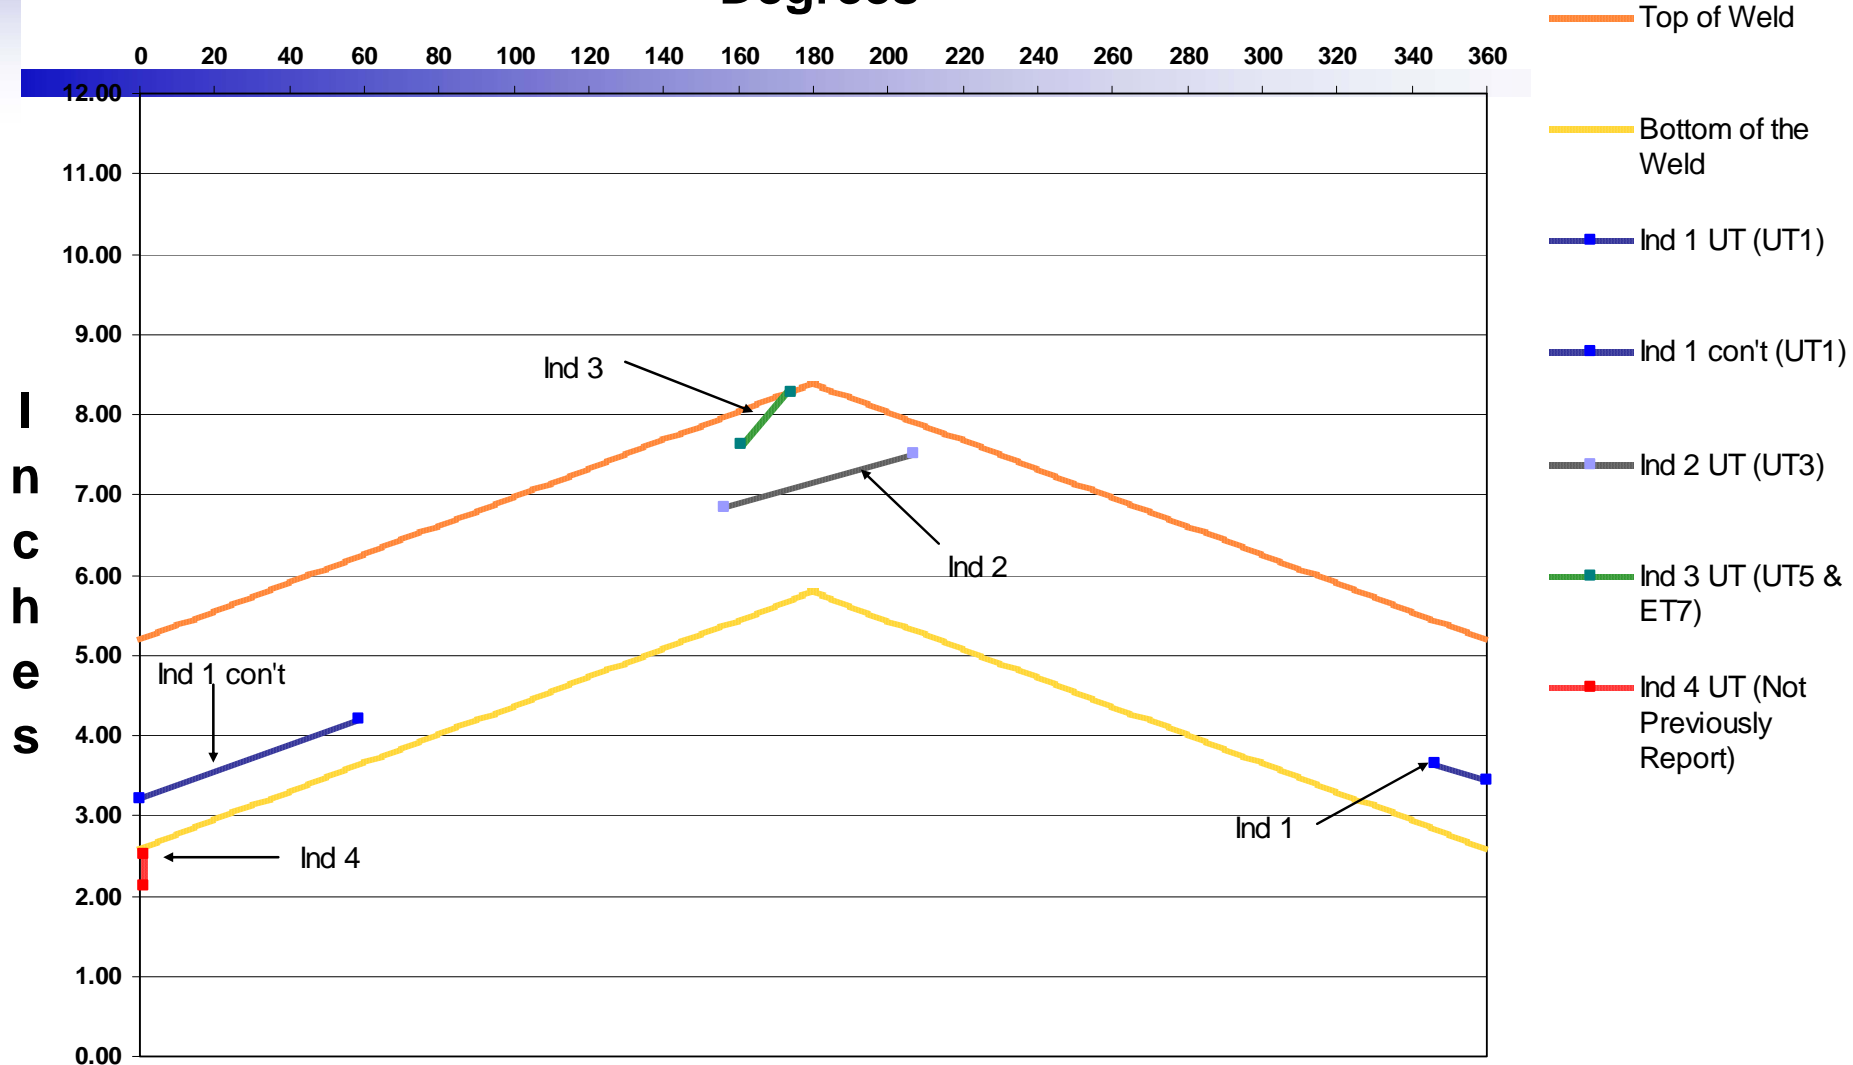
Nozzle #59 UT Indications Reported by Vendors

- Three Vendors inspected the nozzle
 - UT, ET, and EMATS
- J-Groove weld wet surface not inspected at PNNL
 - Indications 2 and 4 in the weld wetted surfaces were reported in the original field NDE. These were not re-inspected
- UT reported one additional axial indication, not reported during field NDE
- This penetration has indications to penetration 54

- **UT 1:** One vendor reported same indication
- **ET 2:** No vendor inspected this region
- **UT 3:** One vendor reported same indication
- **ET 4:** No vendor inspected this region
- **UT 5:** One vendor reported same indication
- **ET 7:** One vendor reported indication with ET and one vendor with UT
- ***One new axial indication was reported using UT***
